Evaluation of Fracture Resistance for Autopolymerizing Acrylic Resin Materials Reinforced with Glass Fiber Mesh, Metal Mesh and Metal Wire Materials: An *in Vitro* Study

Reem Abdulrahim

Department of Prosthodontics, Atatürk University, Erzurum, Turkey

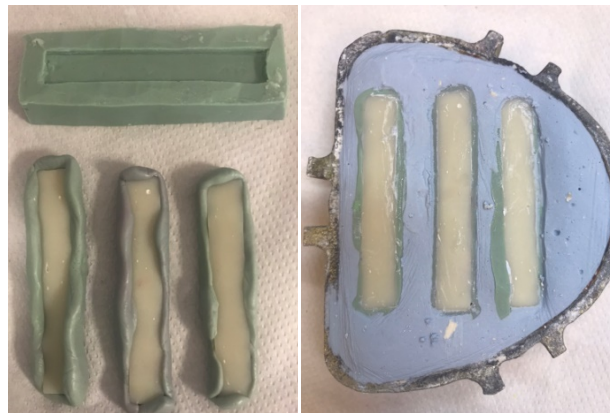
Figure 2. Silicone base specimens with petroleum jelly in the flask.

For the purpose of standardization of the fracture line the following measurements were done in the silicone base specimens (**Figure 1, Figure 2**).

All of these specimens were coated with a thin layer of petroleum jelly and three pair of plates was invested in dental stone (Type III) in the lower half of flask making sure that one half of the thickness was embedded in the stone put in base of the flask. Care was taken so that the plates were placed keeping sufficient distance between them and also from the walls of the flask.

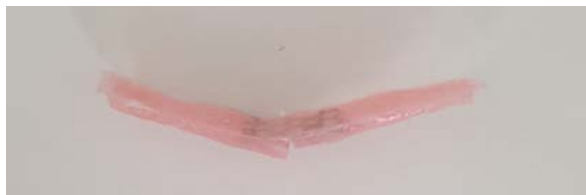
Figure 3. Bending of the sample.

These samples have showed fracture at the side of sample rather than in the middle area and some other samples showed bending statue rather than fracture when submitted to Fracture resistance test (**Figure 3**, **Figure 4**).

Typical fracture sites for the respective groups are presented in **Figure 4**. All specimens in group I fractured at the interface between the heat-polymerized and autopolymerized acrylic resins. On the other hand, all specimens in group II and group IV fractured at the side of the autopolymerized acrylic resin. **Figure 4**, while in group III the specimens showed bending in the middle site rather than fracture **Figure 3**.

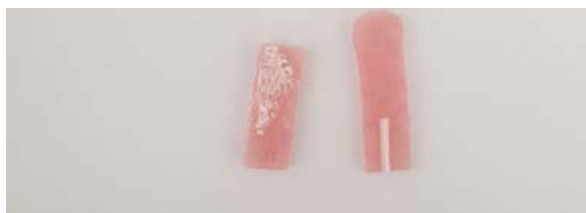
Figure 4. Fracture at the side of reinforcement.

Irregular deformations that occur at side of the reinforcement area of denture base material indicated that fracture strength at the connection side between heat cure acrylic resin and reinforcement area within the autopolymerized acrylic resin was higher than middle area of reinforcement side which indicates the stress concentration against compressive loads at the side more than the center area [23].
