Replacement of Unesthetic Posterior Metal Crowns with Monolithic Zirconia Crowns: A Case Report

Mitsunori Uno, Hajime Ishigami

Department of Prosthodontics, Division of Oral Functional Science and Rehabilitation, School of Dentistry, Asahi University, Mizuho, Japan

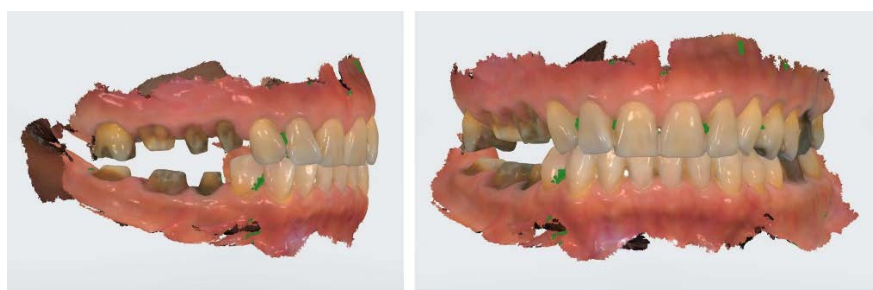
Figure 3. Optical impressions and maxillomandibular relationship records taken using an intraoral scanner (Trios3®).

Zirconia crowns were fabricated based on this model. They were then tried in the oral cavity, and the necessary occlusal adjustments were made. The inner surfaces of the crowns were alumina blasted, followed by application of Clearfil® Ceramic Primer (Kuraray Noritake Dental Inc, Tokyo, Japan), which contains the acidic functional monomer 10-methacryloyloxydecyl Dihydrogen Phosphate (MDP). The tooth surfaces were polished with a fluoride-free dental polishing agent, followed by etching with 37% phosphoric acid (K-etchant gel, Sunmedical Inc, Tokyo, Japan) and application of Panavia V5 Tooth Primer (Kuraray Noritake Dental Inc). The restorations were polished (ZircoShine; Shofu, Japan) to achieve a mirror-like finish and placed on the teeth with a dual-cured resin cement (Panavia V5).

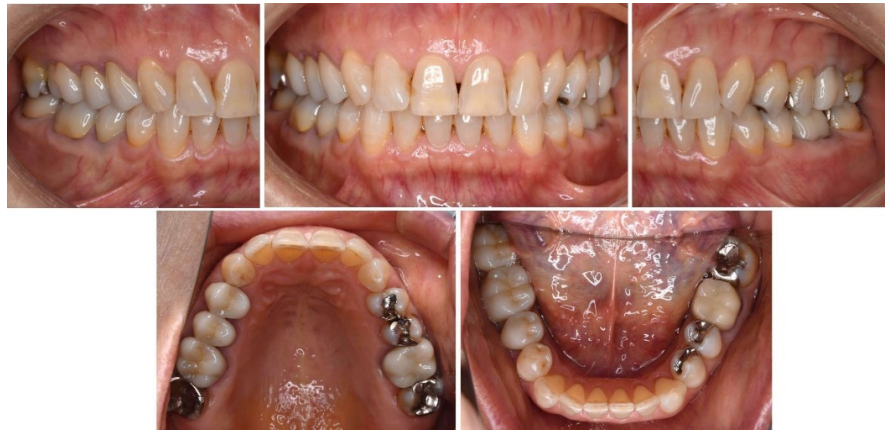
Figure 4. Intraoral photographs taken after placing the prostheses.

Subsequently, the patient requested restorative treatment of teeth 26 and 36. Using a similar approach, we placed a zirconia crown on tooth 26. Tooth 36 underwent root canal treatment and filling, followed by construction of the abutment using a fiber post and Clearfil DC Core Automix (Kuraray Noritake Dental Inc). The patient expressed a preference for final restoration with a composite resin CAD/CAM crown, and the crown was fabricated and placed intraorally using standard procedures (**Figure 4**).

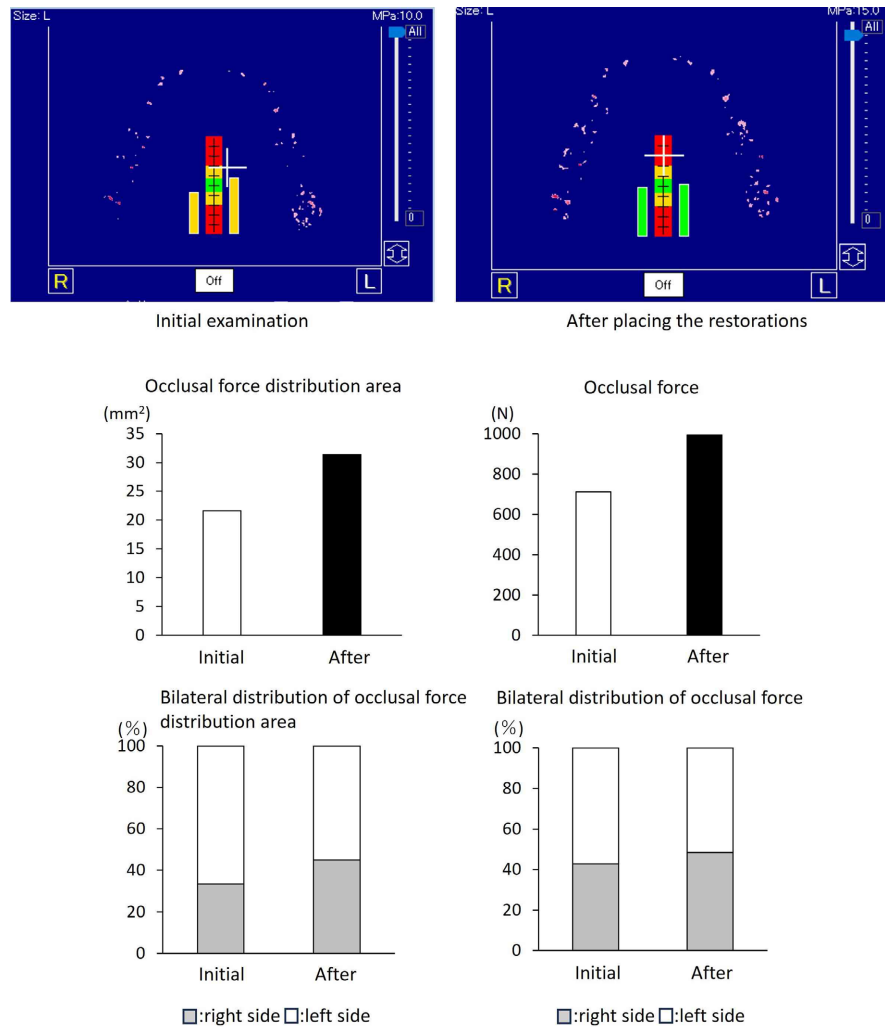
Treatment outcomes were objectively evaluated through occlusal contact examination using a pressure-sensitive film (Dental Prescale, GC, Tokyo, Japan). The occlusal force distribution area increased from 21.6 mm² at initial examination to 31.4 mm² after placing the restorations. Further, the force distribution at initial examination (right side: 33.5%, left side: 66.5%) improved on placement of the restoration (right side: 45.1%, left side: 54.9%). The occlusal force increased from 711.4 N at initial examination to 994.5 N after restoration placement, and the bilateral distribution at initial examination (right side: 42.7%, left side: 57.3%) improved after restoration placement (right side: 48.4%, left side: 51.6%) (**Figure 5**). Moreover, the Oral Health Impact Profile short form (OHIP-14) score [4] decreased from 7 points at initial examination to 0 points after the restorations were placed.

Figure 5. Objective evaluation of the treatment effect on occlusion.

Pretreatment occlusal assessment showed that only 33.5% of occlusal forces were distributed on the right side, indicating the need for occlusal treatment. The patient first received provisional restorations, which were adjusted to qualitatively increase occlusal contact points and contact area. The patient was closely monitored to ensure stable stomatognathic function, and the final restorations were fabricated based on optical impressions taken using an intraoral scanner.
