# Understanding Durability Problems with Dolerite in Roads in South Africa

Akhona Futshane<sup>1</sup>, Philip Paige-Green<sup>2</sup>, Joseph K. Anochie-Boateng<sup>3</sup>

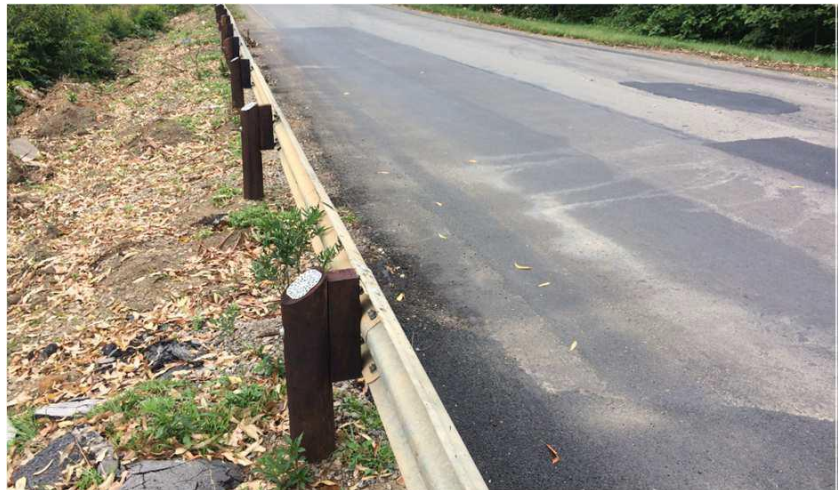
**Figure 2.** (a) Surface defects and pavement failures (site A); (b) Surface defects and pavement failures (site B); (c) Surface defects and pavement failures (site C); (d) Surface defects and pavement failures (site D).

The location and climatic zones of the investigation sites are indicated in **Table 3** and **Figure 1**. Surface and pavement distresses observed during visual condition assessment (VCA) are discussed in **Table 4** and shown in **Figures 2(a)-(d)**. The VCA was conducted following the [14] guidelines.

Site	Findings
A	Rutting was dominant. The reason for rutting was due to the deformation of the base and specifically because the quality of the base has been compromised. The reason was not very clear, but it was expected that secondary weathering of the dolerite had taken place. It was noted that even though the same material was used in the subbase, the PI in the subbase was less due to better protection and reduced traffic loads.
B	The failures consisted of crocodile cracking observed in the continuous medium grade asphalt layer with rolled in chips (RIC), occurring randomly on all the traffic lanes constructed recently, both in the southbound and northbound direction carriageway.
C	Several isolated small potholes were found along the road which was badly damaged due to the structural pavement layers failing. Potholes formed extensively and have to be repaired often. All road distress features have resulted in the premature failure of the pavement.

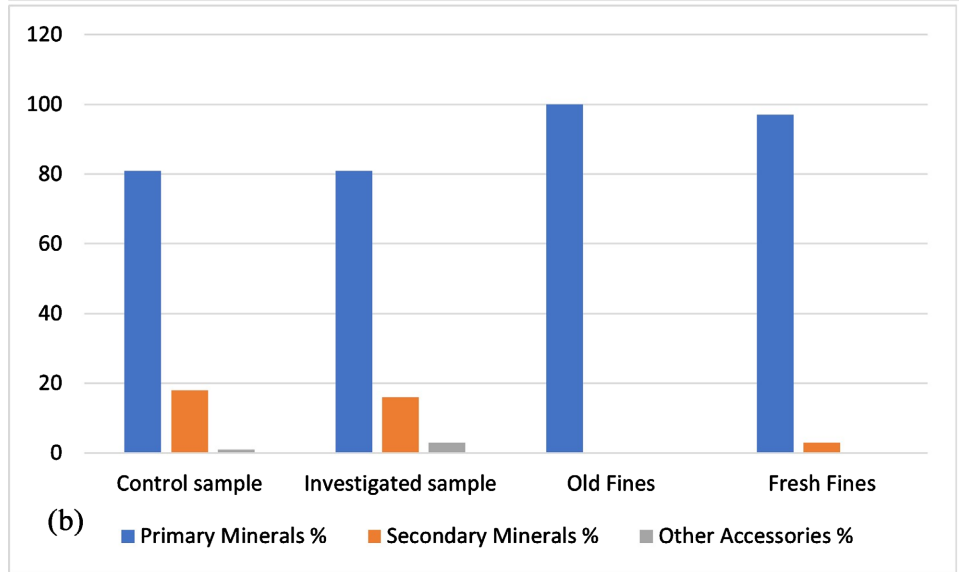
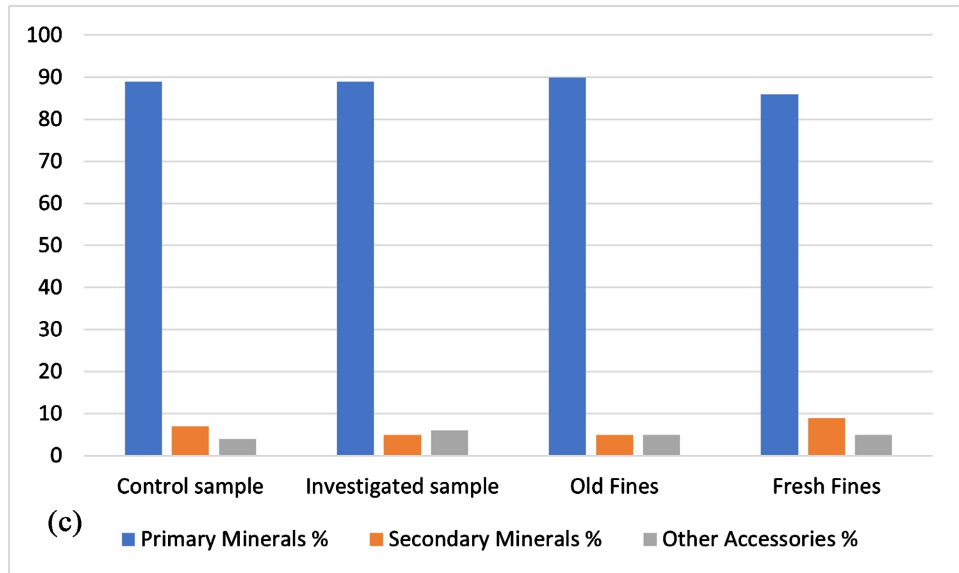
**Figure 3.** (a) Mineral composition and quantification (site A); (b) Mineral composition and quantification (site B); (c) Mineral composition and quantification (site C); (d) Mineral composition and quantification (site D).

The mineral composition of Investigated samples and Control samples for the Crushed Stone Method are indicated in **Table 13**. The results of the control samples are shown in parentheses. The results are also shown from **Figures 3(a)-(d)** presented as Control sample and Investigated sample.

The mineral composition of Investigated samples and Control samples for the Fines Method are indicated in **Table 14** and shown from **Figures 3(a)-(d)** presented as Old fines and Fresh fines. The results of the control samples are shown
