# Flood Hazards in Erbil City Kurdistan Region Iraq, 2021: A Case Study

## Abstract

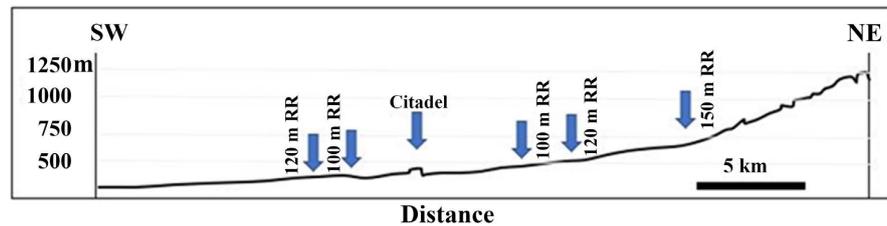
**Figure 1.** Topographic cross section showing different gradients (Note that RR on the graph denoted the Ring Road).

410 m (a.s.l.). The gradient of the plain decreases southwest wards from 4.79% in the northern part to 0.54% in the southern part of the plain “**Table 1**”. Tens of ephemeral wadis dissect the plain flowing mainly SW wards “**Figure 1**”.

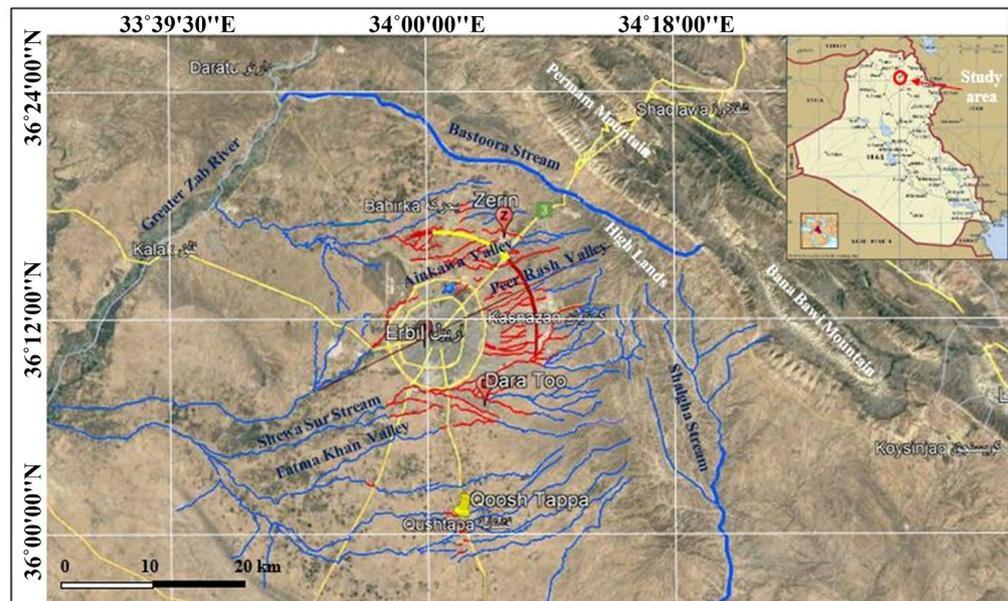
**Figure 2.** Satellite image showing Erbil city, the main wadis, streams, and location map. Note that majority of the wadis disappear in the city.

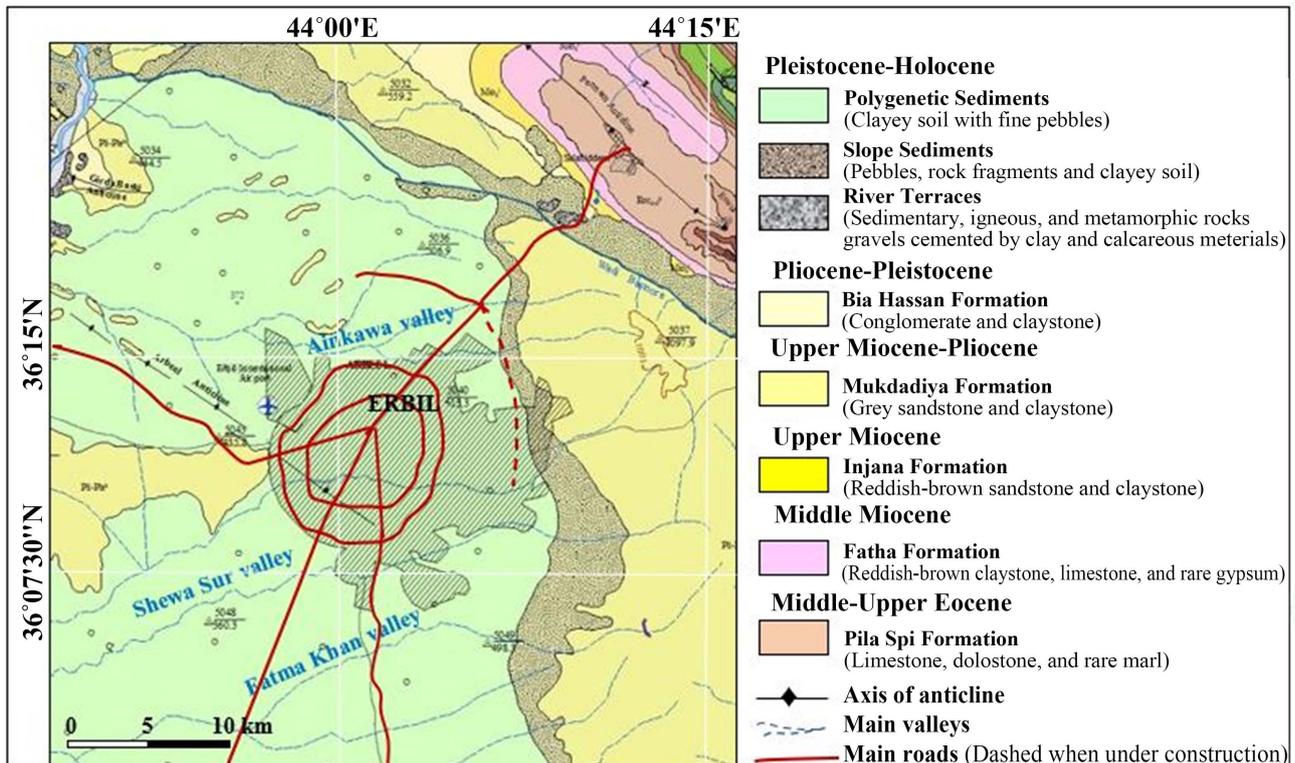
The main part of the studied area is covered by polygenetic sediments, which consists mainly of alluvial fan sediments. In the northeastern part, the rocks of the Bai Hassan Formation are exposed (**Figure 3**). They consist of coarse conglomerate alternated by thick reddish-brown claystone with rare reddish-brown sandstone [9]. The claystone beds are the source of the muddy floods.

**Figure 3.** Geological Map of the studied area and near surrounding (Modified from [8]).
