Is Mosul Dam the Most Dangerous Dam in the World? Review of Previous Work and Possible Solutions

Nadhir Al-Ansari¹, Nasrat Adamo¹, Varoujan Sissakian², Sven Knutsson¹, Jan Laue¹

Abstract

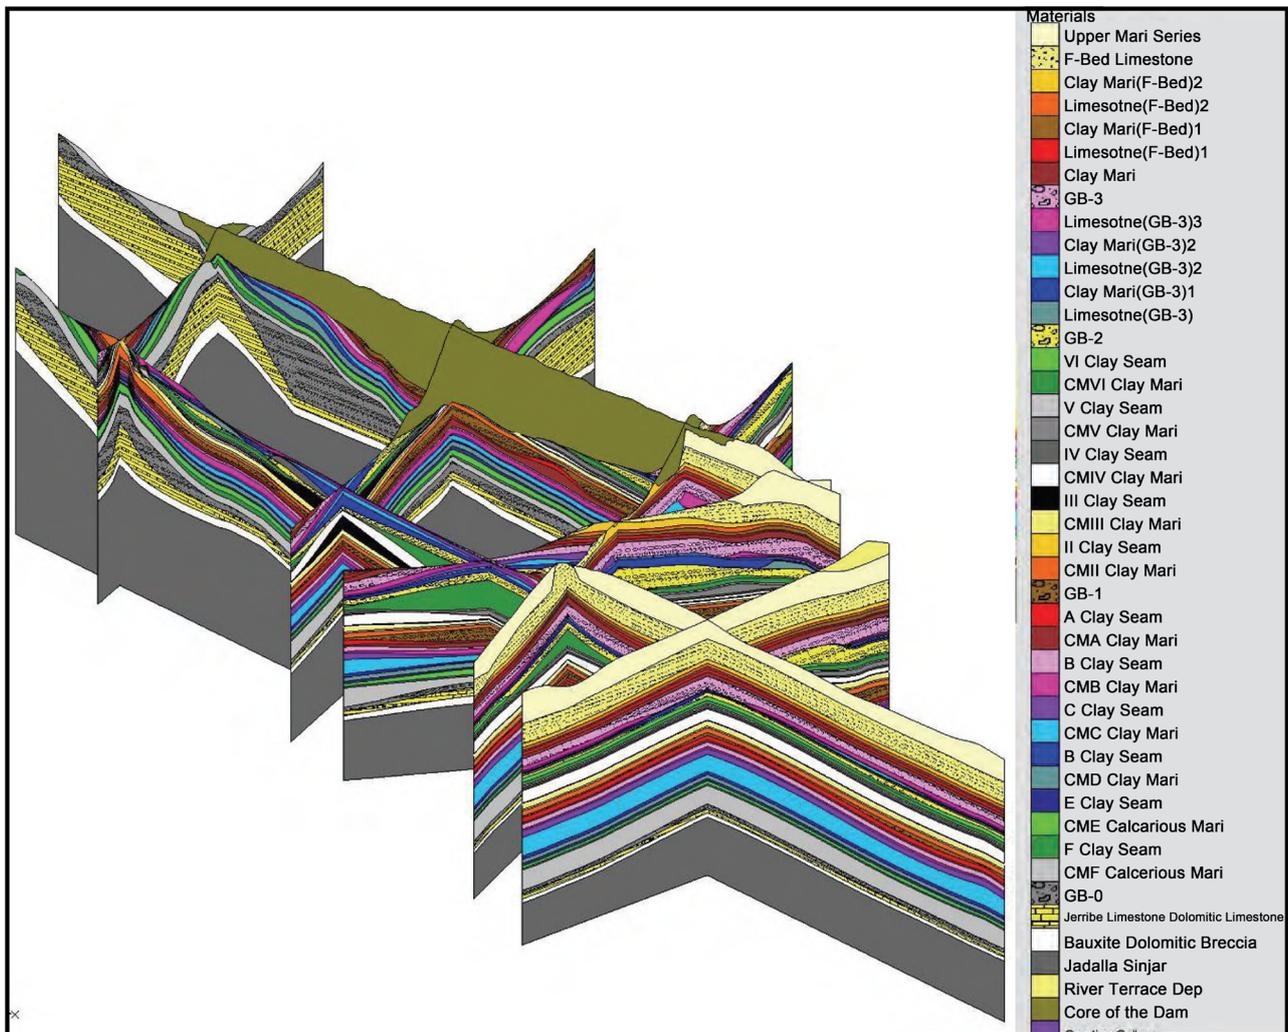
Due to the complexity of the geology of the area, several investigations were carried out (e.g. [5]-[19]). Al-Ansari *et al.* [2] reported that there were two faults within the dam site area. The first is of rotational type striking NW-SE offsetting the northern corner of Butmah East structure. The other fault is trending N NE-S SW along the right bank of the River Tigris. This fault is not clear on the surface and it was detected using Landsat images. This is due to the fact that the fault is deep seated and it might be partly controlling the Tigris River course from the dam site to Aski Mosul. Wakeley *et al.* [20] collected all the borehole data and constructed a model to show the complex geology at the dam site (Figure 3).

Figure 3. Intersecting cross sections from intermediate version of ERDC geologic conceptual model, showing complex stratigraphy and partial resolution of discrepancies in stratigraphy at intersections of the geologic panels from generated boreholes [20].

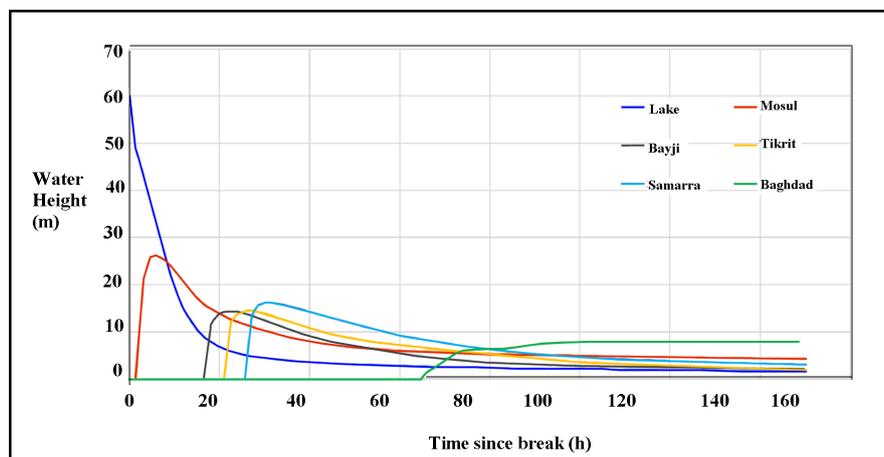
Table 3 summaries the results of the studied scenarios for different reservoir levels and assuming the bottom of the breach at level (252), breach area equal (26%) of the dam surface area, *i.e.* 40,560 m² out of 155,000 m². This table gives the peak height of the wave, time of arrival of the wave and time of arrival of its peak to five cities along the river. Accordingly, the wave will reach Mosul city after 1 hr. 40 min. and Baghdad in 3.5 days. The maximum height will be about (26) meters and (8) meters in Mosul and Baghdad respectively. **Figure 14** gives the wave peak height at five cities and its arrival time.

Figure 14. Mosul Dam Break: Height-Time graph [45].

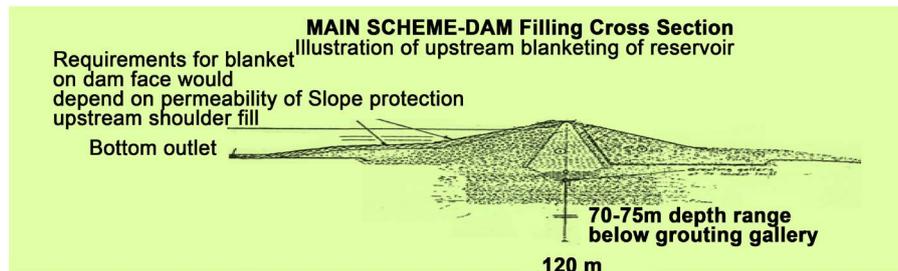
Figure 15. Illustration of upstream blanketing arrangement.

i) Blanketing: Blanketing the upstream side of the dam and reservoir (**Figure 15**). This is normally done by drawing down the reservoir, and to avoid this, dropping the lining materials (bentonite pellets) through pipes lowered into the bottom of the pond then sand would be placed on top to hold the clay in place against any disturbances. This method has not been used in ponds and not in large reservoirs before.

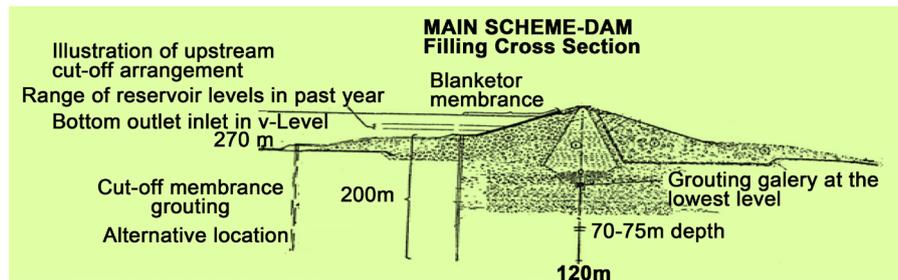
Figure 16. Illustration of upstream cut-off arrangement.

cavities and voids in the foundation, in addition to maintaining the verticality of the diaphragm panels at these unprecedented depths. The Board; however, judged this solution undesirable due to the required lowering of the reservoir level, which could extend 2 - 3 years in addition to the very high cost.

ii) Positive cutoff: A cutoff wall is to be constructed as shown in (**Figure 16**). This procedure is very risky to be executed now on Mosul Dam. The risk involves the great depth of the cutoff wall, hardness of pervious strata, presence of

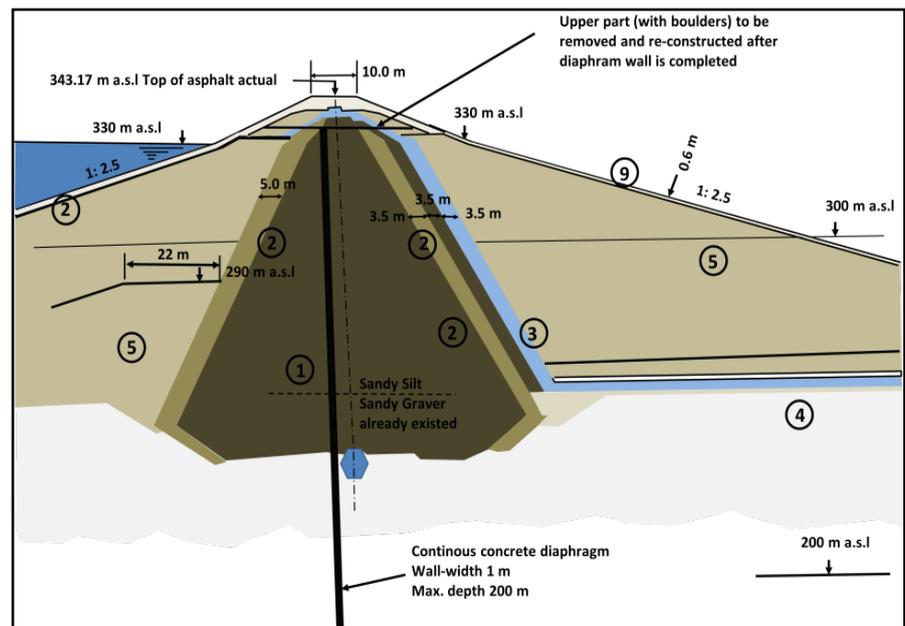
Figure 17. Proposed Diaphragm driven from the dam crest.

d) The fourth alternative was to construct a diaphragm wall from the upstream berm, with a sloping concrete facing from the top of the diaphragm to the top of the dam (Figure 17). Or even to remove part of the top of the dam and install the diaphragm from the top through the core in a location upstream of the gallery. This arrangement was attributed to the unavailability of machines that could cut to the desired level. In a later update, the removal of the dam top was thought unnecessary due to new development in diaphragm machines. This suggestion was disregarded due to technical and economic factors.
