# Slope Instability at Nablus-Al Bathan Road, Palestinian Territories (Causes, Analysis and Remedy Measurements)

**How to cite this paper:** Jardaneh, I., Hijjawi, S. and Odeh, G. (2021) Slope Instability at Nablus-Al Bathan Road, Palestinian Territories (Causes, Analysis and Remedy Measurements). *World Journal of Engineering and Technology*, 9, 538-547.  
<https://doi.org/10.4236/wjet.2021.93036>

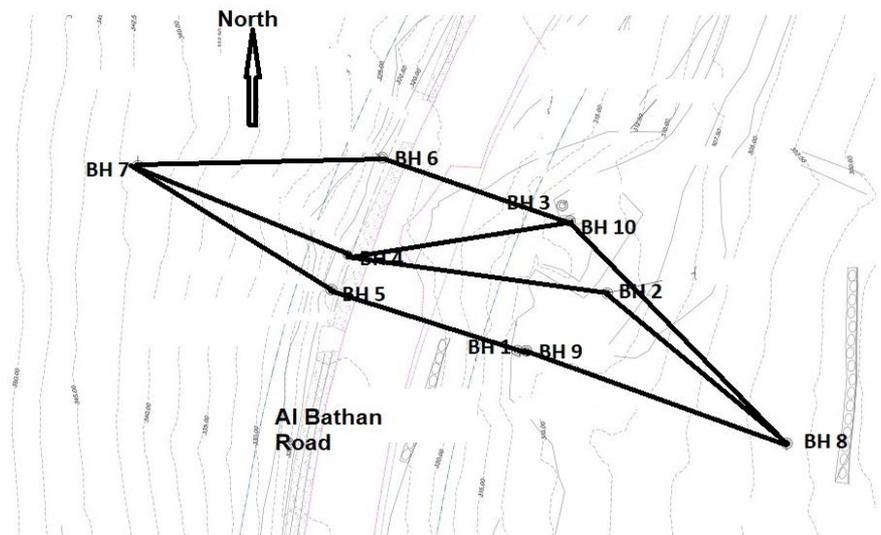
below the existing ground surface, in addition to those 10 boreholes were dug out in the site (east and west of the main road) for depths range between 20 and 30 m from the existing ground surface. **Figure 5** shows the locations of boreholes and the sections that considered in slope stability analysis.

**Figure 5.** Location of borehole and the four critical sections that used in slope stability analysis, section 7-6-10-8, section 7-4-2-8, section 7-6-10-8 and section 7-4-10-8.
