Characteristic Analysis and Comprehensive Control for the Horizontal Stripes of High-Grade Automotive Panels in Continuous Annealing*

Abstract

As to the horizontal stripes defect which exist on the surface of the high-grade automotive panels in continuous annealing process, an effective comprehensive control method is proposed on the basis of full consideration of the equipment and technological features of continuous annealing line. With five field tests as basis, the generation mechanism of the defect was analysed in detail and the comprehensive control measures were put forward. According to actual situation, a detailed technical plan was worked out. Then the relevant technologies were applied to a 1850 continuous annealing line. The statistics shows that this program acquired good effects. The incidence of horizontal stripes defect decreased from 100% to 2.78%. Meanwhile, the surface quality of strip also improved effectively, which created a larger economic benefit.

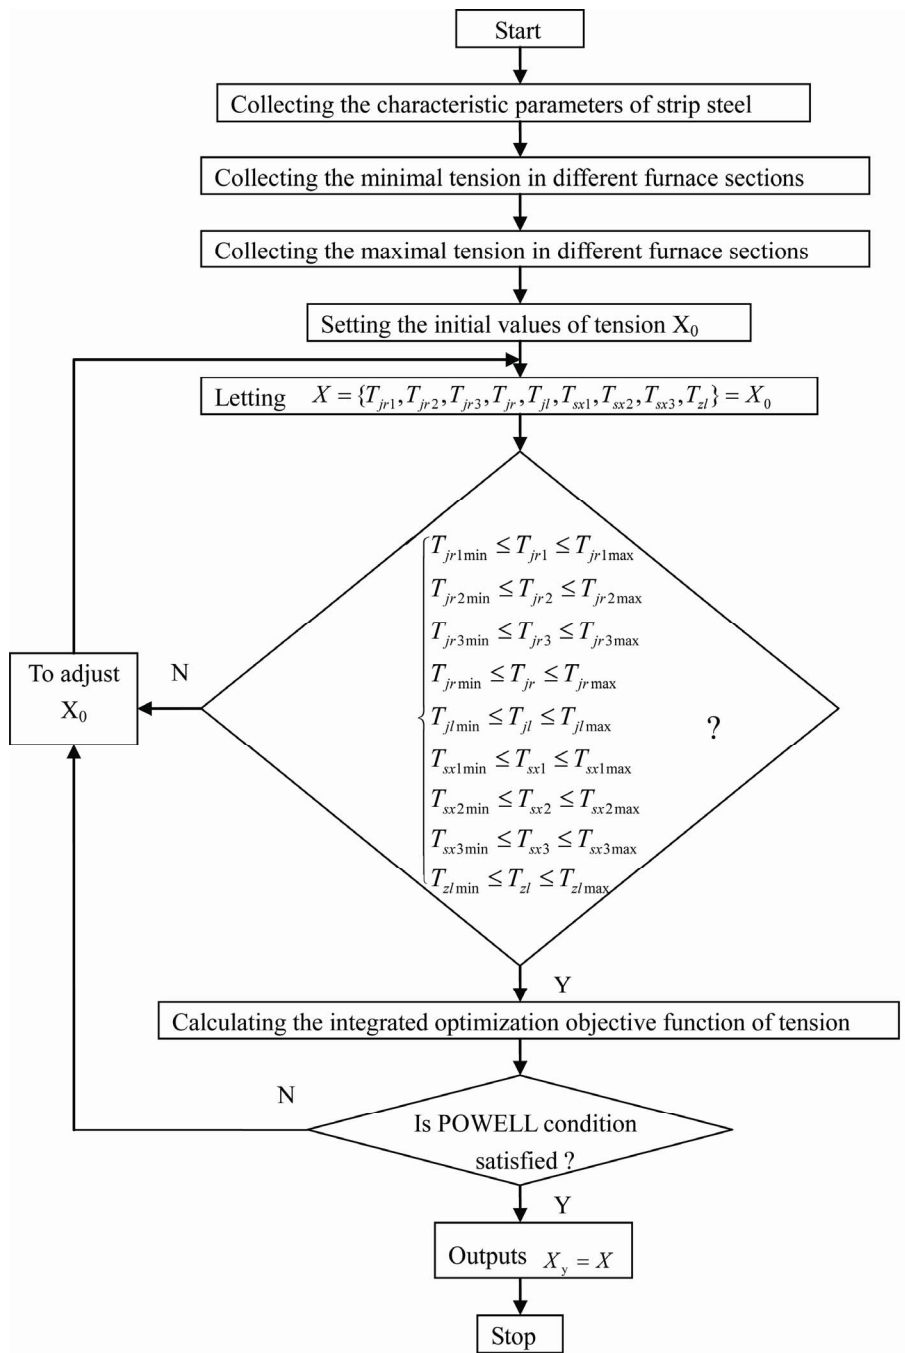
Figure 7. The program flow chart.

6) Suppressing the vibration by optimizing the tension setting. Through optimizing the tension setting in 1# heating section, 2# heating section, 3# heating section, soaking section, quench section, 1# aging section, 2# aging section, 3# aging section and final cooling section, and in the condition of ensuring the stable running, no transverse buckling and no strip deviation, the vibration of strip steel is suppressed maximally. Then the severity of horizontal stripes in strip steel is reduced. It greatly benefit to the quality of the product. The following technical scheme and algorithms are proposed to achieve the above goal. The program flow chart is illustrated in **Figure 7**.
