Mosul Dam: A Catastrophe Yet to Unfold

Nasrat Adamo¹, Nadhir Al-Ansari¹, Sven Knutsson¹, Jan Laue¹, Varoujan Sissakian²

Abstract

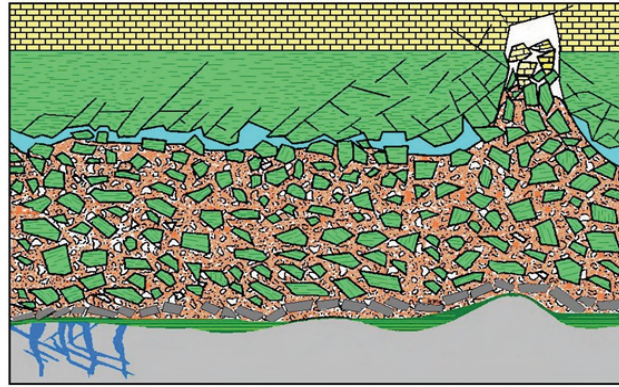
Figure 5 shows how a (GB) layer is formed. As it may be seen from the figure, a dissolution channel which may start as a crack in gypsum/anhydrite formation develops and enlarges continuously by the flow of seepage water to form a big cavernous channel which then collapsed and filled by limestone and gypsum breccias and cemented by clay from badly cracked marly layer from above [5].

Figure 5. Formation of Gypsum breccias layer.
