# Analysis for the Defect of Chromatogram in 35kv Oil-immersed Electric Reactor

Yongdong Li, Qingda Meng, Zheyuan Zhao, Po Yang, Yuzheng Wang

Maintenance of northern Hebei Province Electric Power Co. Ltd, Substation maintenance center, Beijing, China  
Email: zhaozy447525200@126.com

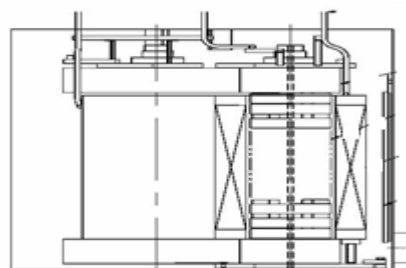
**Figure 1. Diagram of inner structure of the reactor.**

As this reactor is integrated structure, the component is not removed. Bottom of reactor can't be cut. The test of disintegration should be taken by cutting the bottom of the reactor. The structure is shown below as **Figure 1**.

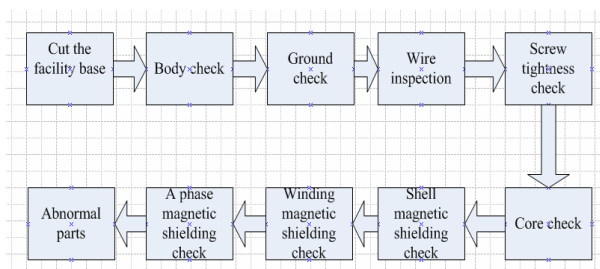
**Figure 2. Flowchart of dismantling the reactor.**

the discharge stains on the top of the seventh layer and the eighth layer, the bottom of the eighth layer and the ninth layer of A core magnetic shielding. The flowchart of dismantling the reactor is shown below as **Figure 2**.
