Rockfall Hazard in an Old Abandoned Aggregate Quarry in the City of Tétouan, Morocco

Hatim Delloero*, Younes El Kharim

Department of Geology, Faculty of Sciences of Tétouan, Abdelmalek Essaadi University, Tétouan, Morocco

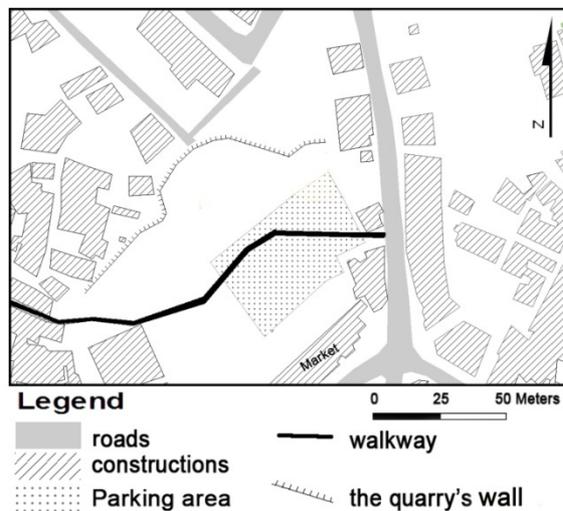
Figure 1. The plan of the quarry.

The subject of this study is a small scale abandoned aggregate quarry exploiting a small hill in the north western part of Tétouan at the following coordinates: 35°34'32"N; 5°23'30"W. The quarry stretches in NE-SW direction with its face toward the south east and it extends approximately over 120 m (**Figure 1**). The face of the quarry from 8 to 30 m high is highly irregular.
