Shoreline Instability Study on Fun Island Resorts, Maldives

E. W. K. Loh, Thoufeeg Usamath, T. J. Deepak

School of Civil Engineering, Linton University College, Mantin, Malaysia.

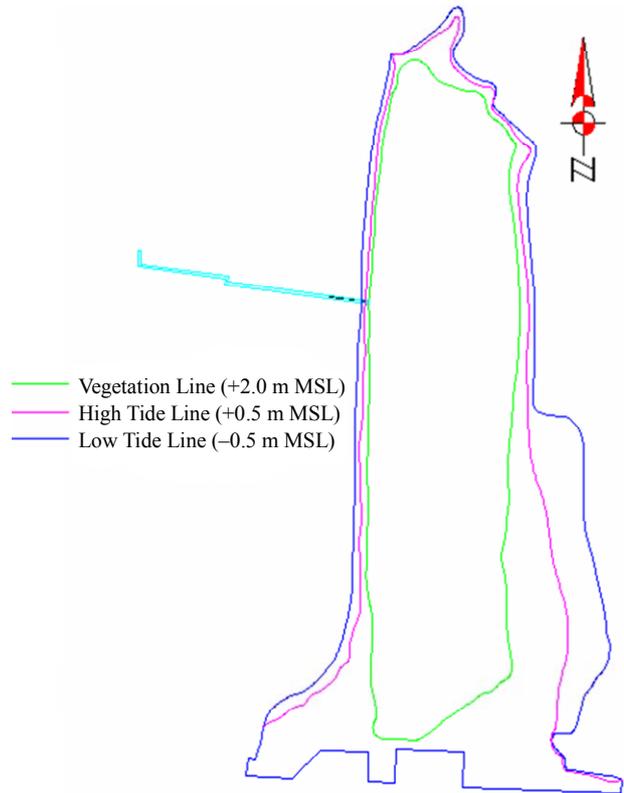
Figure 8. Coastline profile of the Island developed from the site survey May 2011.

topographic survey data was computed by using Autocad 2010 (refer **Figure 8**). The survey shows that Fun Island has an average elevation of +2.0 m (MSL). The high tide level is considered as +0.5 m (MSL) and the low tide level is considered as -0.5 m (MSL).

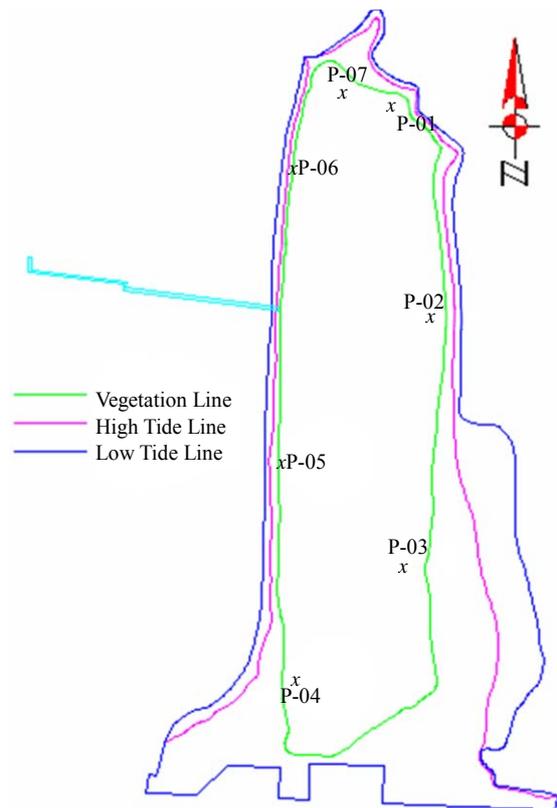
Figure 9. Locations for beach profiles.

Seven additional beach profiles where major erosion has occurred are taken (refer **Figure 9**) to demonstrate the levels and the environmental impacts of the locations. These profiles (refer **Figures 10-16**) are supported with the pictures shown together with each profile.
