Corrosion of Steel Pipelines Transporting Hydrocarbon Condensed Products, Obtained from a High Pressure Separator System: A Failure Analysis Study

Gerardo Zavala Olivares*, Mónica Jazmín Hernández Gayosso

Instituto Mexicano Del Petróleo. Eje Central Lázaro Cárdenas Norte, Col. San Bartolo Atepehuacan, C.P., México D.F., México
Email: *gzavala@imp.mx

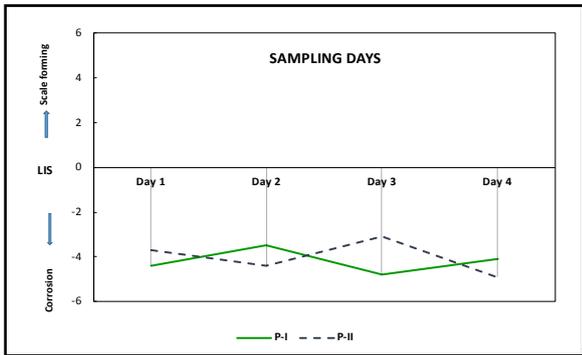
In all cases, the samples were identified as condensation water, with low conductivity. However, the Langelier index indicated a corrosive tendency for all samples [7]. Values between -3 and -5 were observed, as shown in **Figure 1**. This situation implies that water may become very aggressive to the metallic structures.

Figure 1. Langelier Index Stability (LIS) for water samples.

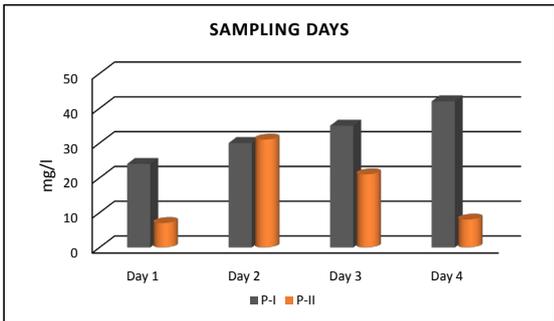
Additionally, it must be indicated that the water corrosiveness for these systems was also related to the content of dissolved gases, including H₂S, CO₂ and O₂. For this case, the H₂S concentration was between 5 and 45 ppm, O₂ between 0 and 2.6 ppm and CO₂ between 28 and 75 ppm (**Figures 2-4**). The presence of these gases in water and hydrocarbon represents a corrosion risk for the metallic structures, and a prevention system must be considered [8]-[10].

Figure 2. H₂S concentration in water samples.

One of the parameters that present bigger differences is the H_2S content. Here, an increase with time for samples taken from P-I was observed, reporting values between 20 and 40 mg/l. For samples taken from P-II, lower values were reported, in the range of 5 and 30 mg/l. It must be noted that the concentration of corrosive gases in water depends upon the general characteristics of the hydrocarbon, specially pressure and temperature. Therefore, the results allow establishing the presence of corrosive gases in the analyzed water samples.

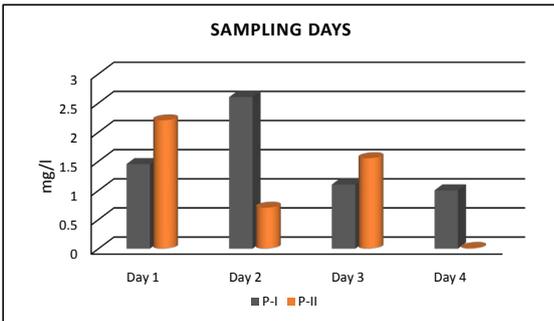
Figure 3. O₂ concentration in water samples.

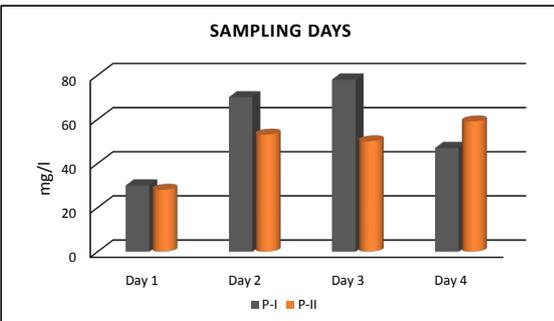
Figure 4. CO₂ concentration in water samples.

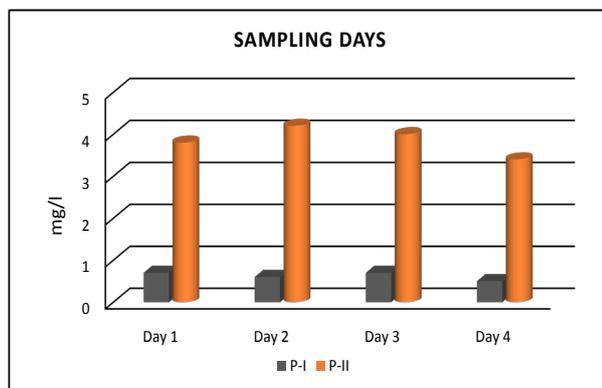
In the same way, it may be indicated that iron content in the water samples is a reference to establish whether the corrosion process is taking place or not, and to determine the necessity of a control system [11]. For this case, both fluids P-I and P-II exhibited corrosive characteristics, although a difference in the iron content could be observed (Figure 5).

Figure 5. Fe^{2+} Concentration in water samples.

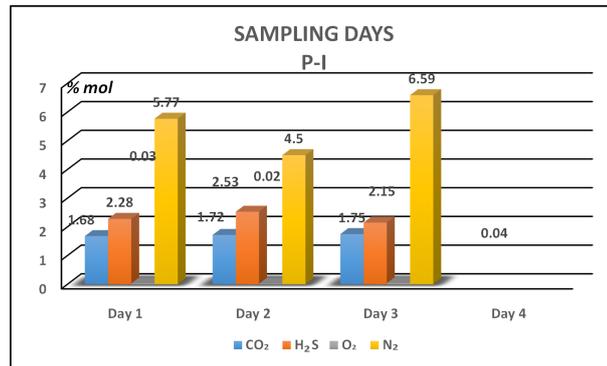
The fluid is mainly composed of light hydrocarbons, such as methane, ethane and propane. This is considered as a normal situation. However, there were some corrosive gases in the hydrocarbon composition. Contents of H_2S , CO_2 and O_2 were determined, as shown in Figure 6 and Figure 7. Here, both points P-I and P-II, show similar gases proportion.

Figure 6. Concentration of corrosive gases in hydrocarbon composition (P-I).

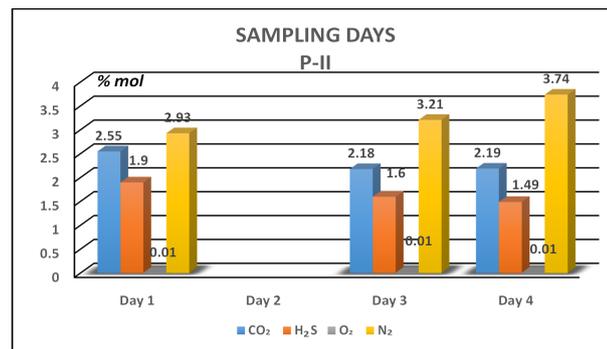
Figure 7. Concentration of corrosive gases in hydrocarbon composition (P-II).
