Adverse Wear in MOM Hip-Arthroplasty Related to the Production of Metal Fragments at Impingement Sites

T. K. Donaldson¹, E. J. Smith², A. Koutalos³, A. John⁴, J. Y. Lazennec⁵, I. C. Clarke^{6*}

How to cite this paper: Donaldson, T.K., Smith, E.J., Koutalos, A., John, A., Lazennec, J.Y. and Clarke, I.C. (2018) Adverse Wear in MOM Hip-Arthroplasty Related to the Production of Metal Fragments at Impingement Sites. *Open Journal of Orthopedics*, 8, 381-412.

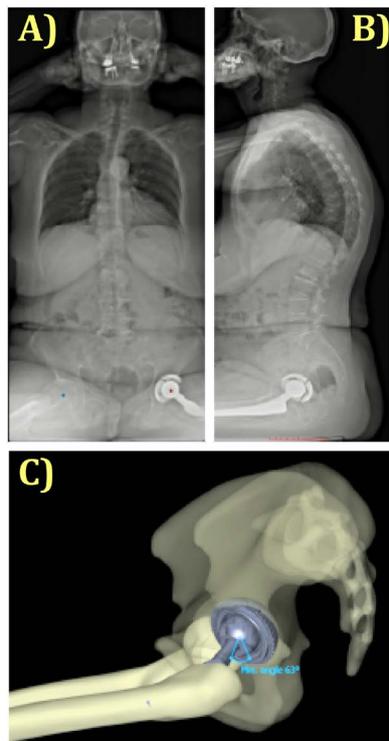
It is known that cup positions change depending on patient position (Figure 3). During sitting, the pelvis generally tilts posteriorly and both cup anteversion and inclination increase (Figure 4). Assessment of patient’s lateral or supine position during surgery does not eliminate the risk of impingement and subluxation,

Figure 4. Sitting EOS-radiographs: (A) anterior view; (B) lateral view; (C) lateral view of 3D-reconstruction, no limitation to hip motion.

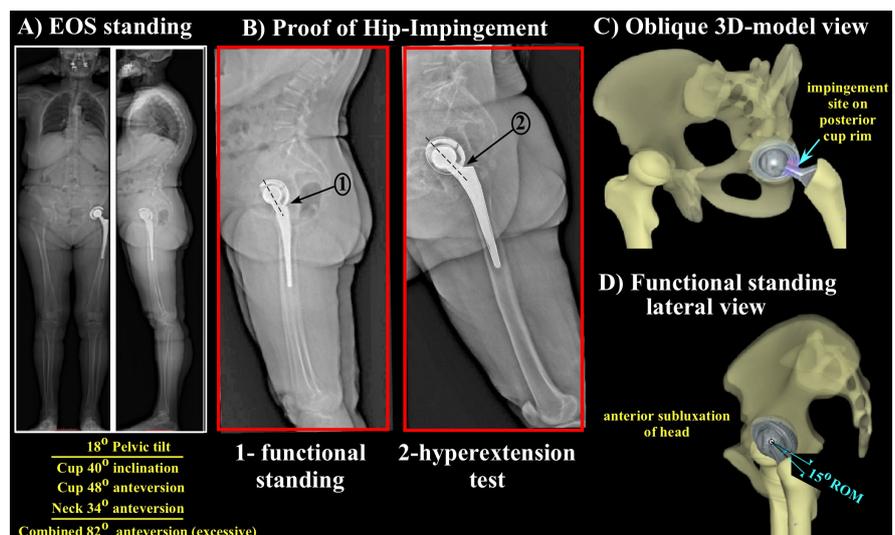
EOS imaging with 3D-reconstructions in standing and sitting positions provided details of cup functional inclination and anteversion. Knowing femoral anteversion, the important combined anteversion could be determined. EOS images in the functional-standing position of our 1st example show a cup with 40° inclination but excessive 48° anteversion (**Figure 22(A)**). With 34° of femoral anteversion, this hip demonstrated 82° combined-anteversion. Shifting from functional-standing posture (**Figure 22(B-1)**) into hyperextension (**Figure 22(B-2)**) determined available range of motion. The cup impingement site was demonstrated by 3D-reconstruction (**Figure 22(C)**). This patient's 15° extension ability in functional-standing position proved insufficient (**Figure 22(D)**) and patient could sense anterior subluxation of the head approaching within 5° of impingement site (**Figure 22(B-2)**). However, in functional-sitting posture, the pelvic tilt increased slightly to 25° thereby providing a 5° increase in cup anteversion. With 58° cup inclination in sitting posture, this hip had 63° of motion before impingement. Thus, EOS imaging demonstrated no limitation in functional-sitting.

Figure 22. EOS-reconstructions with cup-impingement site in functional-standing: (A) frontal and lateral images in functional-standing posture; (B) functional standing (1) and impingement revealed in extension-test (2); (C) Oblique 3D-reconstruction, femoral neck close to posterior cup rim; (D) Lateral reconstruction, 15° arc before neck impinged posteriorly.
