# Aspects of Transformer Fires in Brazil

Dayse Duarte

Departamento de Engenharia de Mecânica, Universidade Federal de Pernambuco, Recife, Brazil

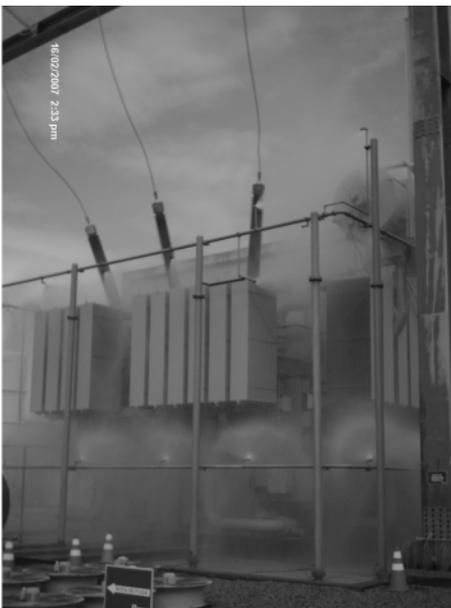
Transformers are typically oil-cooled, and the application of a water spray to a transformer oil spill or fire can control or extinguish the fire by emulsification of the oil (**Figure 8**). When water and oil (immiscible liquids) are agitated together and one of the liquids is dispersed throughout the other, this causes a cooling effect on the oil surface, preventing the release of flammable vapor.

**Figure 8.** Water spray system.

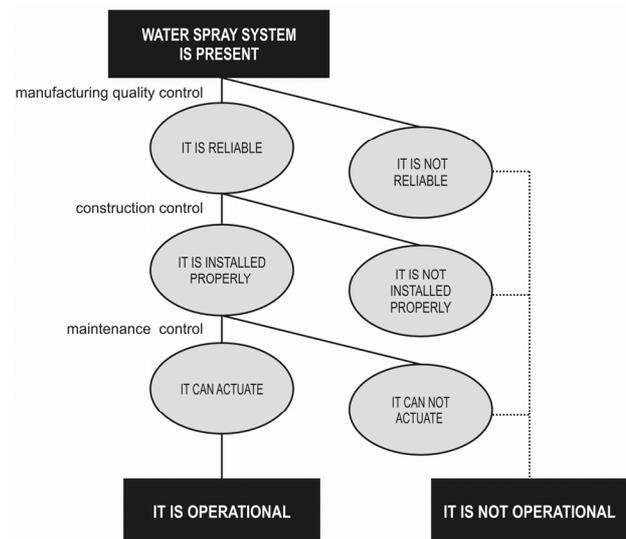
**Figure 9.** Reliability of the water-spray system.

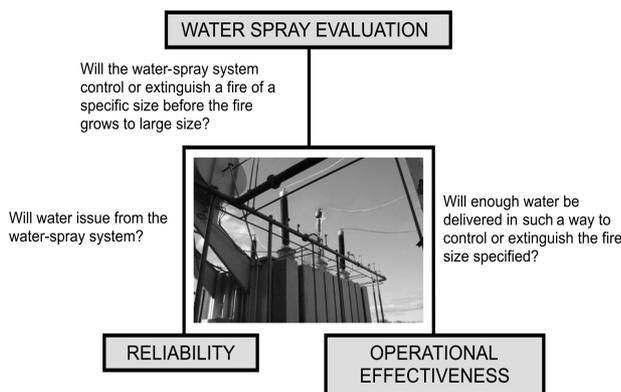
A water-spray system usually involves heat-actuated detectors operating an automatic mechanical flooding valve that supplies water to projectors (*i.e.* spray nozzles) arranged over and around the unit being protected. When the activated detectors call for water, a number of system components must function in order to deliver the water to the projectors. The application of the agent is an expression of the success or failure of water flowing through valves to the projectors. It is essential to have an adequate pressure and flow rate. The expected performance of the water spray system can be evaluated based on information about its reliability and operational effectiveness, as shown in **Figures 10** and **11**.

**Figure 10. Evaluation of water-spray system.**

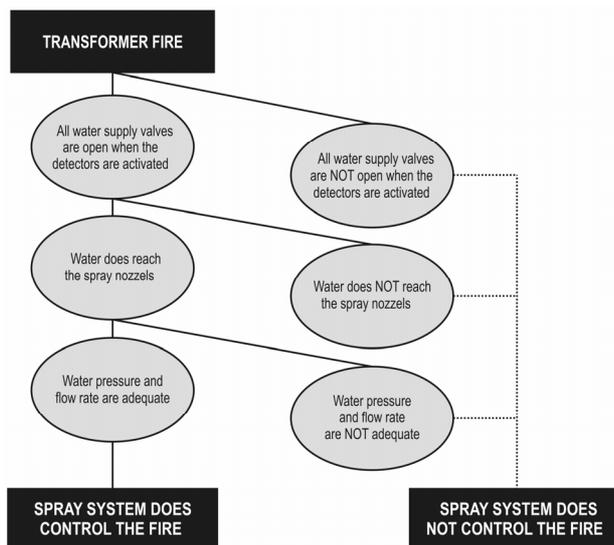
**Figure 11. Success or failure of the agent application.**

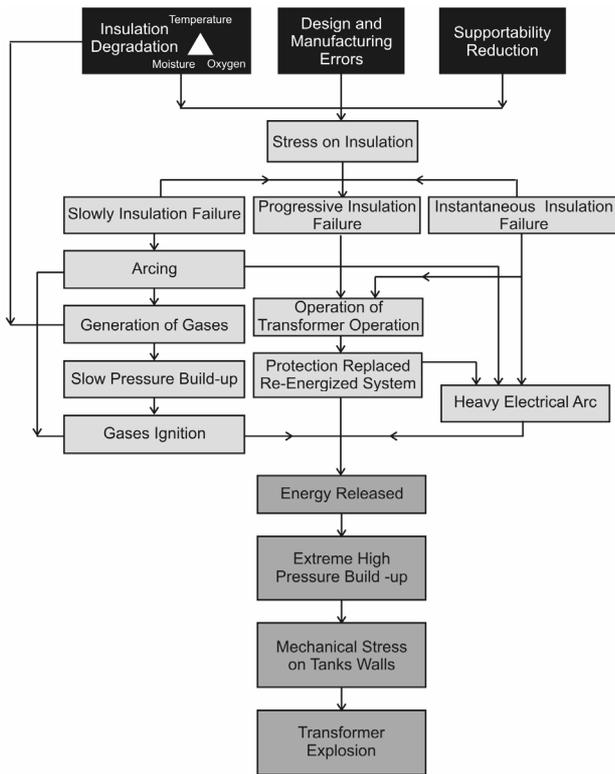
According to Ronningen [4], if an arcing fault occurs within the transformer, ejection of oil aerosol can occur, possibly accompanied by a physical explosion of the transformer tanker (**Figure 12**). If the oil is ignitable, a serious fire or a vapor/mist explosion can happen. When an arc occurs in ignitable oil, hydrogen and acetylene are the main gases produced. By contrast, breakdown of oil due to excessive conductor temperature yields mostly ethane, ethylene and methane, with smaller amounts of hydrogen. Benton [5] suggests the following sequence of events leading up to a transformer explosion:

- A heavy overload degrades the oil sufficiently to cause a fairly high leakage current.
- The leakage current further degrades the insulation

**Figure 12. Sequence of event that can lead to transformer explosion (adapted from Ronningen [4]).**

(i.e. oil, paper or wood) and eventually leads to a turn-to-turn or layer-to-layer fault.

- The fault becomes large enough to cause the primary fused cutout to operate.
- Upon re-fusing and re-closing the cutout, the transformer insulation fully breaks down, drawing a very large arc fault current.
- The energy released from the arc gasifies the transformer oil, primarily into hydrogen and methane.
- Rapid pressure building from the gasification causes the transformer cover to be blown off.
- The combustible escaping gases ignite either due to remaining arc energy or due to sparking associated with rapid metal breakage.

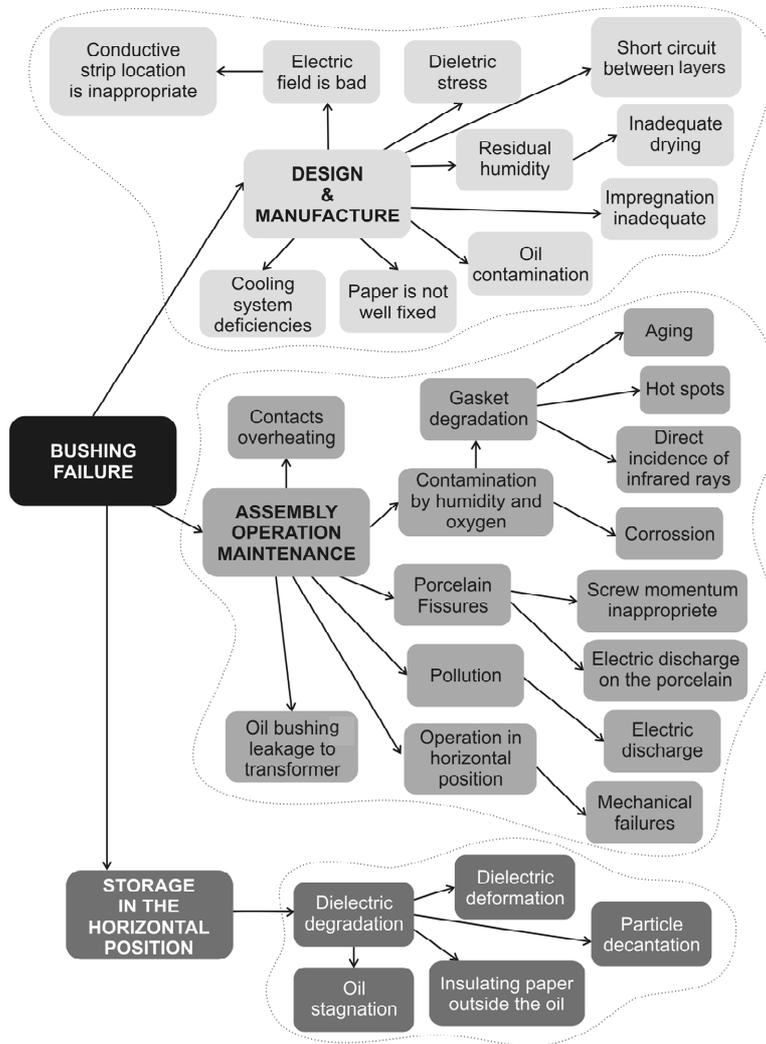
The main causes for bushing failures are extremely difficult to determine. The basic obstacle lies in the fact that the explosion leaves little to trace the origin of the fault and provide a reliable diagnosis. The main cause of bushing failure is poor sealing and the resulting reduction of supportability due to contamination by oxygen (oxidation) and humidity (hydrolysis). Sealing failure occurs due to degradation of seals or corrosion. Other causes that should be considered are the bad connection of a capacitive tap, storage in the horizontal position for a long period, pollution effects on porcelain, overheating and very fast transient overvoltages [7]. **Figure 13** shows bushing failure due to insulation degradation resulting from manufacturing defects. If a bushing fails, oil is expelled. If there is a rupture at the oil end of the bushing housing, oil from the transformer will feed a fire and the fire will spread to the main tank. Some bushing failure causes are represented in detail in **Figure 14**. **Figure 15** shows how a bushing failure can result in a transformer fire.

Figure 14. Probable causes of bushing failure.

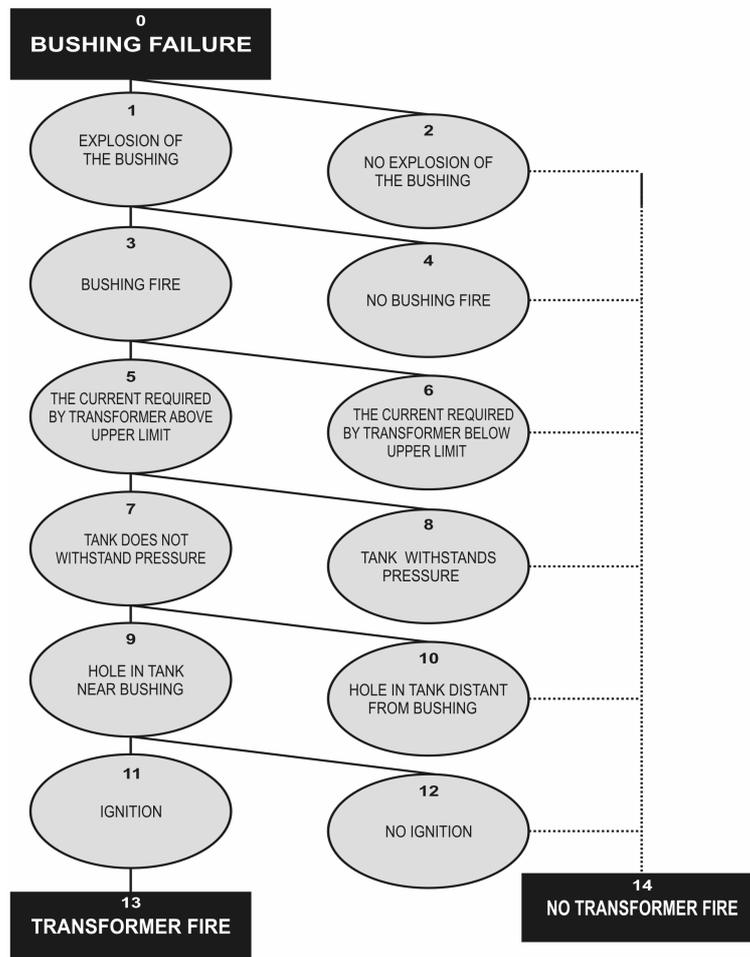
The scenario represented by the path 0-1-3-5-7-9-11-13 shows that a transformer fire could be the result of the following event sequence: after the bushing failure, it explodes and catches fire; the current required by the transformer is above its upper limit; the main tank does not withstand the internal pressure; the hole in the tank is located near the bushing; and so an ignition source is present.

The scenario represented by the path 0-2 shows that a transformer fire will not take place if the bushing does not explode after it fails.

The scenario represented by the path 0-1-4 shows that even after the bushing failure and the explosion, the transformer fire will not happen if the bushing explosion does not start a fire.

The scenario represented by the path 0-1-3-6 shows that as a result of a bushing failure there could be an explosion followed by a fire, but if the current required by the transformer is below its upper limit, the transformer

The scenario represented by the path 0-1-3-5-8 shows that as a result of the bushing failure there is an explosion followed by a fire, and in addition the current required by the transformer is above its upper limit, but as the tank withstands the internal pressure, the transformer fire will not happen.

The scenario represented by the path 0-1-3-5-7-10 indicates that a transformer fire could be avoided if the hole in the tank is located far from the bushing, even if the bushing fails, explodes and catches fire as well as if either the current required by the transformer is above its upper limit or the tank fails.

The scenario represented by the path 0-1-3-5-7-9-12 indicates that the transformer fire will not happen if there are no ignition sources present, even if the bushing fails, explodes and catches fire, the current required by the transformer is above its upper limit, as well as the hole in the tank being near the bushing.

Figure 15. Bushing failure.
