Characteristics of Seismic Hazard in a V-Shaped Valley and Hazard Mitigation Methods

Yan-Ling Qiu¹, Ling-Kan Yao^{1,2*}, Quan Yuan³

How to cite this paper: Qiu, Y.-L., Yao, L.-K. and Yuan, Q. (2015) Characteristics of Seismic Hazard in a V-Shaped Valley and Hazard Mitigation Methods. *Open Journal of Safety Science and Technology*, 5, 27-36.

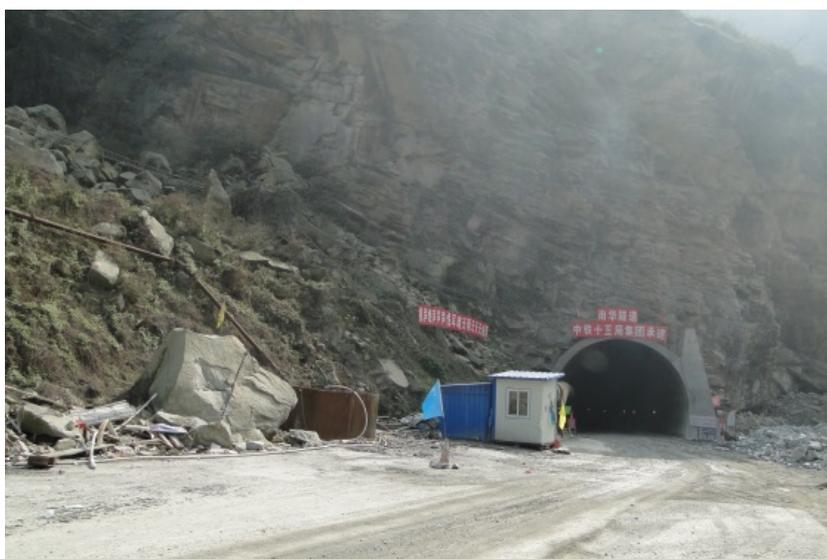
The Xiaojiagou gully is very close to the portal of newly-built Nanhua Tunnel. An excessive large-scale debris flow of 0.5 million-m³ outbreak in the gully, accumulating together with the slope debris flow near tunnel portal. The deposits buried the entire tunnel portal and stuffed the whole tunnel. The river silted up and the riverbed uplifted 30 m high. The water level rose above the route elevation more than 20 m and reached the roof of the tunnel. More than 1km length of roadbed was buried and submerged. It was one of the most affected sections by debris flow hazard. Figure 7 and Figure 8 show the portal before and after the event. The Xiaojiagou

Figure 7. The portal of Nanhua tunnel before August 13, 2010.
