# Explanation of the Damage to the Royal Family's Cemetery in Historic Cairo and Examination of the Building Materials

Ahmed Elyamani<sup>1\*</sup>, Nabil A. Abd El-Tawab Bader<sup>2</sup>, Mahmoud Algohary<sup>1</sup>, Ragab Abou El Hassan<sup>3</sup>

<sup>1</sup>Department of Archaeological Conservation, Faculty of Archaeology, Cairo University, Cairo, Egypt

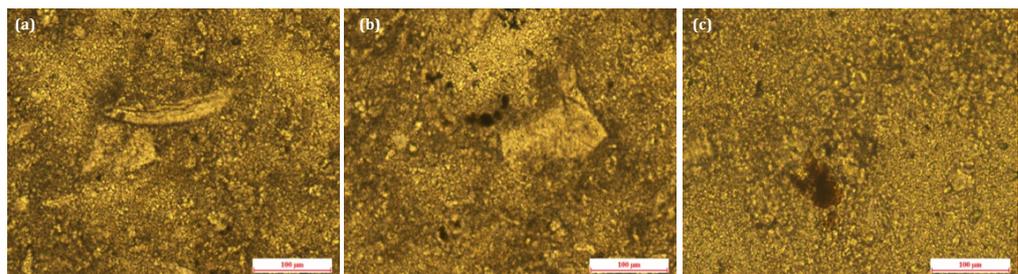
The examination of thin sections of the limestone samples under plane polarized light microscope (PLM) displayed fine-grained calcite crystals, on top of iron oxides, clay minerals, and numerous grains of quartz that were also found occurring as subrounded to angular. The study showed fossils fragments as shown in **Figure 31**.

**Figure 31.** Optical micrographs: (a) fine grained calcite (micrite) and fossil fragments, (b) quartz grains as sub-rounded to angular, (c) iron oxides.

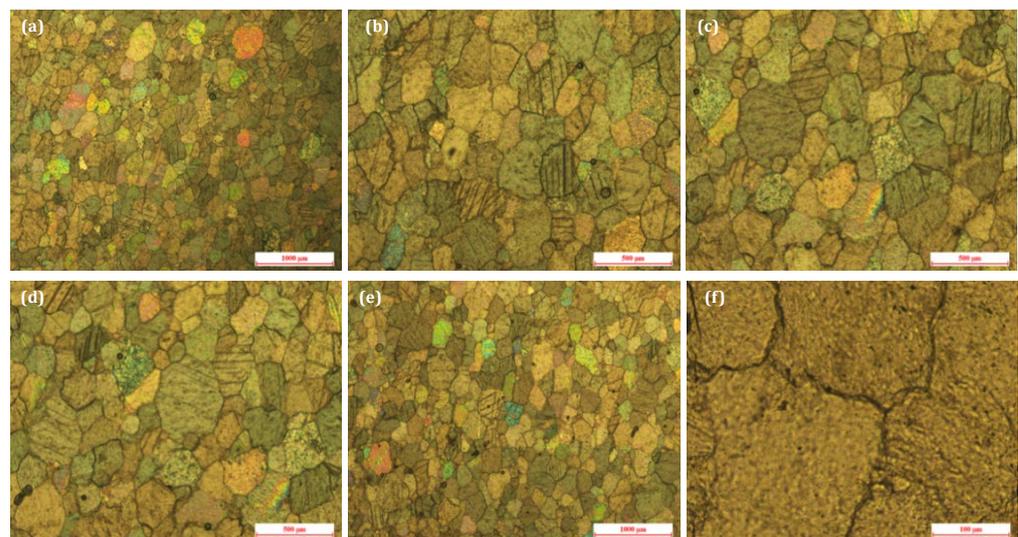
The examination of thin sections of the marble samples under PLM revealed that all marble samples are carbonate rocks consisting of both calcite and dolomite in rather variable proportions, with significant to moderate contents of quartz and orthoclase, **Figure 32(a)**. Most of the calcite crystals were granoblastic, with equidimensional shapes (pseudo-hexagonal) and different sizes, **Figure 32(b)** & **Figure 32(c)**. The presence of the distinctive mosaic texture of marble is illustrated in **Figures 32(c)-(e)**. Marble is characterized by the sugar-crossed texture of the mineral granules of the calcite as a result of the transformation processes and the presence of the separation lines characteristic of the calcite the main component of the marble, **Figure 32(f)**.

**Figure 32.** Petrography study of marble: (a) carbonate rocks consisting of both calcite, dolomite, quartz and orthoclase, (b) crystals were granoblastic with equidimensional shapes, (c), (d) and (e) distinctive mosaic texture of marble, (f) presence of the separation lines characteristic of the calcite.

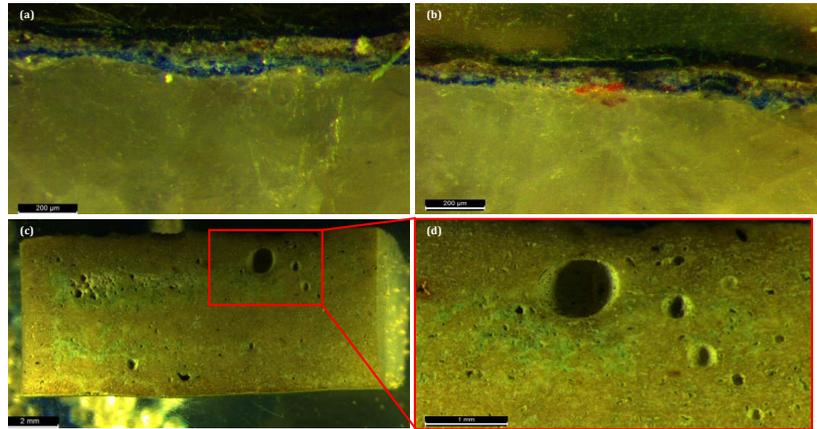
The microscopic examination of the cross-section of the painted marble revealed that the artist carried out the pigments directly on the marble decorations as traces of the blue, red, and brown pigments were found (**Figure 33(a)** & **Figure 33(b)**). The examination also showed that marble support is full of holes resulting from the carbonization process (**Figure 33(c)** & **Figure 33(d)**).

**Figure 33.** Cross-section of the painted marble: (a) & (b) Stereomicroscope image of pigment at marble, (c) & (d) holes at marble.

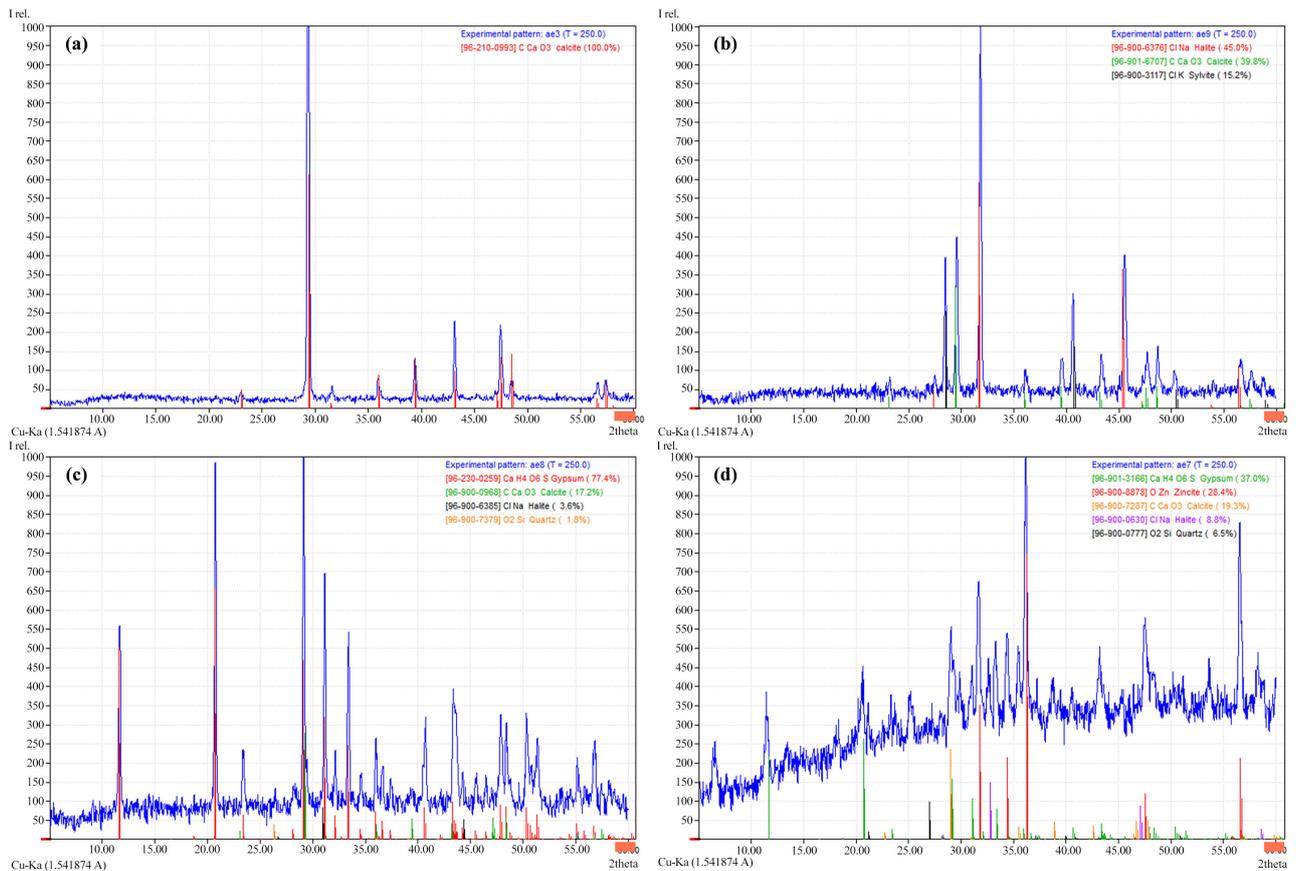
The XRD pattern of the limestone sample is given in **Figure 34(a)** showed

that the sample consisted essentially of Calcite ( $\text{CaCO}_3$ ). The XRD pattern of the salt sample taken from the limestone surfaces or between the blocks (**Figure 34(b)**) found to be consisted of Calcite (39.8%), Halite ( $\text{NaCl}$ ) (45%), and Sylvite ( $\text{KCl}$ ) (15.2%). This result could be interpreted that the chlorides salts are the basic reason for stone deterioration at Hosh al-Basha and the salts are due to the groundwater salinity resulted from Ain Al-Sira and Khayalat Al-Shorta lakes as mentioned in section (3) above.

According to this analysis, the mortar consisted mainly of Gypsum ( $\text{CaSO}_4 \cdot 2\text{H}_2\text{O}$ ) (77.4%), Calcite (17.2%), Quartz ( $\text{SiO}_2$ ) (1.8%), and Halite (3.6%) was found due to salt penetration (**Figure 34(c)**). The Calcite originated from the limestone powder, the Quartz was the filling material and the Halite found due to salts' presence in the mortar. The sample taken from the plaster found to be mainly from Gypsum (37%), Zincite ( $\text{ZnO}$ ) (28.4%), Calcite (19.3%), Halite (8.8%), and Quartz (6.5%) (**Figure 34(d)**). The Calcite was from the limestone powder, the Quartz was the filling material, the Zincite was from Zinc and the Halite was due to the salt presence.

**Figure 34.** XRD patterns: (a) weathered limestone, (b) salt, (d) mortar, (e) plaster.

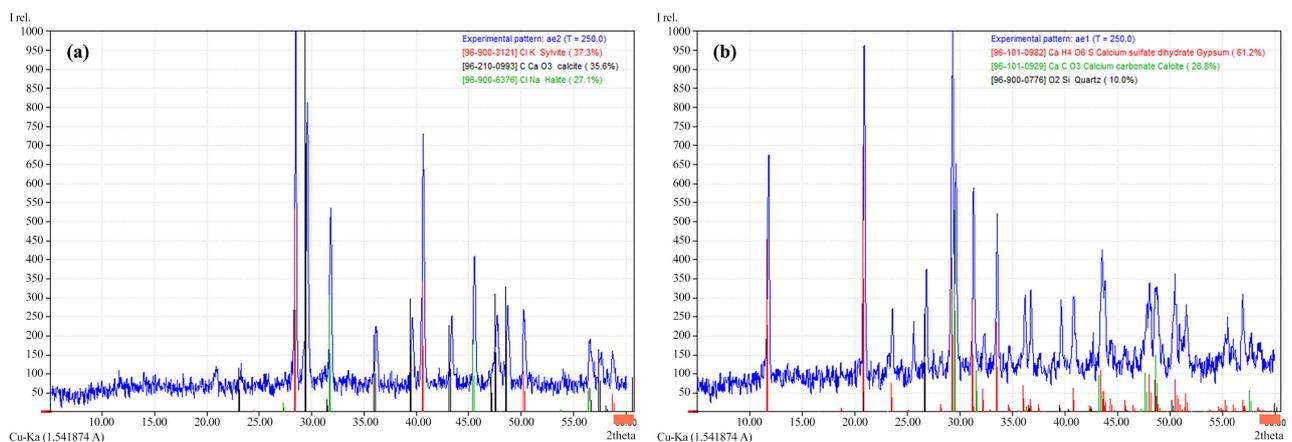
The XRD pattern of the deteriorated marble (**Figure 35(a)**) showed that the sample consisted of Calcite (35.6%), Sylvite (73.3%), and Halite (27.1). The XRD pattern of the mortar taken from between the marble slabs (**Figure 35(b)**) consisted essentially of Gypsum (61.2%), Calcite (28.8%), and Quartz (10%). Accordingly, it is understood that the marble mortar consisted of mixing Gypsum as a major, lime, and a small amount of sand.

**Figure 35.** XRD patterns: (a) deteriorated marble, (b) marble slabs mortar.

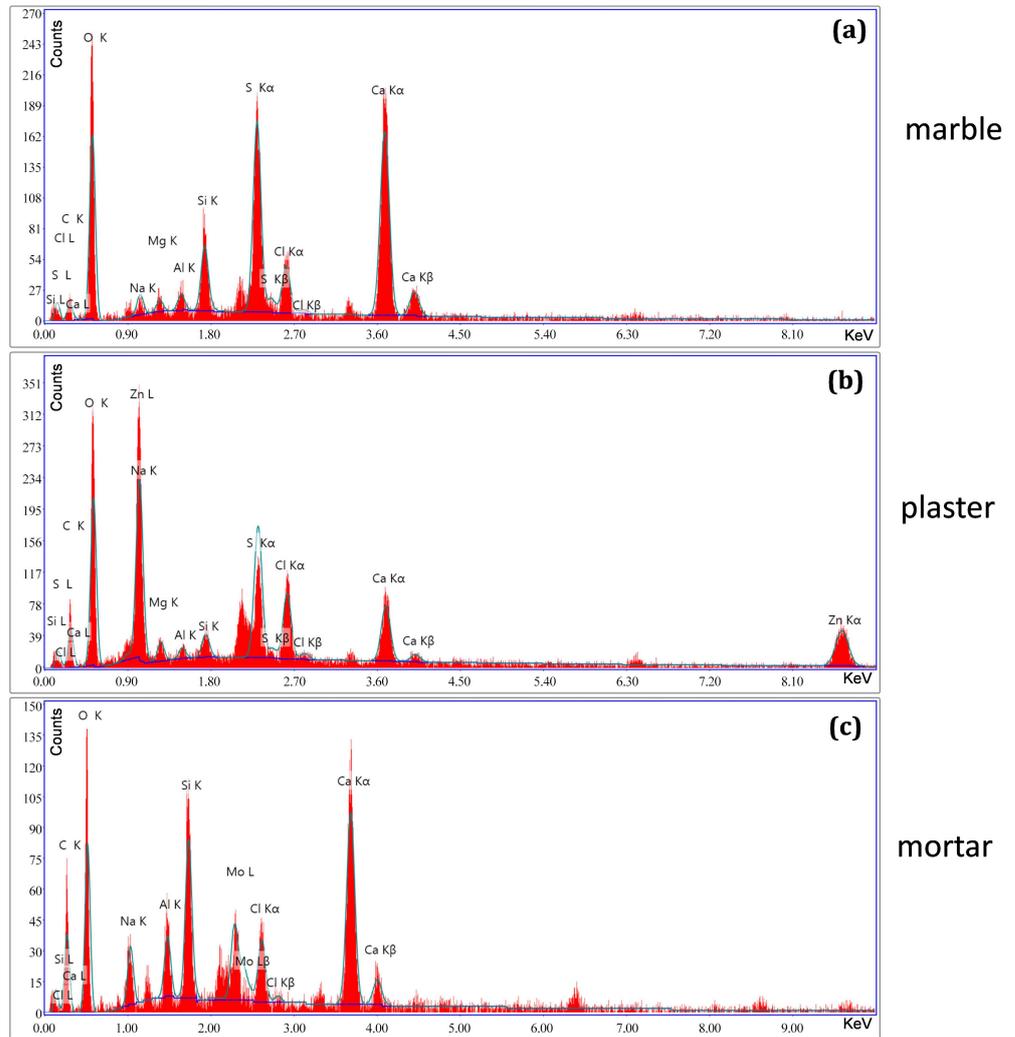
The EDX microanalysis of the marble sample showed an almost pure carbonate composition with low amounts of Magnesium (Mg), Silica (Si), and alumina (Al), **Figure 36(a)** and **Table 1**. The distinguishing geochemical feature may be related to the different mineralogical compositions and the genetic environment of the materials.

The EDX microanalysis of the plaster sample (**Figure 36(b)** and **Table 1**) showed that Zn, Ca were the major elements in the sample. Considerable amounts of S, Na, and Cl were also recorded due to salt presence. The EDX analysis of the mortar sample confirmed the XRD result. The EDX microanalysis (**Figure 36(c)** and **Table 1**) showed that Ca and Si were the major elements in the sample. Considerable amounts of Na and Cl were also recorded due to salt presence.

**Figure 36.** EDX patterns: (a) marble, (b) limestone plaster, (c) mortar samples between limestone blocks.
