High Temperature Sintering and Oxidation Behavior in Plasma Sprayed TBCs [Single Splat Studies] Paper 1—Role of Heat Treatment Variations

Swarnima Deshpande

Center for Thermal Spray Research, Department of Materials Science and Engineering, State University of New York at Stony Brook, New York, USA.

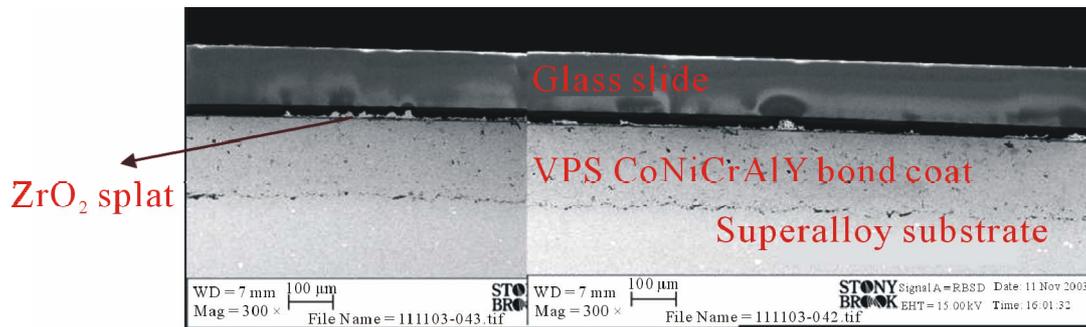
Cross-section (CS) samples were prepared by covering the single splats with glass slide, **Figure 1**, and then polishing using the SEM T-tool of the tripod polisher.

Figure 1. Cross-section sample preparation of single splats on bond coat surface.

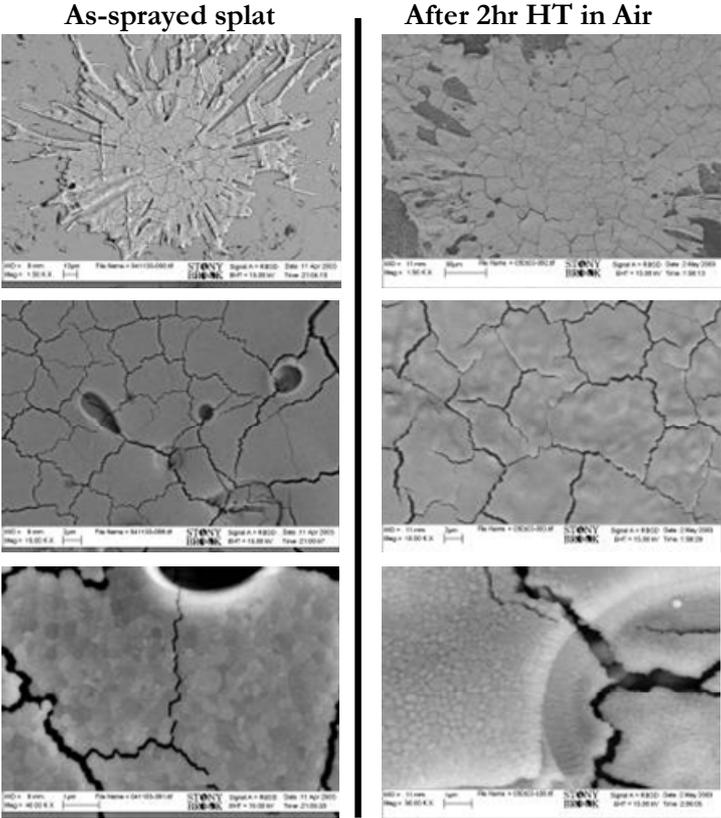
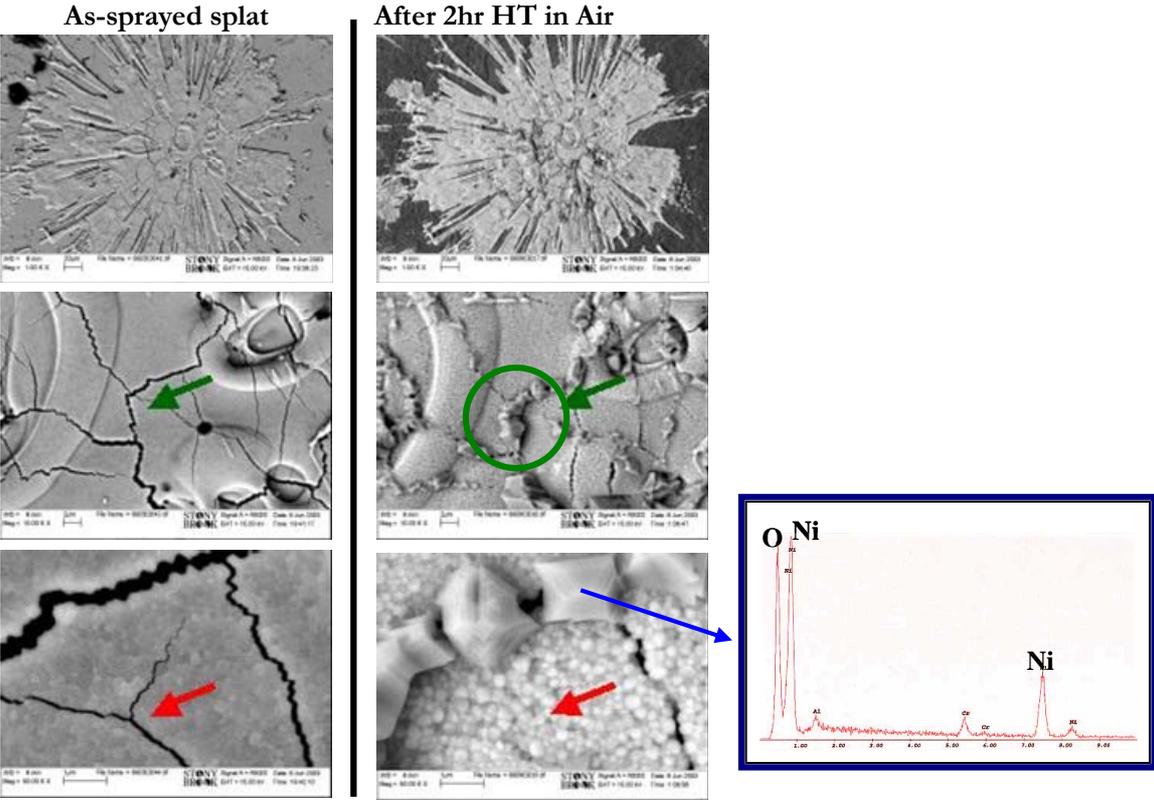
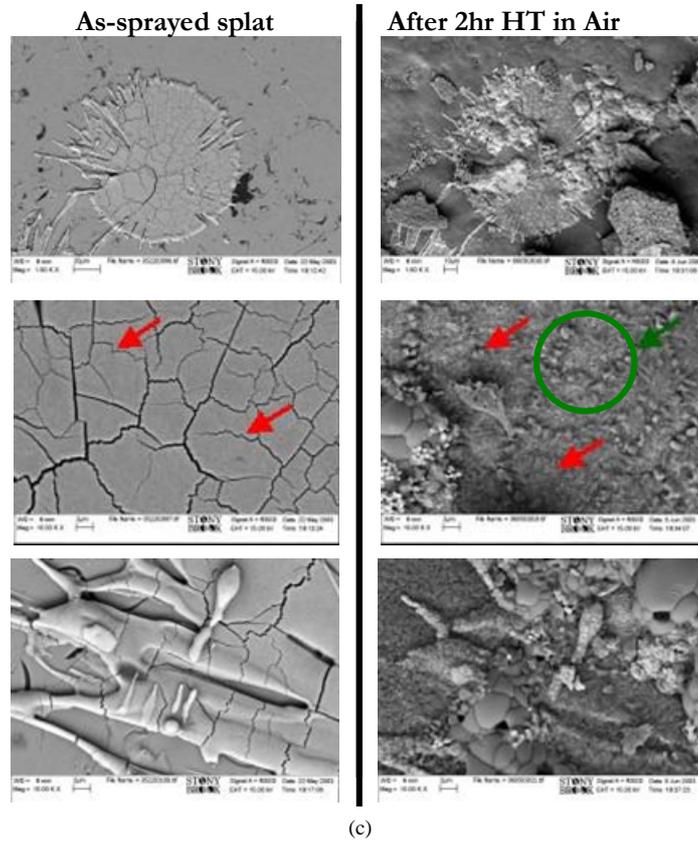
YSZ splats on bond coated substrate were subjected to a 2 hr heat treatment in air (isochronal) at different temperatures: 1100°C, 1200°C and 1300°C. Particular splats were identified and their top surface microstructures, at exact locations, in the as-sprayed and heat treated condition are shown in **Figures 2(a)-(c)** for the three temperatures respectively.

In **Figure 2(a)**, it is seen that after HT at 1100°C, the overall crack network between the as-sprayed and the heat treated splat seems unchanged. The grain size does not seem to have altered either.

According to **Figure 2(b)**, after HT at 1200°C, the as-sprayed and heat-treated splats still show same overall crack network. However, some outward oxide growth from the bond coat is now visible at the larger microcracks as shown by the circle marks. Finer microcracks have also started sintering as indicated by the arrows.

These effects are even more pronounced after the 1300°C HT, **Figure 2(c)**.

More of the fine microcracks are seen to have sintered and the entire microcrack network is now lined with the oxide growth from below. These grains growing outward through the microcracks were analyzed using EDS and indicated Ni and O peaks. These phenomena are schematically illustrated in **Figure 3**.

Figure 2. (a) Splat exposed to 1100°C; (b) Splat exposed to 1200°C; (c) Splat exposed to 1300°C.

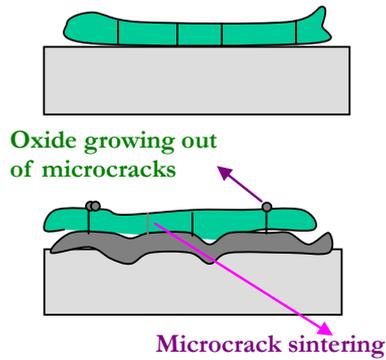
Figure 3. Isochronal HT in air—effect of temp (schematic).

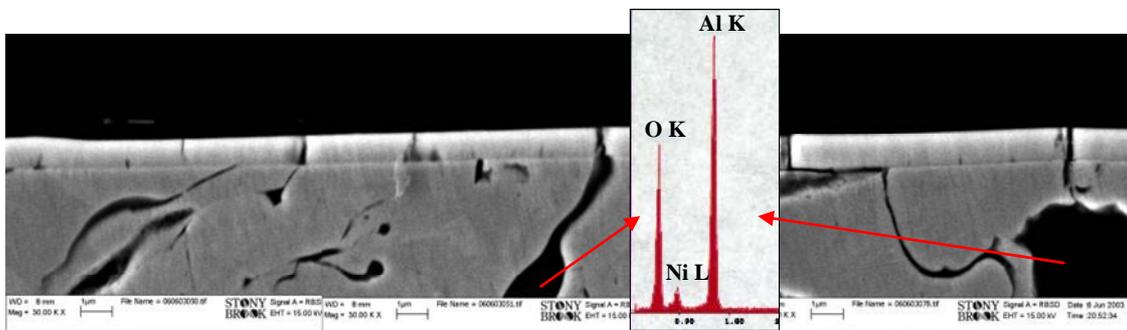
APS NiCrAlY bond coat microstructure (**Figure 4**) contains internal oxide chunks of alumina. These regions

may be locally depleted of aluminum. Microcracks in splats are seen to coincide with oxide points in the bond-coat, **Figure 4**.

Figure 4. Microcracks coinciding with oxide points.

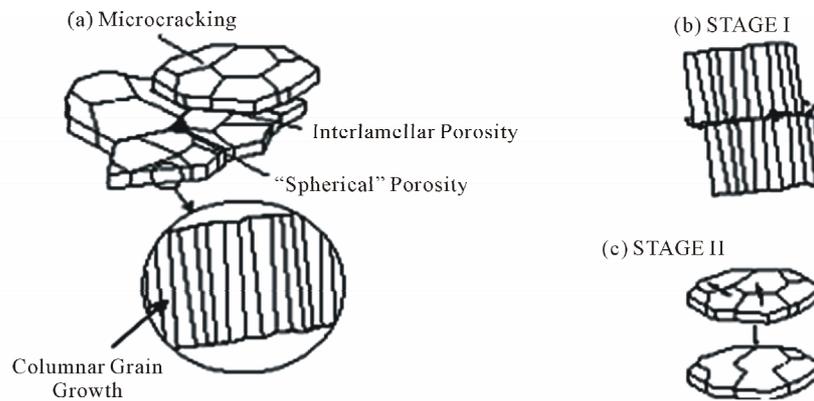
A study by Thompson *et al.* speculates regarding sub-processes occurring at a splat level during sintering, as shown in **Figure 5**. The as-sprayed microstructure (a) incorporates three types of pores. Stage I (b) involves healing of interlamellar porosity, where the separation in the material is very small. While at longer times and at higher temperatures, Stage II (c) occurs by micro-crack healing [3].

Figure 5. Schematic representation of the proposed sintering mechanism occurring at high temperature [Ref 3: J. A.Thompson, W. Ji, T. Klocker and T. W.Clyne].

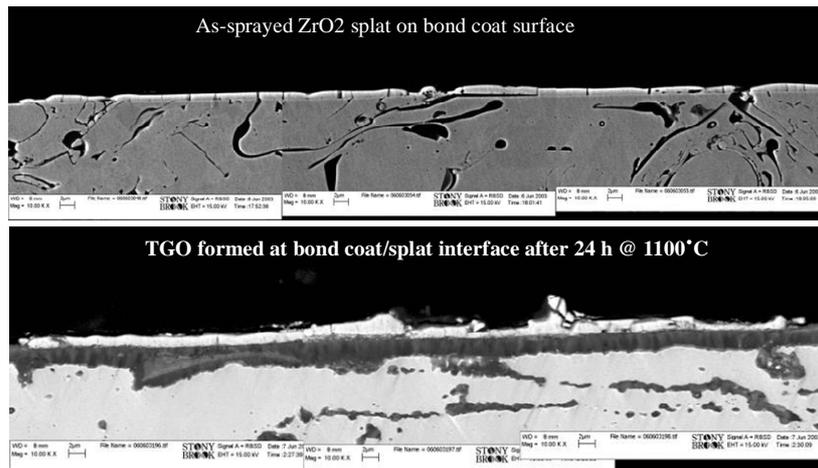
YSZ splat samples were subjected to an isothermal heat treatment in air at 1100°C for different durations: 2 hr, 8 hr and 24 hr. **Figure 6** shows thermally grown oxide

Figure 6. Interface between bond coat and ZrO_2 splats (shown as composite images).

layer formed at the interface between bond coat and top coat after 24 hr HT in air.

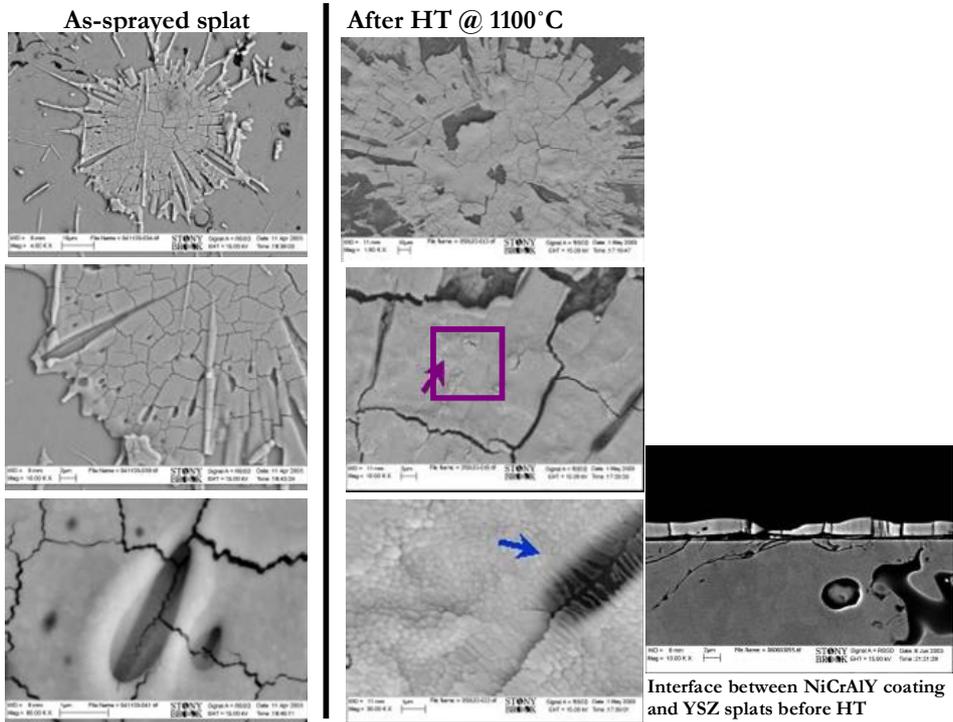
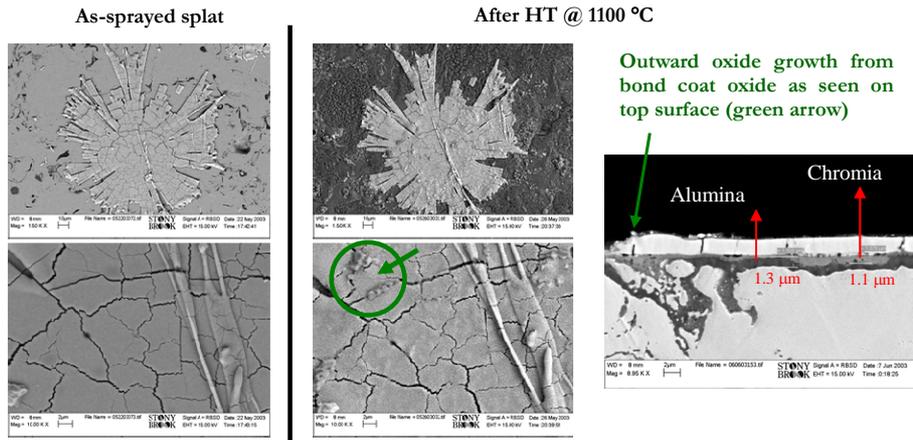
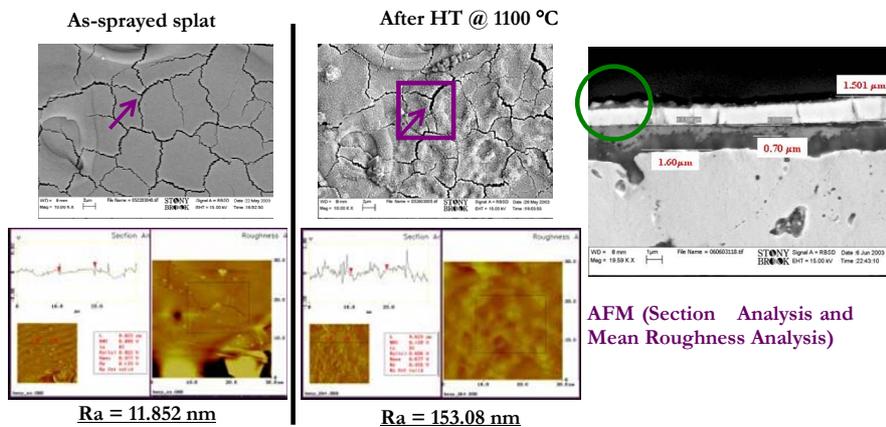
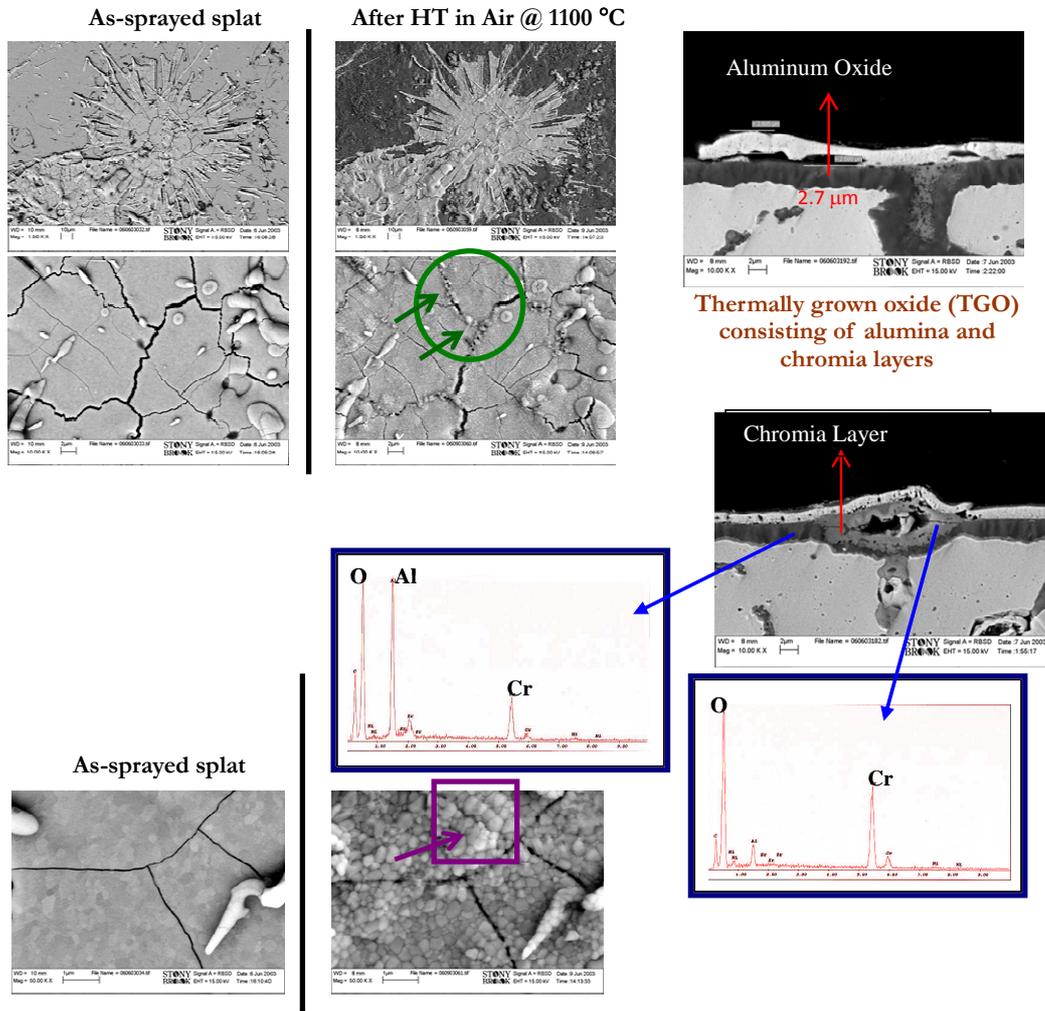
Splats are imaged at particular locations and their top surface microstructures in the as-sprayed and heat-treated condition are compared in **Figures 7(a)-(c)** for the three HT times respectively.

Figure 7(a) shows that after a 2hr HT at $1100^\circ C$ the overall crack network has not changed significantly. The columnar grains in the splat appear to have been pushed slightly upwards in some areas. Such regions are marked by square marks.

As seen in **Figure 7(b)** below, after an 8 hr HT, the microcrack network still remains unchanged between the as-sprayed and the heat-treated splats. Most of the fine microcracks are also still present. However the top surface of the heat-treated splat appears much rougher compared to the top surface of the as-sprayed splat. Square marks denote this roughening. This has been quantified using Atomic Force Microscopy (AFM). Wave patterns depicting the roughness are obtained using section analysis. Mean Roughness analysis over a given area measures

From **Figure 7(c)** below, it is seen that even a 24 hr HT at $1100^\circ C$ does not cause the overall microcrack network to change or fine microcracks to sinter. More instances of outward oxide growth as marked by circle marks are now visible even at $1100^\circ C$ because of longer HT duration. Thus this outward oxide growth is enhanced by an increase in HT temperature as well as an increase in duration of HT.

Once again splat surface after HT becomes rougher because of lifting of columnar grains in some regions. An examination of cross-section samples revealed that this is probably due to oxide growth over the bond coat (TGO) and its thickness imperfections.

A comparison of **Figures 7(a)-(c)** shows how the TGO thickness gradually increases with HT duration. This

Figure 7. (a) Splat exposed for 2 hr; (b) Splat exposed for 8 hr; (c) Splat exposed for 24 hr.

A comparison is made between this and the as-sprayed splat that directly underwent the 24 hr air HT, as shown in **Figure 7(c)**. As discussed earlier in section 3.2, the splats directly exposed to the 24 hr Air HT at 1100°C showed instances of outward oxide growth through microcracks (circle marks) and surface roughening due to splat lifting (square marks).

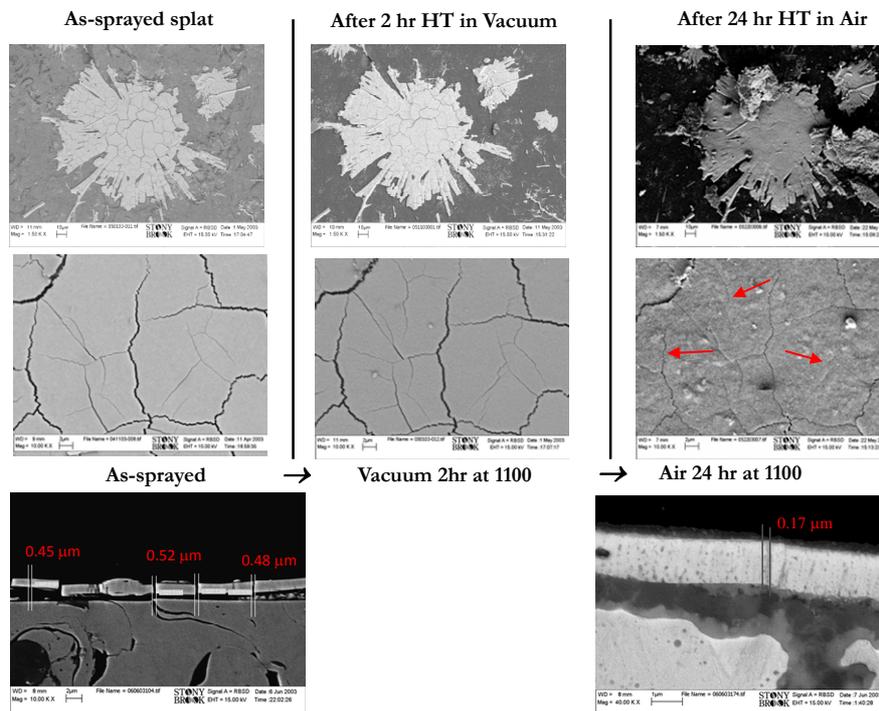
Figure 8 shows an as-sprayed YSZ splat subjected to an intermediate vacuum heat treatment at 1100°C for 2 hrs before exposure to the 24 hr air HT at 1100°C. After

Figure 8. As-sprayed splat → exposed for 2 hr in Vac → exposed for 24 hr @ 1100 C in air.

the intermediate vacuum HT of 2 hr at 1100°C, the overall microcrack network appears unaltered as seen in the top surface microstructures. The oxide grain growth through microcracks or the splat surface roughening are however, not visible.

However, the splats with intermediate vacuum HT as shown in **Figure 8** when thermally treated in air for 24 hr showed no signs of grain growth through microcracks or of upward lifting of grains. Additionally, most fine microcracks are seen to have sintered as marked by arrows. The cross-section images show that microcrack widths are much reduced compared to the as-sprayed splat. TGO growth does occur in the subsequent air HT but the outward oxide growth is curtailed probably because the intermediate vacuum treatment started the sintering or sealing of most microcracks from their bottom end. This may be related to the increase in lattice spacing that was observed by Thornton *et al.* [13] when a TBC coating was heat treated in vacuum. In vacuum, there is no oxygen to replace that lost from zirconia in the formation of bond coat oxide and less oxygen appears to cause larger
