Mechanical Behavior of Glass Fiber Reinforced Polymer Pultruded Composite Gratings

Rahul Mangire¹, Malur N. Srinivasan²

Keywords: Mechanical Behavior; GFRP Composite; Pultrusion; Grating; FEM; Deflection

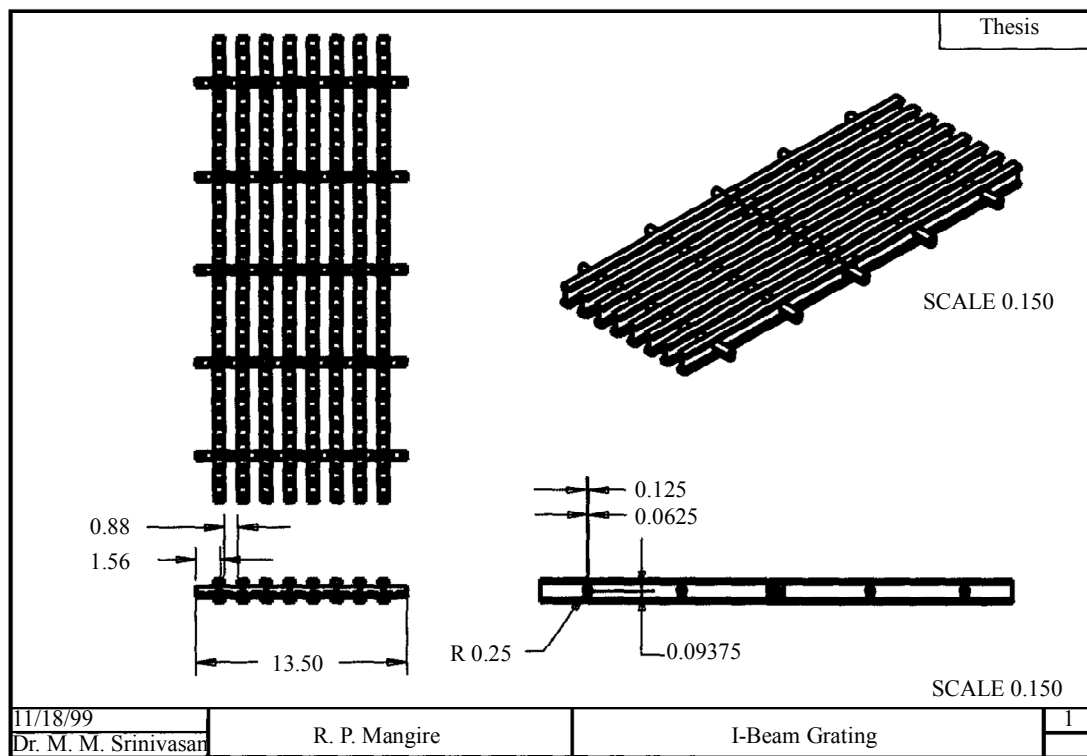
Figure 1. Views and dimensions of grating.

In **Figure 1** are shown views and dimensions of the gratings used in the present investigation. Each I-section composite beam was pulled through die cavities in a pultruder, adopting standard and well-established procedures, as the manufacturer has extensive experience in this area. The pultruded beams were longitudinally aligned and transversely spaced according to established dimensions using approximately cylindrical bars, in order to produce a grating. The gratings were then brought to the authors' laboratory and subjected to three-point bend test using a standard compression-tension testing machine. In **Figure 2** is shown a schematic diagram of the loading set up. Instead of using a knife edge for loading, a cylindrical bar was placed along the grating flange to minimize damage while loading.

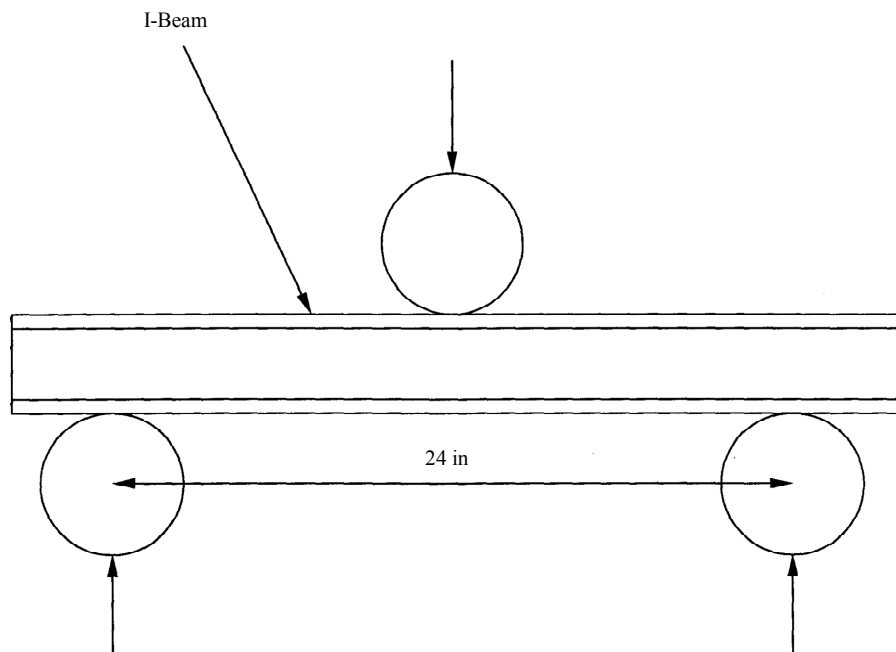
Figure 2. Schematic diagram of loading setup.

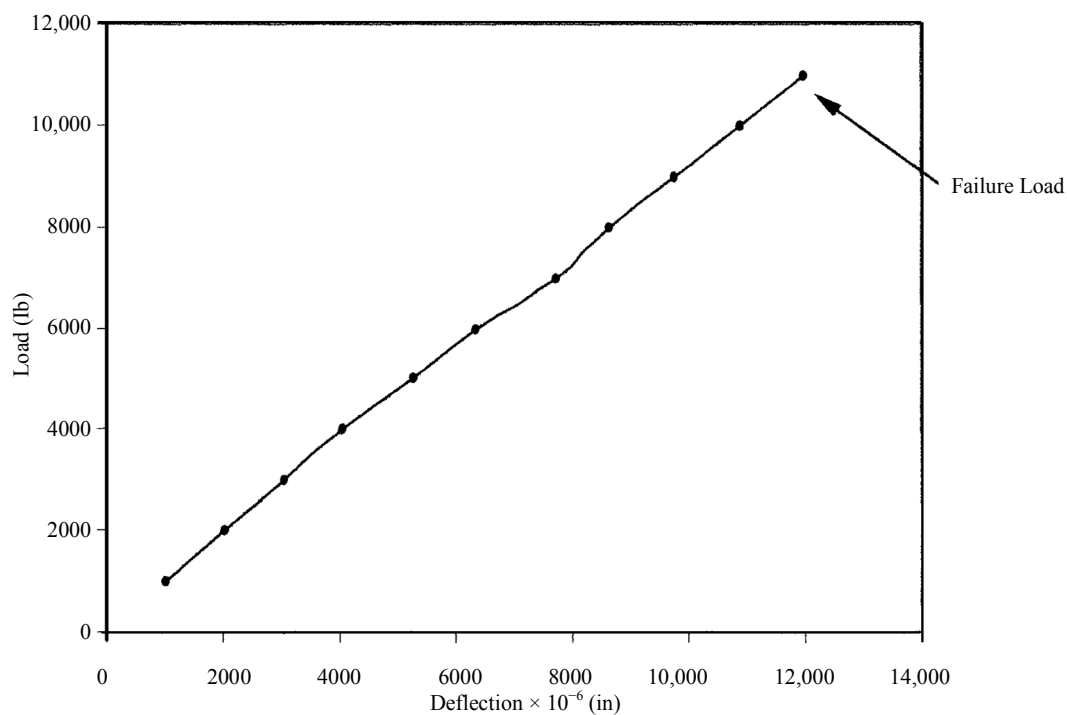
Figure 3. Load-deflection curve for grating (1 inch = 25.4 mm, 1 lb = 4.4 N).

One of the primary objectives of this study was to determine the mechanical behavior of the grating in frequent pedestrian traffic. For this purpose a grating was initially loaded to full failure under monotonic loading and the maximum load was noted. As seen in **Figure 3**, this load is 11,000 lb (48,400 N). The load-deflection curve shows linear behavior up to 4000 lb (17,600 N) and this was assumed to be the maximum safe load for pedestrian traffic. Another grating was then loaded up to 4000 lb (17,600 N), unloaded and loaded again to 4000 lb (17,600 N) and unloaded again. This procedure was repeated 5 times and load-deflection in each case was noted. The results are shown in **Figure 4**. It is seen that the load-deflection curves are nearly the same in each case, indicating that a maximum load of 4000 lb (17,600 N) may be considered to be safe for frequent pedestrian traffic. The next object was to evaluate the fracture zone features of the grating that failed at 11,000 lb (48,400 N). For this purpose, carefully sawed-off pieces from the fracture zone were examined in a scanning electron microscope (SEM). A typical SEM picture is shown in **Figure 5**.

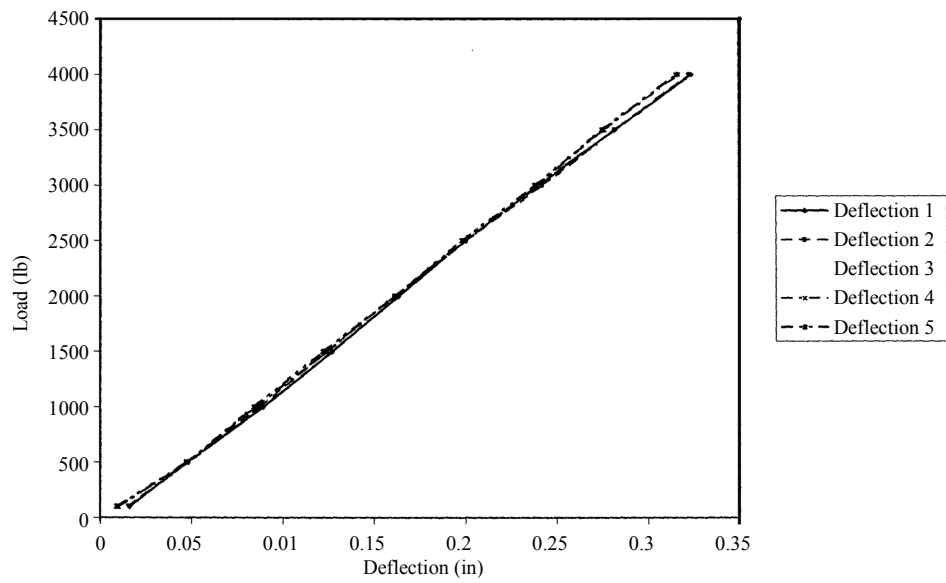
Figure 4. Load-deflection curves for repeated loading and unloading of grating (1 inch = 25.4 mm, 1 lb = 4.4 N).

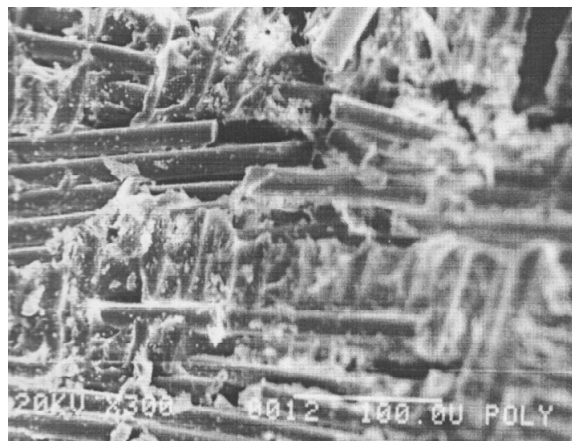
Figure 5. SEM picture showing neighboring fibers fracture ($\times 300$).

The mode of fracture is predominantly neighboring fiber fracture, indicating that the probable reason was the high volume fraction of the fiber (~60%).

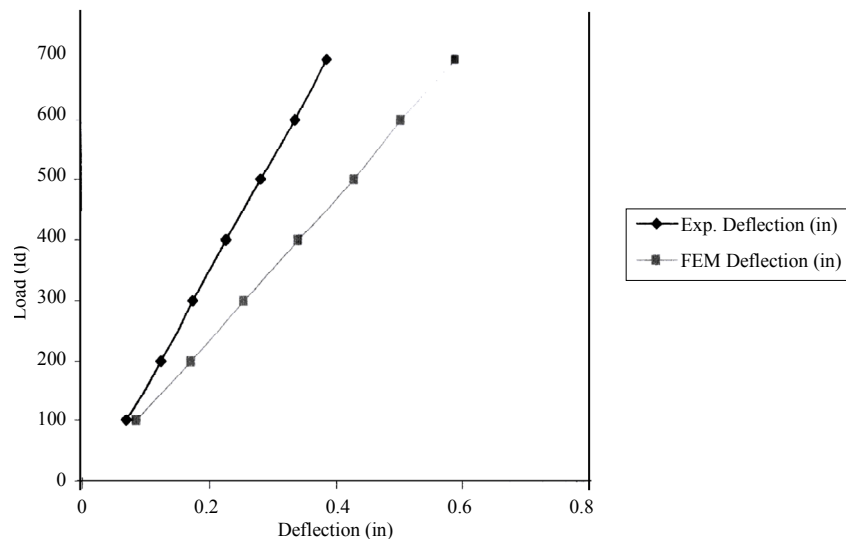
Figure 6. Comparison of FEM and Experimental Deflections.

Individual grating beams were modeled using an industry-standard software (Pro/MECHANICA) and deflections were determined at different loads similar to those used in experimental work. **Figure 6** shows the comparison of the FEM results with the experimental.

It is seen from the figure above that though the trend in the deflection is similar in both cases, the FEM values are somewhat lower than the experimental values. The interface between the spacer bars and the I beams was made strong with adhesives in the actual gratings, but this could not be modeled in FEM. The strong adhesive imparts additional rigidity to the grating making the ac-

tual (experimental) deflections lower for a given load.
