# Outdoor Corrosion Performance Study of Selected Construction Materials in Bonny Island

Chinedu Martin Ekuma, Tolulope Charles Ogunyemi\*

Department of Science Laboratory Technology, School of Applied Science, Federal Polytechnic of Oil and Gas, Bonny, Nigeria  
Email: \*charlestolulope@gmail.com

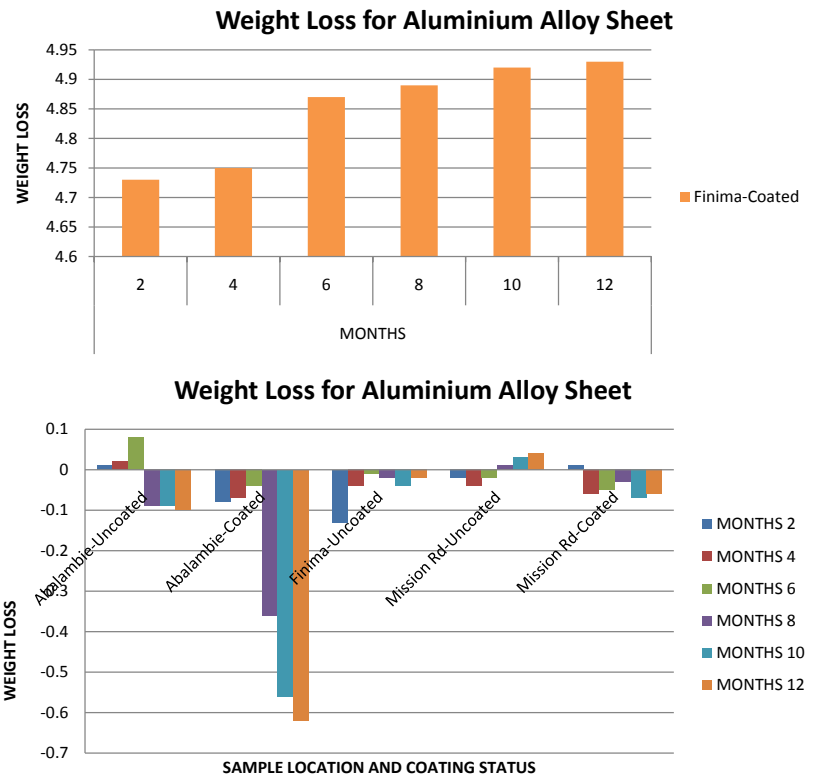
Figure 2. Weight loss of coated and uncoated aluminum alloy sheet.

There was a significant weight loss of coated aluminum at Finima area of bonny island compared to the results obtained from Ablamabie and Mission road within the same metropolis ([Figure 2](#)). This could be attributed to the aerosol particle deposition which is high at the industrial zone (Finima) and the climatic condition of the zone with high proximity to the Ocean. However, the results obtained from Ablamabie and Mission Road could be ascribed to the above condition but with a low effect as described for coated aluminum. Furthermore, the positive values denote that the coated aluminum may be peeling off based on its possible chemical degradation catalyzed by environmental parameters. The weight loss at Finima was obvious in the aluminum samples as a result of the degradation of the protective coating owing to the harsh environmental condition. The loss of the coating layer could be attributed to the permeation via the layer's

Furthermore, it was observed that the uncoated aluminum underwent continuous depletion owing to the unprotected material's exposure to various corrosion enhancing conditions. Although, aluminum forms a stable thin aluminum oxide layer that protects it from corrosion phenomenon, it is still susceptible to chemical degradation especially in an aggressive medium justifying the observed depletion.

At each of the exposure site, uncoated Aluminum sheet tends to form protective film which resulted in weight increase. Thus, the use of protective coating on aluminum sheet tends to improve the durability and corrosion resistivity especially in an environment that is more susceptible to corrosion process.

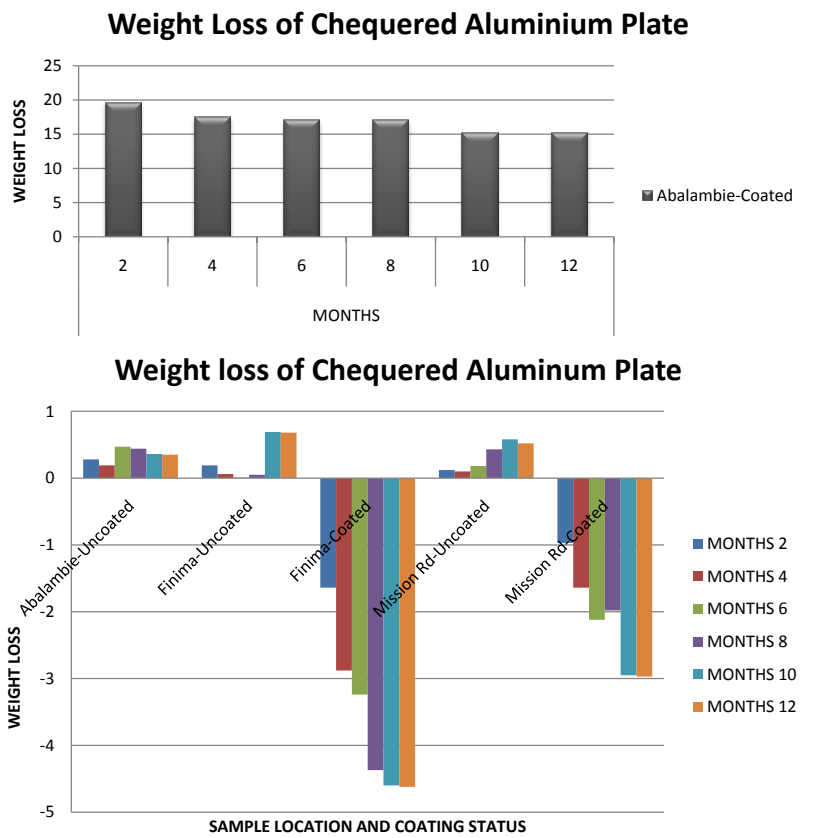
Figure 3. Weight loss of chequered aluminum plate.

Chequered aluminum plate which is widely used in the construction of caravans within the island showed different trend of corrosion mechanism across the exposure sites and its coating. It was observed that coated chequered aluminum plate at Finima and Mission Road, had an increase in weight compared to the uncoated chequered aluminum which had loss of weight. This could be associated to the fact that some of the environmental influences such as energy, permeation (moisture, solvent, chemical, and gas), stress and biological influences acting on the protective coating film can result in deterioration [16].

Uncoated Chequered aluminum plate showed weight loss at all exposure site. It implies that there will be a consistently corrosion taking place with loss of parts of the material. This could be attributed to the embossment enclave on the plate which permits the retention of corrosion enhancing entities such as dust,  $O_2$ ,  $H_2O$ , etc. on the surface thereby, creating sufficient surface area for corrosion to take place. However, coated chequered aluminum plate had an increasing

weight as a result of the possible add-up of moisture which gradually depreciates with time. Though the weight gain is highest at Finima which could be due to high salt and water content of the environment along anthropogenic and industrial activities in the area.

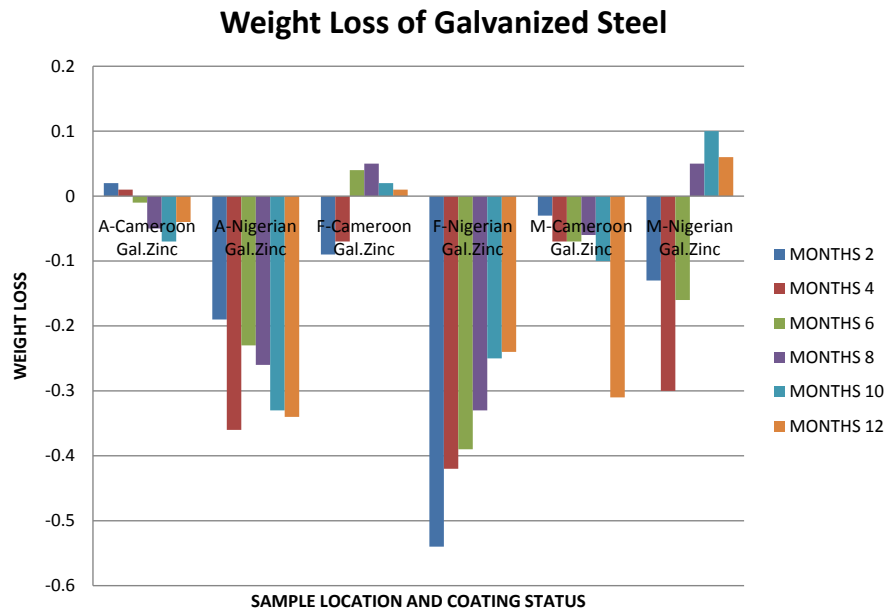
**Figure 4.** Weight loss of Cameroon and Nigeria galvanized steel sheet.

The loss in weight of galvanized steel can be related to the extent of additional film formed on the surface of the material upon reactions with the atmospheric entities. Hence Nigerian galvanized steel is more reactive to environmental conditions compared to the Cameroon galvanized steel across the exposure sites. However, Nigerian galvanized steel at Finima, Bonny Island had the highest extent of film formation. This could be attributed to the high industrial activities sequel to industrial effluents, particulate deposits, aerosol deposition and its proximity to the Atlantic Ocean.

Cameroon galvanized zinc sheet at Ablamabie and Mission road follows the same trend as there was a gradual weight gain as a result of protective film oxide formed on the material. However at Finima, Cameroon galvanized zinc sheet showed possibility of undergoing depreciating corrosion via consistent loss of some fraction of the sheet and formation of unstable protective film which after precipitation will undergo dissolution. This accounts for the consistent weight gain and loss procedure. Based on this understanding, galvanized zinc could have been reactive to the atmospheric entities from the industrial and salty water environment more than Cameroon galvanized steel environments, having less of this corrosion enhancing entities.

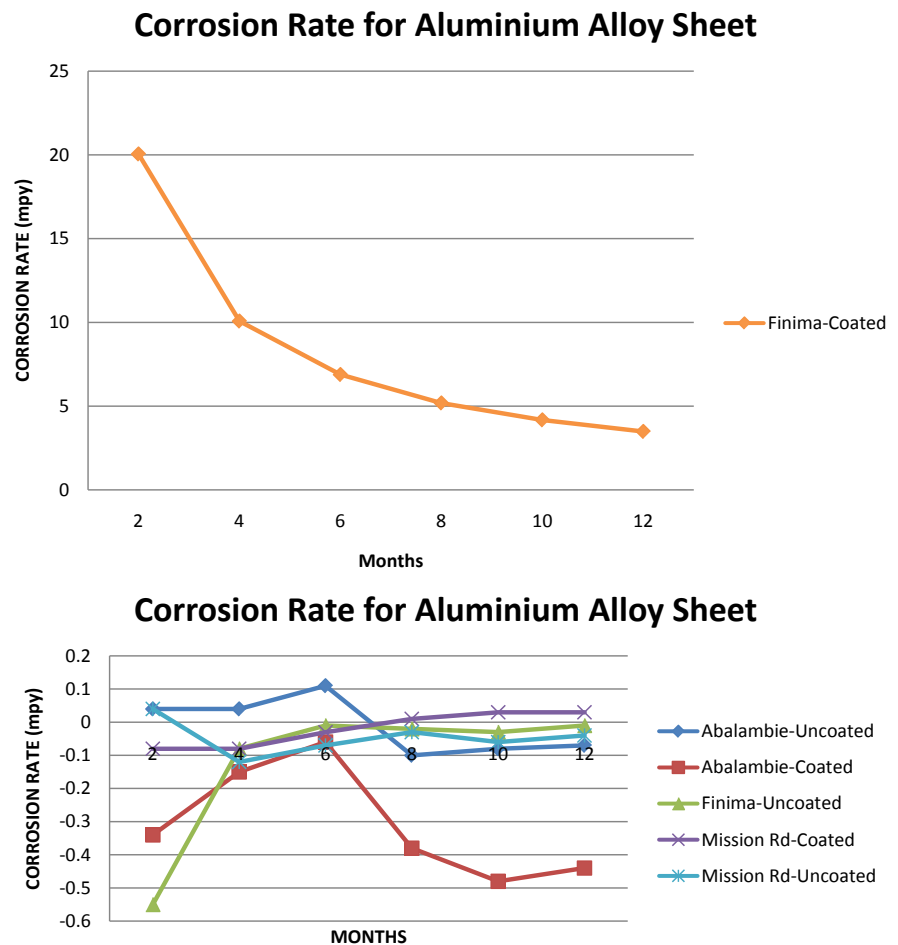
**Figure 5.** Corrosion rate of coated and uncoated aluminum alloy sheet.

Based on the corrosion rate of aluminum alloy sheet shown in **Figure 5** below. Coated aluminum sheet at Finima, Bonny island exhibited huge corrosion which could be due to high reactivity of industrial aerosols, corrosive gases and high moisture content synergistically reacting and reducing the corrosion resistivity

of the aluminum sheet [8]. Generally, the decrease in corrosion rate could be due to passivation [15] while increase in corrosion rate could be attributed to depassivation when the protective corrosion oxide is broken [3].

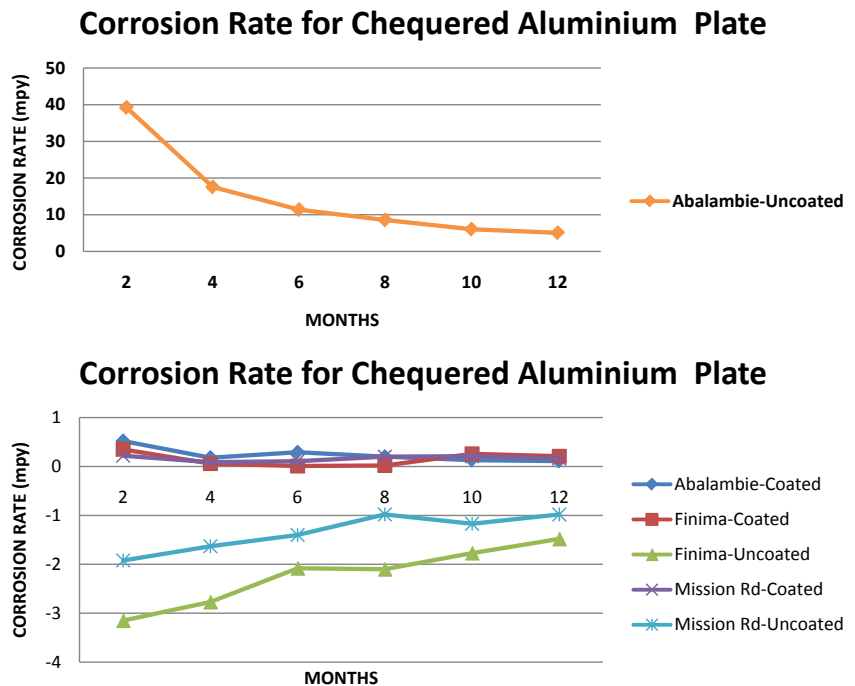
Figure 6. Corrosion rate of coated and uncoated chequered aluminum plate.

Furthermore, coated and uncoated chequered aluminum plate profile corrosion rate within 12 months of study is depicted in **Figure 6** below. The profile showed an irregular pattern of corrosion. The corrosion reduction is due to the formation of the protective oxide formed on the structure, and corrosion rate could slightly increase as a result of depassivation of the protective corrosion oxide [17]. The corrosion rate profile showed that uncoated chequered aluminum was unfit as a construction material owing to its vulnerability to chemical reaction from moisture and other gas permeation prevalent at Abalambie environment. A mid corrosion resistance was observed in coated chequered aluminum at Abalambie, Finima and Mission Road. The uncoated chequered aluminum at Finima and Mission Road showed high resistivity to corrosion.

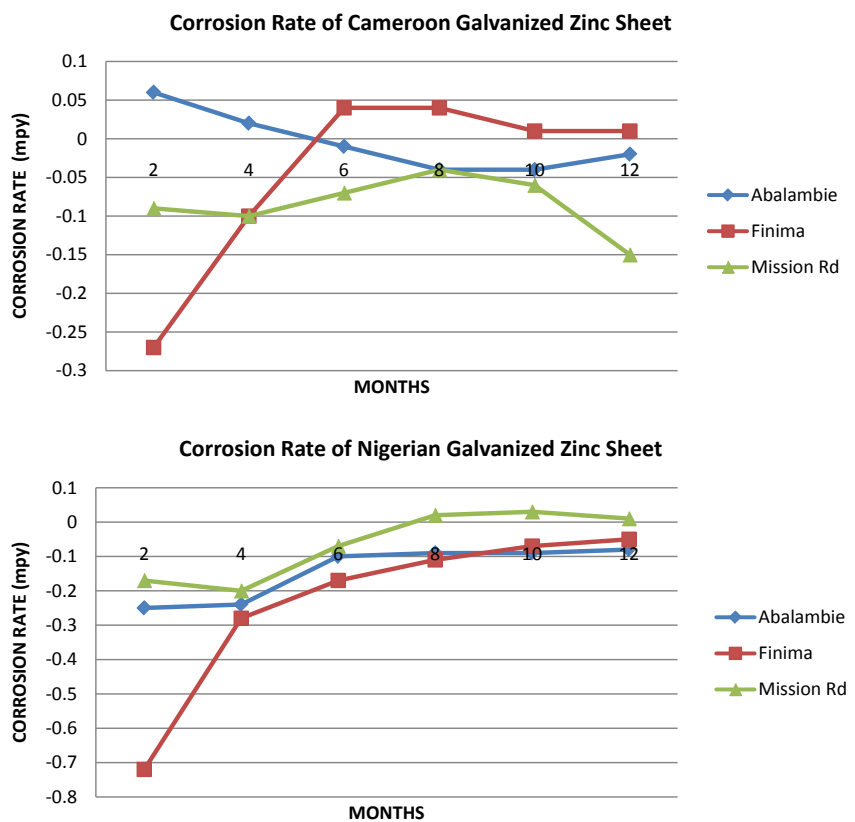
Figure 7. Corrosion rate of Cameroon and Nigerian roofing sheet.

Corrosion of the field exposed galvanized Cameroon and Nigerian roofing sheets is represented in **Figure 7** below. The corrosion rate of Cameroon roofing sheet at Finima was moderate compared to the same samples at Abalambie and Mission road which could be attributed to intense industrial activities and anthropogenic

resultant effects in the area. In addition, a uniform and speedy corrosion was observed for the Nigerian roofing sheet which is highest in Finima when com-

Zinc and zinc-coated products corrode easily in some environments forming white corrosion products [18]. As revealed in the two charts above (Figure 7), the rate of corrosion of Nigerian galvanized zinc sheet was faster which shows that the Cameroon roofing sheet is preferably better roofing material for construction in such industrialized area based on its extreme corrosion resistant properties. It has been reported that Cameroon zinc sheets is a product made from the alloy of rust resistance metals.
