Role of Metallurgy in the Localized Corrosion of Carbon Steel

Recep Avci*, Bret H. Davis, Nathaniel Rieders, Kilean Lucas, Manjula Nandasiri, Dave Mogk

Imaging and Chemical Analysis Laboratory, Montana State University, Bozeman, MT, USA

How to cite this paper: Avci, R., Davis, B.H., Rieders, N., Lucas, K., Nandasiri, M. and Mogk, D. (2018) Role of Metallurgy in the Localized Corrosion of Carbon Steel. *Journal of Minerals and Materials Characterization and Engineering*, 6, 618-646. <https://doi.org/10.4236/jmmce.2018.66044>

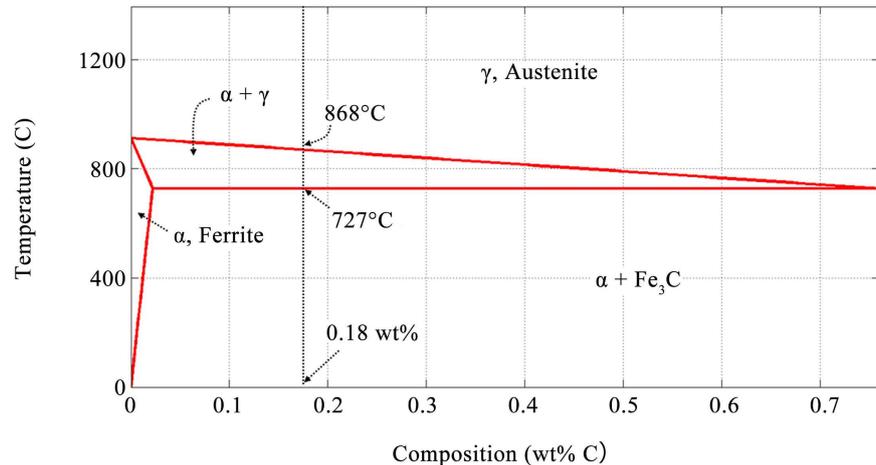
Figure 1. Iron-carbon phase diagram for a hypoeutectoid steel (<0.76 wt% carbon) for temperatures below the liquidus line. The composition of 1018 steel (0.18 wt% carbon) is indicated by a dashed line. The two iron/carbon phases (*i.e.* austenite and ferrite) are indicated, as are important phase transition temperatures pertaining to 1018 steel.

Figure 1 shows a Fe-C phase diagram of carbon steel within the carbon content of interest. The 1018 carbon steel has an alloying carbon concentration of 0.18 weight percent, as marked by the dotted vertical line in the figure. If we follow this line vertically at high temperatures, we see that when solid steel is white hot (approximately 1200°C) it is in the austenitic phase, the fcc structure of γ -Fe. When hot rolled at these temperatures, iron is in the γ phase and the highly malleable MnS inclusions are stretched along the rolling axis into stringers, because the MnS, with a melting temperature of about 1617°C, has already solidified. However, it is a different story for the C, which, because of the large size of the fcc lattice of the γ -Fe, is distributed interstitially in the austenite lattice, diffusing randomly in the lattice with no particular order. As the steel cools down slowly, maintaining a quasi-thermodynamic equilibrium, it starts forming islands of ferrite iron (also known as α -Fe), a body-centered cubic (bcc) structure with a smaller lattice size, when it reaches about 868°C. The α -Fe phase cannot accept much C interstitially because of the smaller lattice size. Therefore, in the temperature range between 868°C and 727°C the carbon steel is a mixture of

α -Fe and γ -Fe whose composition is determined by lever rule. Most of the C is randomly distributed in the γ -Fe phase, which is distributed interstitially in the fcc lattice; some of the C may already have started forming the carbide phase and be residing in the α -Fe. However, when the temperature is reduced slowly below 727°C, where there is no γ -Fe left in the mixture and all the Fe is now bcc α -Fe, the majority of the carbon atoms are locked into the pearlite phase, a mixture of Fe₃C (iron carbide) layers and α -Fe iron layers with submicron-thick lamellar structures. Depending on the temperature, very limited amounts of C reside interstitially in the α -Fe; these are eventually reduced to a negligible amount as the temperature approaches room temperature. At this temperature almost all the carbon in low-carbon steel is locked into the Fe₃C (cementite) phase. Cementite is a very hard carbide, and in alternating layers with strained ferrite [3] [4] [5] produces the well-known pearlite lamellar structure. In this manuscript we make a distinction between the two ferrite phases in the carbon steel; the thin layers of ferrite phase squeezed between two Fe₃C cementite layers are expected and hypothesized to be highly strained because of lattice mismatch between the bcc α -Fe and the orthorhombic cementite structure. While the ferrite crystals making up the majority of the steel will be relaxed within the grains, atoms residing at the grain boundaries will be strained because of lattice mismatch. These two ferrite structures (strained and unstrained) corrode at different rates as will be shown below.

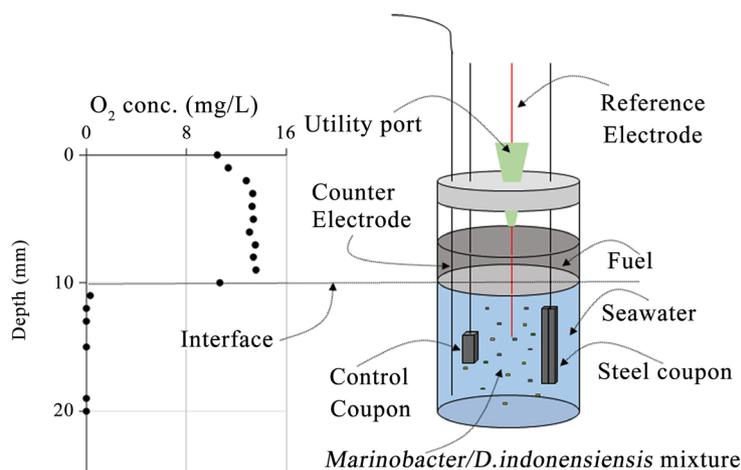
Figure 2. Schematic of the suboxic bioreactor utilized in corrosion experiments (right). Corroding samples (control and 1018 steel) are shown hanging from shielded wires. The control can be pure Fe or $\text{Cu}_{70}\text{Ni}_{30}$ alloy. Other components of the electrochemical cell are indicated. The seawater medium was inoculated with a mixture of *Marinobacter/D. indonensis*. The fuel layer over the seawater was filter-sterilized JP5 fuel, and the seawater was non-sterilized San Diego Bay seawater. The ATP, dissolved oxygen, open circuit potential, linear polarization resistivity, and reduction potential of the medium were all measured several times a week. The seawater used for the ATP assay was replenished weekly. Also given is an oxygen concentration profile in ppm as a function of depth taken after the system reached a steady state suboxic condition and remained there (left). A sharp drop in the oxygen concentration as the seawater/fuel interface is crossed is easily seen. The system was kept exposed to the air via the utility port, which was also used for inserting an Ag/AgCl electrode during our electrochemical measurements.

The tops of our reactors were kept open to the atmosphere, and the O₂ in the air was in a steady state thermodynamic equilibrium with the dissolved O₂ in the fuel and seawater phases. Dissolved O₂ in seawater was consumed through one of three mechanisms: 1) aerobic respiration of *Marinobacter*, 2) oxidation of metallic surfaces or 3) production of thiosulfates by H₂S reacting with O₂. A schematic of the system is presented in **Figure 2**. Measurements showed that the oxygen concentration in the seawater was below 50 ppb and remained more or less constant starting ~ 1 mm below the seawater/fuel interface (see **Figure 2**), a suitable condition for mixtures of aerobic and anaerobic species.

Corrosion experiments were conducted in the reactors described in **Figure 2**, in which the coupons were exposed to aerobic fuel-degrading *Marinobacter* and anaerobic, sulfate-reducing *Desulfovibrio indonensis*. Experiments were conducted in an environment with both aerobic and anaerobic bacteria present (herein referred to as suboxic/sulfidogenic) and in an environment with no anaerobic bacteria present as a control (referred to as suboxic). Hence all experiments were conducted in a suboxic environment. The corrosive medium was

When samples were removed from the corrosion reactors as described in **Figure 2**, the surfaces of the samples were covered with corrosion products, as shown in **Figure 8**. The surface illustrated in **Figure 8** was exposed to a suboxic/sulfidogenic environment as described above for ~50 days. A $\text{Cu}_{70}\text{Ni}_{30}$ alloy was coexposed with the carbon steel to simulate the pipes in Naval fuel tanks. The inset in **Figure 8** shows an EDX spectrum obtained from the corrosion products. The S associated with the corrosion products, mostly FeS, was in sulfide form (S^{2-}) as confirmed by the XPS analysis. Because FeS is a conductive mineral it provides electrically conducting pathways from the carbon steel surface to the cathodic reactants (O_2 , H^+ , HS^-) on the surface of corrosion products hence increasing the reach of cathodic processes and the rate of corrosions. The Cu and Ni signature in the EDX spectrum is due to corrosion products originating from the CuNi coupon (**Figure 2**). After the sample was removed, rinsed with Nanopure water and dried with dry nitrogen, it was analyzed using FEM. A large pit was obvious, but most of the other pits were obscured by thick corrosion deposits. In order to assess where the metal was eroding relative to any MnS inclusions, grain boundaries, and pearlite grains, as discussed above, the corrosion deposits on most of the surfaces were removed by dipping the corroded coupons into Clarke solution for a brief period (~5 s) before they were analyzed using FEM. On all the corroded coupons reported here, regardless of the corrosive environment, we observed excess localized corrosion in the immediate vicinity of MnS inclusions, in ferrite lamellae of pearlite bands and at many of the grain boundaries.

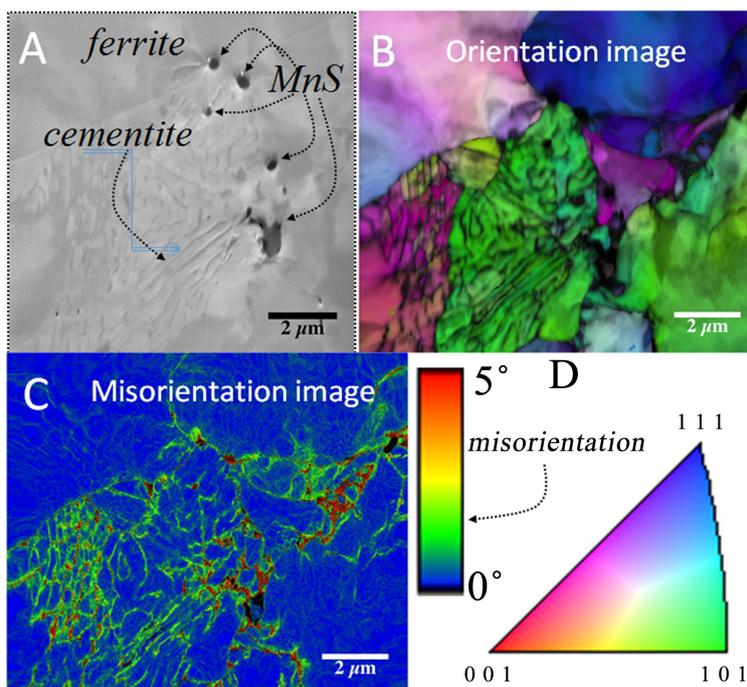
Figure 3. (A) Auger nanoprobe field emission secondary electron image of a 1018 coupon. (B) Auger nanoprobe EBSD orientation image shown in (A) but tilted by 70 degrees. (C) EBSD misorientation image generated from orientation image in (B). The sample was prepared by cutting the coupon perpendicular to the rolling axis of the rod and polishing to a 30 - 50 nm finish. (D) Orientation color legend associated with the image in (B) and misorientation color band associated with the image in (C). Indicated are MnS inclusions, pearlite bands and ferrite grains. Black represents unresolved points, indicating a region of high disorder. The misorientation map shows the locations of residual strain generated during the metallurgical preparation of the steel and hence of potential anodic sites. Shades of blue in ferrite grains and the colors green and red at defect sites indicate degrees of misorientation at these locations.

The localized residual strain left from the metallurgical history of a metal can be assessed by investigating the EBSD image of a clean 1018 coupon surface to demonstrate the degree of lattice-preferred orientation of adjacent grains and sub-grains, as shown in **Figure 3**. Panel A shows the Auger nanoprobe secondary electron image of a $10 \times 10 \mu\text{m}^2$ region of a 1018 coupon. Panel B shows the Auger nanoprobe orientation image of area A, but the sample is tilted by 70° .

Various microstructures are marked in this panel including MnS inclusions, cementite phase, and ferrite grains. Panel C shows the EBSD misorientation image of the lattice-preferred orientation of grain aggregates generated from the orientation image in B, where misorientations of grains of up to 5° are mapped. There is a direct relation between the misorientation and the strain of the metal which can be correlated [5] [49]. In Panel D of **Figure 3** we show the color correlations (legends) associated with the orientation indices (panel B) and misorientation angles of the grains (panel C). The sample was prepared by cutting the coupon perpendicular to the rolling direction of the rod and polishing to a 30 - 50 nm finish. Dark colors represent unresolved points, indicating a high degree of disorder. In principle a single grain should have a single solid color associated with a known orientation. The misorientation map shows the locations which have high residual strain [5] [49] and are potential anodic sites. It appears that the immediate surroundings of the MnS inclusions and the pearlite grains are highly strained and that these areas play a major role in localized corrosion [5] as well as in the overall corrosion of carbon steel that eventually leads to disastrous fail-

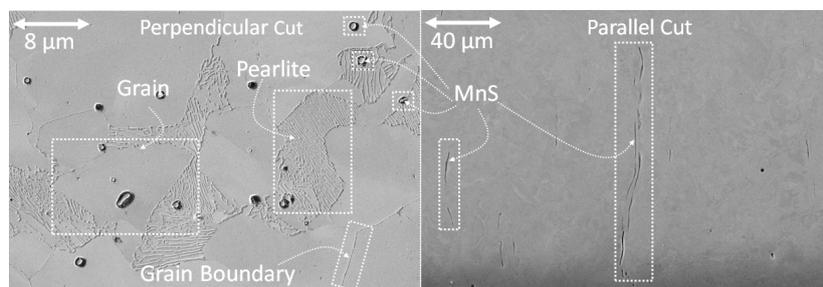
Figure 4. FEM images of clean carbon steel surfaces cut and polished perpendicular (left) and parallel (right) to the rolling axis of the rod. The image in the left panel was produced with a 1-kV accelerating voltage and etching with Nitol; the one in the right panel, with a 20-kV accelerating voltage. Examples of individual ferrite crystalline grains, MnS inclusions, a grain boundary, and pearlite grains are indicated.

The FEM investigation of clean, polished coupon surfaces illustrates the major microstructures of interest in this study. FEM images of coupons cut parallel (right) and perpendicular (left) to the rolling direction are given in **Figure 4**. The perpendicular-cut sample was prepared the same as the parallel-cut sample as described above, but additionally was treated with Nitol in order to enhance the surface microstructures of interest. Nitol was used here only to emphasize these microstructures; it was not used on any other coupons that were subjected to the biocorrosive environment. In the image (left panel in **Figure 4**), the cross sections of the MnS stringers appear small ($\leq 1\text{-}\mu\text{m}$ diameter) on the surface. Pearlite bands and grain boundaries are also clearly visible. The parallel-cut coupon was prepared by polishing to a 30 - 50 nm finish, following the procedure described above. This surface was not subjected to Nitol treatment to prevent etching of the MnS inclusions. As explained above, the microstructures of MnS inclusions and pearlite bands were stretched along the rolling direction of the steel rod. MnS appeared as long stringers stretching for hundreds of microns along the rolling direction, illustrating that the inclusions were long, pervasive features permeating throughout the material. Repeated investigation of 1018 carbon steel coupons using FEM in conjunction with EDX analysis gave the researchers familiarity with the appearance of the various mineral inclusions (MnS and others), so that they could be easily located and identified on surfaces. FEM imaging using low-energy primary electrons of 1 keV (as in the left panel in **Figure 4**) show the MnS inclusions with dark rings around them. These dark rings are where the Nitol preferentially corroded the surface, leaving dark, shallow trenches in the boundary region between the inclusion and the surrounding iron matrix. Similarly, FEM imaging with an accelerating voltage of 20 kV, as in the case of the parallel-cut sample shown on the right in **Figure 4**, show the MnS inclusions as long, dark lines. Grain boundaries and bands of pearlite were ubiquitous throughout the steel, as seen in the perpendicular-cut sample. Without the Nitol treatment, these features were not as obvious in the FEM of polished clean surfaces.

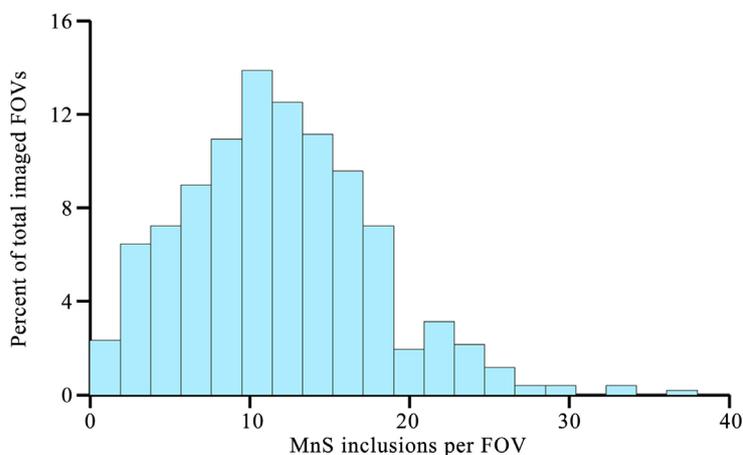
Figure 5. Histogram of the number of MnS stringer tips found per field of view (FOV) compiled from 512 images taken from a sample cut perpendicular to the rolling direction of the rod. The area of a single FOV was $3463.9 \mu\text{m}^2$. The x-axis gives the number of MnS stringer tips, and the y-axis gives the percentage of images found with that number of stringer tips exposed.

The number of inclusions counted per FOV image in the perpendicular-cut sample is given as a histogram in **Figure 5**. The x-axis gives the number of MnS inclusions counted per FOV, and the y-axis gives the fraction of the 512 images for which that number of stringer tips was found. The average was found to be 12 ± 6 inclusions per FOV image. This means a square mm area of 1018 carbon steel cut perpendicular to the rolling direction has on the average ~ 3400 inclusions, or each inclusion on the average occupies a $\sim 17 \times 17 \mu\text{m}^2$ area.

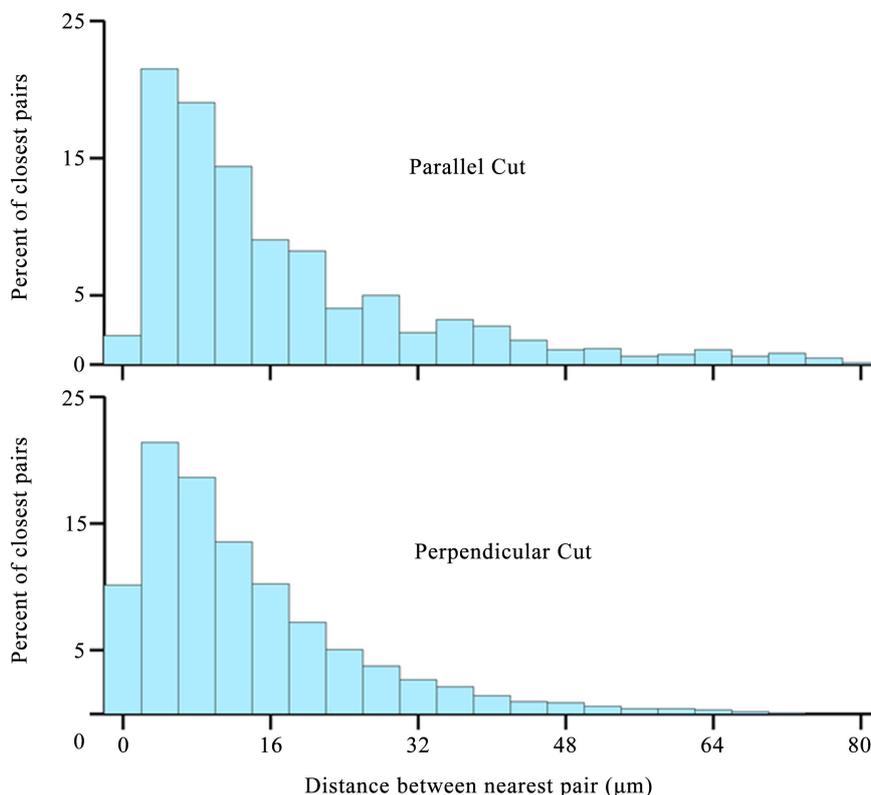
Figure 6. Histogram of distances between nearest neighbor pairs (both perpendicular- and parallel-cut surfaces) as a fraction of total number of pairs per range of distance. Each bin on the x-axis is 4 μm wide. The two distributions are very similar, as expected.

In the case of the parallel-cut samples, the pertinent metric to describe the spatial distribution of the MnS inclusion stringers is the distance (perpendicular to the rolling direction, or x-distance) between closest neighboring inclusions. A histogram of the distances between closest neighboring inclusion pairs is shown in **Figure 6** (top). This distribution is compared with the histogram of closest paired MnS stringer tips compiled from the data associated with the surfaces cut and polished perpendicular to the rolling direction, also shown in **Figure 6** (bottom). The maximum distance considered between pairs was chosen to match the size of the FOV utilized for the perpendicular-cut sample. This corresponds to a diagonal length of $88 \mu\text{m}$ for the FOV images of the surface cut perpendicular to the rolling axis. Overall it was found that on average an inclusion stringer is within $\sim 18 \pm 16 \mu\text{m}$ of another inclusion stringer.

The exponential decaying manner of the distribution in **Figure 6** suggests that inclusion stringers were more often in tight groups than spread far apart. **Figure 7** shows one of many FEM FOV images used to create the histogram for the parallel-cut coupons shown in **Figure 6** (top). Here the channels left by dissolved MnS stringers appear as dark lines, while bands of pearlite stand out as white islands in the otherwise grey ferrite metal grains. **Figure 7** shows that MnS stringers appeared to be often, but not always, localized along pearlite bands (Type A in **Figure 7**) and that in regions lacking in pearlite, stringers were observed less often (Type B in **Figure 7**). This reflects the difference between zones of the metal that possessed a high density of crystallographic disorder, or residual strain, and those that were more or less pure Fe grains, which were less strained. These highly strained ferrite zones will be more susceptible to localized corrosive attack and will serve as sacrificial anodes relative to the unstrained ferrite grains. This is a new view of corrosion, in which the anodic and cathodic sites on carbon steel are predetermined by its metallurgical history.

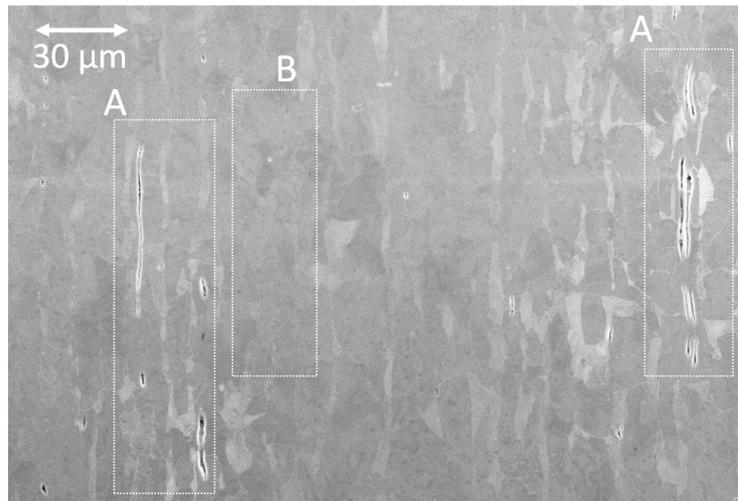
Figure 7. FEM image of pearlite bands (light regions) and elongated MnS stringers in a parallel-cut 1018 coupon. The sample was prepared by polishing to a 30 - 50 nm finish and then treating for five seconds with Clarke solution to dissolve the MnS inclusions exposed on the surface. The locations of MnS stringers appear in FEM images as dark lines. Pearlite appears as light regions in the slightly darker ferrite matrix. MnS inclusions were observed in the regions of high pearlite concentration (Type A regions) and were mostly absent in regions of pure ferrite (Type B regions). The Type A regions were highly strained compared to the Type B regions.

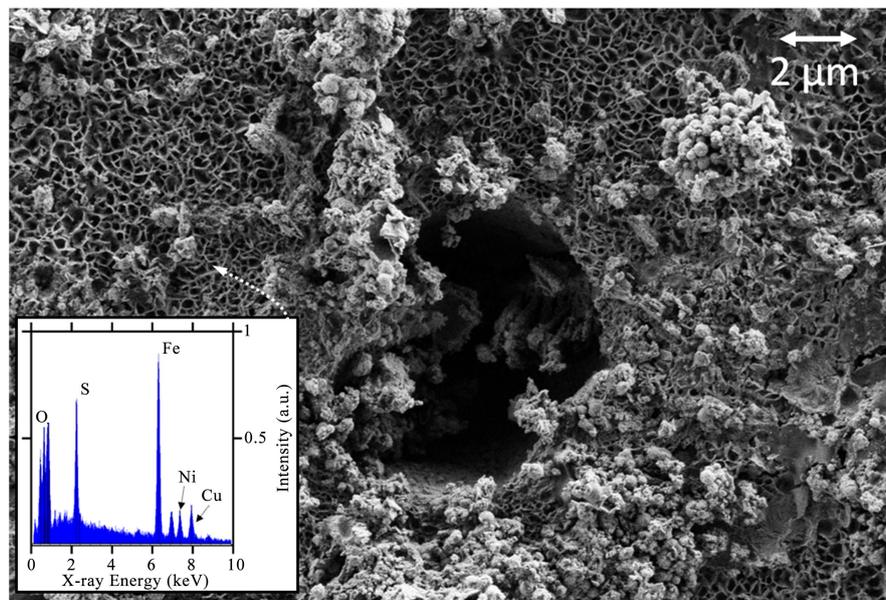
Figure 8. FEM image of a corrosion pit and its surroundings covered with corrosion products after 50 days of exposure to the suboxic/sulfidogenic environment described in the text. The inset shows an EDX spectrum identifying some of the corrosion products. The morphological features of the underlying metal are obscured by the corrosion deposits. These features were revealed by cleaning off the deposits by dipping the corroded surface briefly (~5 s) into Clarke solution.

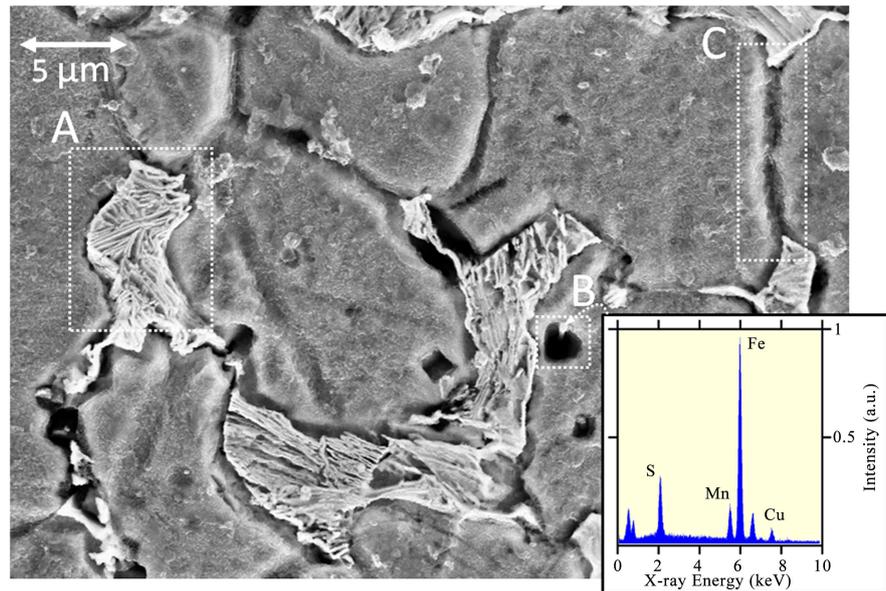
Figure 9. FEM image of corroded 1018 coupon cut perpendicular to the rolling direction after corrosion products were removed using Clarke solution. The sample was exposed to a suboxic/sulfidogenic environment for 50 days. Indicated are (A) pearlite, (B) a MnS stringer protruding from the pit, and (C) grain boundaries with accelerated corrosion in the boundary region. The inset is an EDX spectrum taken from the tip of the MnS inclusion. A zoomed-in view of the MnS inclusion is shown in **Figure 10**.

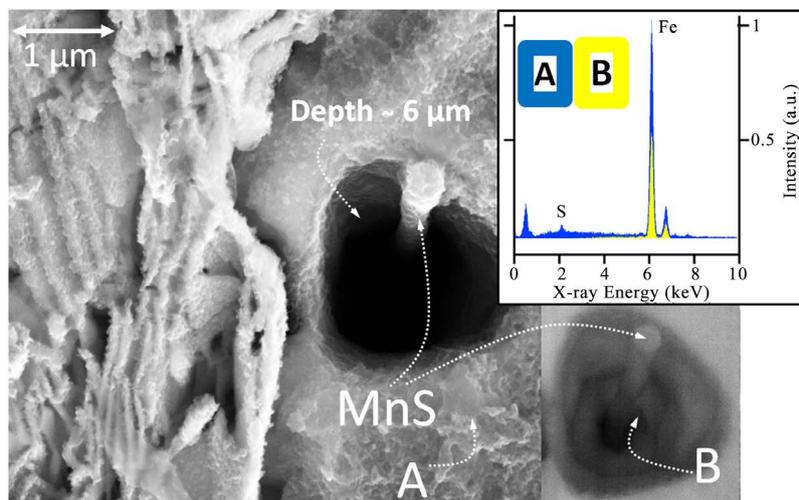
Figure 10. FEM image of the MnS stringer marked in Figure 9 and its surroundings. The surface was cut and polished perpendicular to the rolling direction, and corrosion products were removed using Clarke solution. The sample was exposed to the suboxic/sulfidogenic environment for 50 days. Marked are the MnS stringer sticking out of the pit and points A and B, from which the EDX spectra shown in the inset (upper right-hand corner) were taken to determine the pit depth ($\sim 6 \mu\text{m}$). The inset in the lower right corner is a backscattered contrast-adjusted image of the pit, where one can see the bottom of the pit. Such MnS inclusions eventually dissolve and produce localized H_2S and S as the acidity of the pit increases.

The localized corrosion around MnS inclusions grew deeper and wider as it tunneled down beneath the sample surface along the length of the MnS stringers as reported in our previous work [3] [4] and illustrated in **Figure 10**: the inset in the right-hand corner of **Figure 10** shows two EDX spectra, colored blue and yellow. The blue spectrum was taken from point A, while the yellow one was taken from the bottom of the pit at point B. The pit depth ($\sim 6 \mu\text{m}$) was determined using the methodology reported in our earlier publication [4]. It is possible to see inside the pit, as long as it is not too deep, using contrast adjusted secondary electron imaging, as shown in the inset in the lower right-hand corner of **Figure 10**.

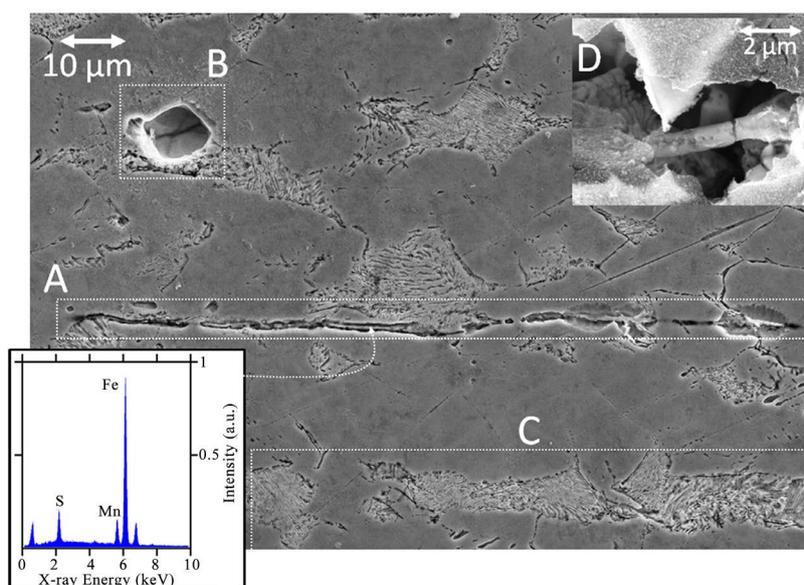
Figure 11. FEM image of a corroded 1018 coupon cut parallel to the rolling direction. The sample was exposed to a suboxic environment generated by *Marinobacter* in unfiltered San Diego seawater with 5 mL of JP5 fuel on top for 33 days and stripped in Clarke solution for approximately 5 seconds. Indicated are (A) a MnS stringer along the rolling direction with excess corrosion at the boundary and an EDX spectrum from a point on the MnS inclusion, (B) a corrosion pit growing in a region where pearlite and a grain boundary are co-located, (C) a pearlite band along the rolling direction, and (D) a stringer which broke because of stress release when the iron matrix no longer supported the MnS stringer.

Analogous results may be seen in the case of coupons cut parallel to the rolling direction. Stringers exposed on the polished surface during the initial stages of corrosion produced excess corrosion along the entire length of their sides, as illustrated in **Figure 11**. The degree and severity of the corrosion depended on the local surroundings of the MnS inclusion. The surface in **Figure 11** was exposed to the suboxic environment produced by anaerobe *Marinobacter*; the environment was not sulfidogenic. The presence of H_2S in solution exacerbated localized corrosion. An example of this is shown in the inset in the upper right corner of **Figure 11**. The surface associated with the inset image was exposed to a suboxic/sulfidogenic environment. Notice also that although the corrosion was initiated locally around the MnS inclusion, the presence of H_2S created localized pitting at the ferrite grain in the form of trenches and pits. This creates a positive

A broken MnS stringer, something that was commonly observed, is seen in the inset in **Figure 11**. When the immediate surroundings of a MnS stringer were corroded and etched away, a great amount of stress was released by the loss of ferrite matrix holding the stringer in place. The two ends of the break point separated and in some cases were no longer aligned after the MnS stringer assumed a less stressed configuration without the surrounding ferrite matrix holding it in place.

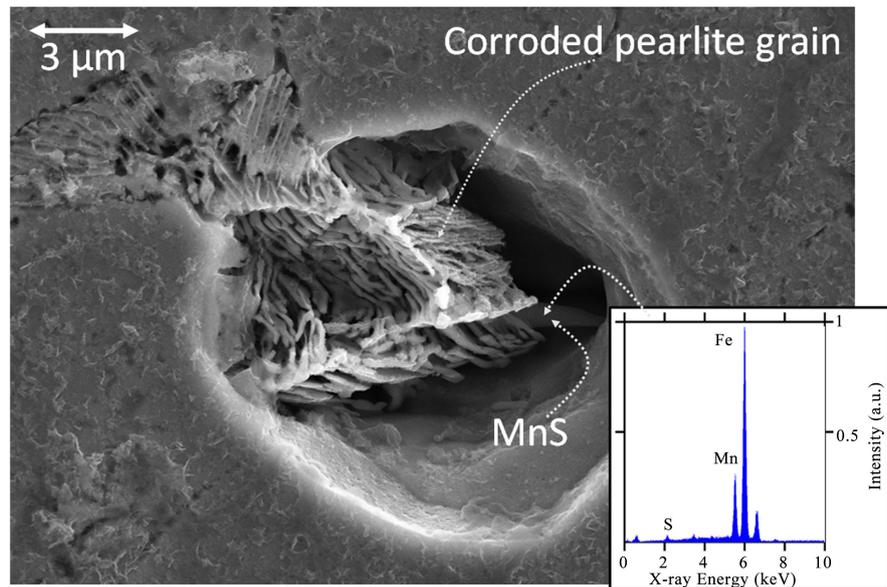
Figure 12. FEM image of a pit generated in and around a pearlite grain. This is the same surface as that shown in **Figure 11**, but a different region. The inset shows an EDX spectrum taken from a MnS inclusion exposed at the bottom of the pit, as marked. Notice the beginning of the hole around the MnS inclusion underneath the surface and extending along the MnS stringer.

The density of lattice defects in the ferrite matrix increased in zones where pearlite and MnS inclusions intersected each other. The result was excessive localized corrosion. An example is given in **Figure 12**, where a pearlite grain appears to be co-located with a MnS inclusion that was initially buried under the surface. This coupon was cut and polished parallel to the rolling direction, from left to right. Notice that the pit initiated around a pearlite grain on the surface exposed the MnS inclusion below the surface to the corrosive environment. Subsequently the localized corrosion followed the MnS inclusion under the surface, creating a hole around the stringer and burrowing into the metal along the stringer. The corrosive environment was suboxic without any sulfate-reducing bacteria in the medium. Our observations point to the fundamental corrosion processes taking place in these systems, which do not depend upon the presence of sulfate-reducing bacteria (SRBs). Regardless of the particular corroding medium, the corrosion initiates and grows where there is strain in the iron lattice. Even though the corrosion illustrated in **Figure 12** was not initiated by a sulfidogenic environment, the fact that dissolved MnS releases abiotic H_2S into the local environment of a pit means that the immediate surroundings of MnS inclusions become sulfidogenic abiotically, giving rise to accelerated corrosion within these deep, long, narrow regions.

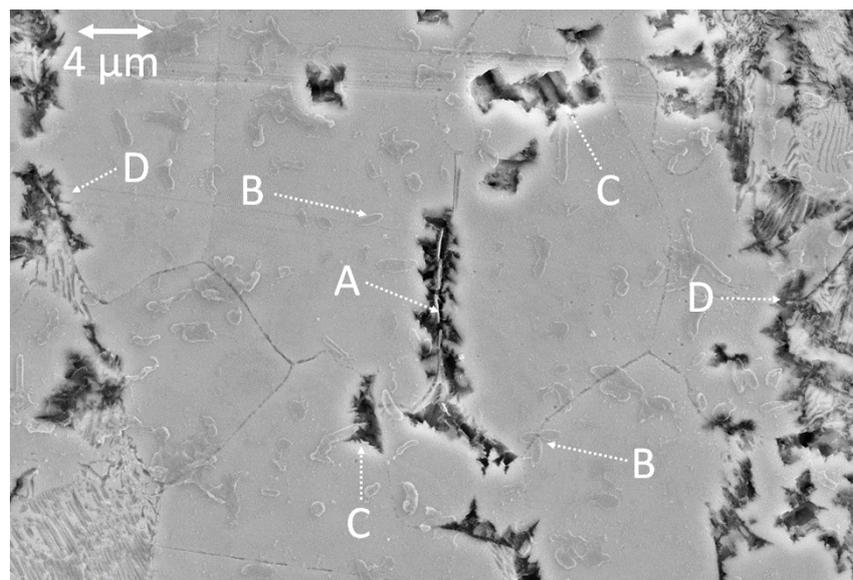
Figure 13. Excess corrosion at grain boundaries on a 1018 coupon surface. Indicated in the center is (A) a cementite lamella lined up with a grain boundary. EDX analysis at point A shows a nearly pure Fe signature. Also indicated are (B) examples of *Marinobacter* cells left behind, (C) grain boundary corrosion with no pearlite in the region, and (D) corrosion at grain boundaries and around pearlite grains. The sample was cut and polished parallel to the rolling direction and exposed for 33 days to the suboxic environment created by *Marinobacter* activity in San Diego Bay seawater.

Figure 13 illustrates another corrosion trench on a surface cut and polished parallel to the rolling direction. This time the corrosion was initiated along a

grain boundary. Notice at the point marked A that there is a broken line of structure extending along the trench. When analyzed with EDX, this line of

structure gave a signature of nearly pure Fe. This was most likely a cementite lamella localized along the grain boundary; EDX is not very sensitive to a C signature. In a corrosive environment, individual grains will etch out at different rates depending on the local density of lattice imperfections and differences in the orientation of the grains at grain boundaries. The particular grain boundary marked A in **Figure 13** apparently intersected a pearlite grain, and it was one of the Fe₃C lamellae running along the interface which caused the excess lattice strain in this region that resulted in enhanced localized corrosion. In this figure, we also notice a multitude of other grain boundaries exhibiting excessive localized corrosion which have pearlite grains nearby. These are marked D in the figure. Other grain boundaries, marked C in the figure, corroded at an accelerated rate without the nearby presence of pearlite or MnS inclusions.

Although this manuscript is not focused on distinguishing between suboxic and suboxic/sulfidogenic corrosion processes, it is worthwhile to mention some differences we have noticed. **Figure 13** shows the morphology of a corroded surface exposed to the suboxic environment of *Marinobacter* for 33 days, and **Figure 14** shows a similarly corroded surface exposed to the suboxic/sulfidogenic environment of *Marinobacter/D. indonensis* for 50 days. The morphology of the surface in **Figure 14** is qualitatively similar to that shown in **Figure 13**, but there are noticeable differences between the two surfaces, principally that the localized attack was much more severe in the case of suboxic/sulfidogenic exposure. Comparing the scale bars in **Figure 13** and **Figure 14**, one observes that suboxic/sulfidogenic exposure gave rise to deeper, wider localized corrosion pits and crevices. The corrosion was initiated at strained areas in both cases, with and without biotically produced sulfide, but it became more severe in the system with SRBs. In **Figure 14** the majority of grain boundaries are not corroded, but some near pearlite grains or MnS stringers are severely etched away. These are marked with circles in the figure. This differs from the results in **Figure 9** (sulfidogenic/suboxic exposure, perpendicular cut) which show all grain boundaries being preferentially etched relative to the bulk iron. As mentioned above, coupons of CuNi alloy were corroded alongside the 1018 coupons (**Figure 2**) in these experiments, and their corrosion was investigated as well. We noticed that in the case of corrosion in a suboxic/sulfidogenic environment, substantial dissolution of the CuNi resulted in the deposition of Cu and Ni corrosion products on the 1018 coupon surfaces (see inset in **Figure 8**). Only very limited, if any, corrosion of the CuNi alloy was observed in suboxic corrosive environments. Work on the corrosion products of CuNi and carbon steel will be published elsewhere.

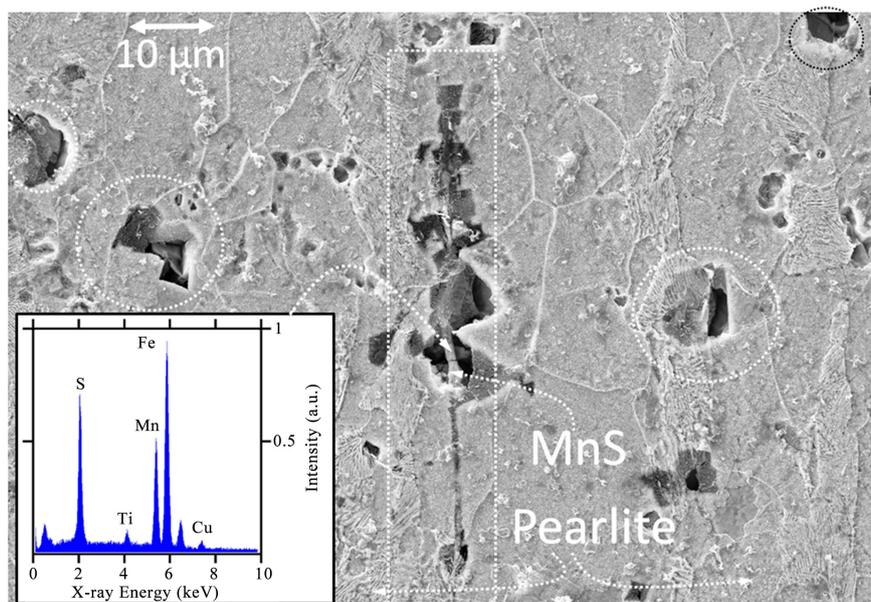
Figure 14. FEM image of accelerated corrosion around a MnS inclusion on a 1018 coupon surface cut parallel to the rod axis. The sample was corroded for 50 days in a *Marinobacter/D. indonensis* mixture in unfiltered San Diego seawater and 5 mL of JP5 fuel. The coupon was glued back to back to another 1018 coupon and corroded alongside a CuNi coupon. Corrosion products were removed by briefly immersing the coupon in Clarke solution. The inset shows an EDX spectrum taken from a MnS stringer as marked. The entire length of the inclusion is outlined by a box. Locations of grain boundary corrosion near pearlite grains are shown in circles. Notice also the excess corrosion at locations where broken MnS, pearlite grains and ferrite iron were co-located.

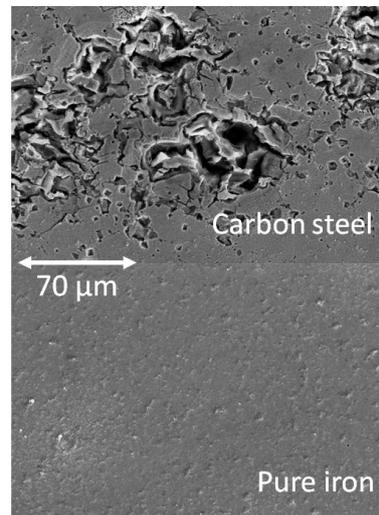
Figure 15. FEM images of corroded surfaces of a 1018 coupon (top) and a pure iron coupon (bottom), both cut perpendicular to the rolling direction, that were glued together back to back and corroded under identical *suboxic/sulfidogenic* conditions for 170 days in the presence of *Marinobacter/D. indonensiensis* in artificial seawater (Widdel medium) with JP5 fuel on top. The reason we used a pure Fe is that pure Fe does not have MnS inclusions and pearlite grains, which we claim is where most strains occur and most localized corrosion starts and propagates. Thus, theregions of accelerated corrosion are obvious as deep pits in the 1018 sample, but virtually nonexistent in the pure iron sample.

which, in a corrosive environment, cause the initiation and growth of localized corrosion. In what follows an expanded version of this idea is described. **Figure 15** summarizes our conclusions. It compares a pure Fe coupon (99.995% purity) (bottom) and a 1018 carbon steel coupon (top) that were corroded simultaneously under the same experimental conditions; the coupons were cut and polished perpendicular to the rolling direction and exposed to the same suboxic/sulfidogenic environment for 170 days. Notice that at the scale shown there are a large number of localized corrosion pits on the 1018 coupon, whereas there is hardly any localized corrosion on the pure Fe coupon. Deep crevices and holes exist on the 1018 coupon around pearlite features, and many of them contain MnS inclusions at their deepest points. With the exception of grain boundaries, pure Fe does not possess many of the localized defects, such as MnS inclusions or pearlite bands, that are abundantly present in 1018 carbon steel. Furthermore, this was not galvanic protection of pure Fe, for we have observed a lack of localized corrosion on pure Fe in many instances where pure Fe was co-exposed with a carbon steel coupon to a corrosive environment without physical contact with similar results.

Therefore, the only localized corrosion in the case of pure Fe is expected to be along the grain boundaries; we see such corrosion locally upon closer inspection.

This comparison greatly clarifies the message that it is the defects and imperfections in the lattice of carbon steel that create anodic sites susceptible to corrosive attack. These defects are lacking in pure Fe, and therefore the availability of anodic sites and severity of corrosion are limited. The corrosive environment does not control whether or where corrosion initiates, although this does control the rate and reactive pathway of corrosion. Metallurgical history plays a major role in determining where corrosion initiates. This forces us to formulate a new view of corrosion that considers the residual strain due to defects, imperfections, and mineral inclusions generated in the ferrite matrix as a result of the metallurgical preparation and alloying of the steel. The metallurgical history of steel leaves behind a distribution of strained and unstrained regions at the microscopic scale, this predetermines the locations of micro scale galvanic cells. The localized areas where the ferrite lattice is strained, depending on the density of dislocations and lattice defects, are the natural anodic sites. These are distributed within the Fe lattice in sizes ranging from the nano- to the microscale. The areas of the lattice that are not strained and are mostly intact without a high density of dislocations are the cathodic sites of the carbon steel. In this new view of corrosion the strained areas of the carbon steel act as sacrificial anodes for the unstrained regions of the same steel. The corrosion potential differences between the anodic and cathodic sites of the carbon steel can be calculated by means of the mechanochemistry approach introduced by Gutman many decades ago [51], and these can be compared quantitatively with the experimental measurements mentioned here.
