Environmental Impact of Flooding in the Main (Smallwood) Reservoir of the Churchill Falls Power Plant, Labrador, Canada . III. Environmental Impact Zones and Direct and Indirect Changes.

Denes Bajzak¹, Bruce A. Roberts²

Keywords: Reservoirs, Flooding, Boreal, Dykes, De-watered, Vegetation Re-growth, Shore Line Development

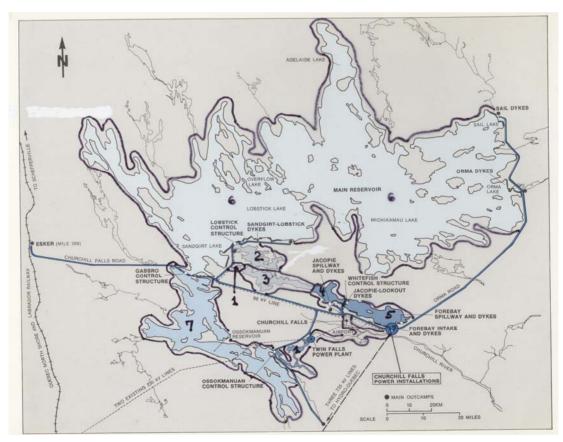
Figure 1. Location of Major Structures and Environmental Impact Zone.

LEGEND:Zone boundary: Thick line Code #:1: De-watered sections of the original rivers. 2: Original river with sustained increased flow. 3: Relatively unchanged rivers. 4: New reservoir, flooded river valleys with fluctuating water levels in ice-free months. 5: New reservoir with substantially raised water level of many lakes, nearly constant water level during the summer months. 6: Main Reservoir, flooded flat plateau with many lakes of substantially raised water level which fluctuates on an annual cycle. 7: Older reservoir (Ossokmanuan) similar to 6 above.

The field investigations concentrated along the 'Sandgirth-Lobstick' dykes because of easy accessibility of this area by motor vehicle as we had time limitation on our field work. The changes around the Orma and Sail dykes are considered similar to those of the Sandgirth-Lobstick dyke system (**Figure 1**). In addition observations and oblique aerial photos taken from helicopter during regular dyke surveys, enabled investigations to be made on the whole perimeter of the flooded reservoir. Interpretations on small scale, color infrared vertical aerial photographs were conducted on various sections of the reservoir. Detailed descriptions were carried out in three defined areas (gravel pits & quarries, flooded areas below the dykes and the test lake). This material was then evaluated and interpreted and the descriptive results pre-

The 'birds eye view' of changes in the environment above and below the dykes is illustrated by **Figure 4**, (see also **Figure 1**). **Figure 4** also shows the location of the test lake (arrow), its surroundings and the major dewatered rivers { (#1) and Zone 1 in **Figure 1**}. The original spray zone [3,4]) contains wooded areas with several Boreal tree species (see **Figure 5** for falls and spray area). This figure_illustrates the falls in 1969 (a), and in 2006 (b). The falls was originally named Hamilton Falls but was renamed Churchill Falls in connection with the development. Originally this largest river in Labrador was referred to as the Grand River with the Innu name Mishta-Shipu.

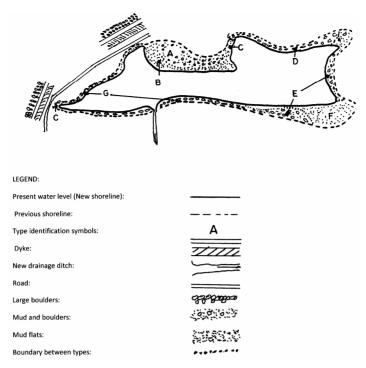
Figure 3. Test Lake.

Near the original shore line a dense mixture of Alder and Willow (Salix pirifolia Anderss) thickets can be found (area at letter A). Between this area and the water, muddy surfaces exist (at B). On the higher-drier parts various moss colonies (Polytrichum and Bryum species) established soon after the de-watering. There is a continuous struggle existing here between the new vegetation cover and surface erosion. The area identified by letter C is composed of water-logged silt deposits covered by a thick layer of sedges (Carex aquatilis, Carex saxatilis and Eriophorum opacum,) bordered by willows. The area at D is a narrow strip of large boulders with some Alder bushes growing in the hollows between the boulders. The shores of muddy materials (at E) are sparsely vegetated but later succeeded by Alder bush growth. The area at letter F is a very large gentle sloping mud flat composed of impermeable silty-clay and does not support any vegetation growth. Where the shore is steep (at G) a narrow area of large boulders is present,

bare of any herbaceous vegetation (here no soil can be found between boulders). Between the road side and bolder shore, thick alder growth developed and increased in size to 3 meters by 2006. When we revisited the site during the summer of 2006 our test lake was completely filled with water to the 'Alder' shore line for the very first time in our observations. The lowering of the water in this type of lake significantly improved the habitat of waterfowl by providing easily accessible food and nesting places.

nearby dykes caused considerable drop of water level there. Large areas were dried up and new shore lines were established. Since this type of change can occur during the construction of other reservoirs, we established a long term research project in one of the lakes where we carried out very detailed field observations. In places where the near shore lake bottom was gently sloping mud flats were developed, while steep sloped areas contained very large boulders. In our test lake the water level was lowered by approximately 1 m (3 feet) exposing a 10 to 80 m (30 to 300 feet) wide strips of periodically dried-up land (Figure 3). The type of newly established vegetation communities on these areas, identified by capital letters on Figure 3, was determined by the underlying soil material and by periodic water level fluctuation.

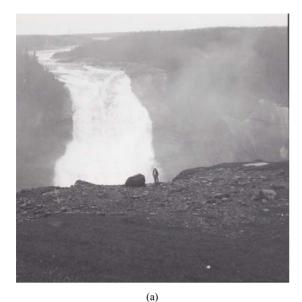
Figure 5. Churchill Falls then and now. a) Original Falls in 1969 b) Dewartered Falls in 2006).
