Effect of Hot Dip Galvanized Steel Surface Chemistry and Morphology on Titanium Hexafluoride Pretreatment

How to cite this paper: Saarimaa, V., Markkula, A., Arstila, K., Manni, J. and Juhanaja, J. (2017) Effect of Hot Dip Galvanized Steel Surface Chemistry and Morphology on Titanium Hexafluoride Pretreatment. *Advances in Materials Physics and Chemistry*, 7, 28-41.

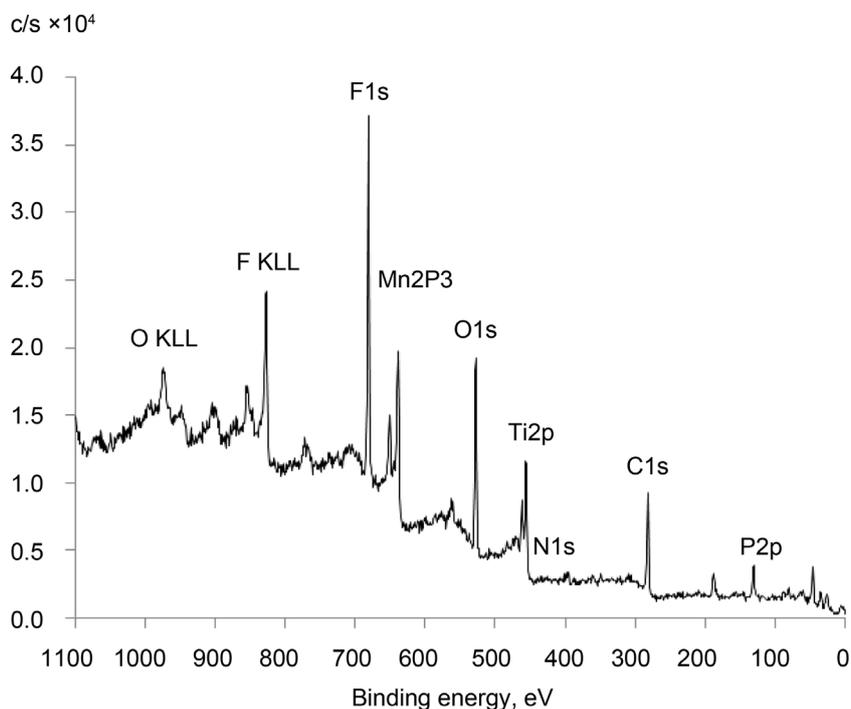
Figure 1. XPS spectrum recorded on a dried pretreatment chemical droplet on a glass slide.

A mildly acidic pretreatment chemical (Bonderite M-NT 1455T, Henkel) containing titanium hexafluoride, manganese phosphate and organic polymer was used [12] [17]. The chemical was characterized by XPS (X-ray photoelectron spectroscopy). For the measurement, a microscopy glass slide was submerged in a pretreatment chemical solution sample for 30 s. The XPS analysis was performed after air drying of the slide. An XPS spectrum is shown in **Figure 1** and the atomic-% concentrations of different elements are shown in **Table 2**.

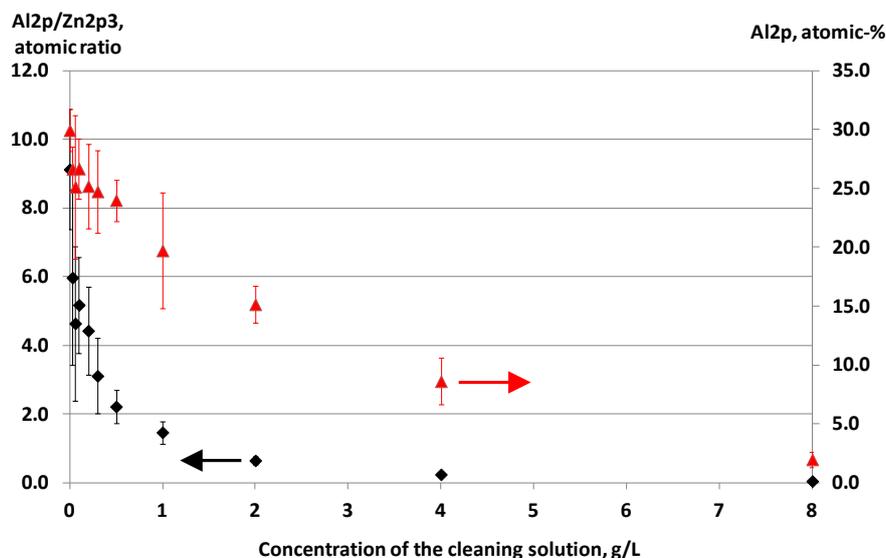
Figure 2. Dissolution of aluminum (oxide) from HDG samples as a function of the cleaning solution concentration. The results are average values of nine measurements.

solution concentration is shown in **Figure 2**. On the surface of non-etched HDG surface, over 30% of the atoms detected in the outermost few nanometers were aluminum. The rest was mostly oxygen with small contributions from zinc and carbon [20]. The surface aluminum concentration decreased when the sample was treated in an alkaline solution. The Al/Zn atomic ratio decreased rapidly already at low concentrations of the cleaning solution. Similar trends have been obtained by increasing the treatment time and temperature [19]. In this study, the concentration of aluminum decreased much slower than the Al/Zn ratio. The zinc signal, derived from metallic Zn below the Al_2O_3 layer, increased rapidly as the Al_2O_3 layer thickness decreased, which explains the difference. For instance, at 2 g/L the decrease in Al atomic-% was about 50% while the decrease in Al/Zn atomic ratio was about 90%. The Al/Zn atomic ratio has been used in some studies to depict the aluminum content of a surface, since the Al atomic-% values are generally rather small [6] [19]. Also, decrease in signal intensity due to local impurities such as carbon plays a lesser role if the Al/Zn atomic ratio is considered instead of solely the Al atomic-% data. Good adhesion and corrosion resistance properties have been reported with about 70% removal of Al [21]. A complete removal of Al requires severe etching and may not be process economically feasible [7] [19].

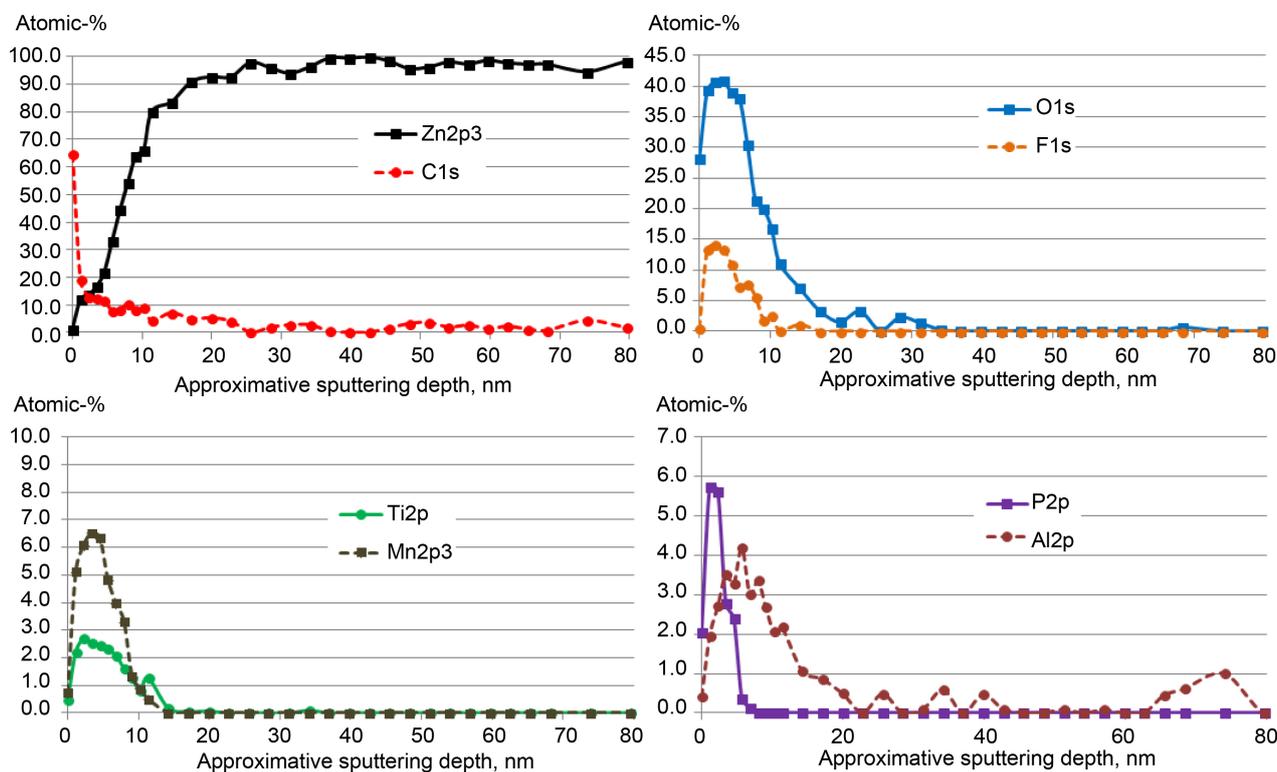
Figure 3. XPS depth profiles of the different elements in the pretreated layer on a non temper rolled hot dip galvanized steel sample (concentration of the cleaning chemical was 0.2 g/L). The results are averages of three parallel measurements.

Samples with low removal of aluminum (0.2 g/L) and high removal of aluminum (4.0 g/L) were pretreated. XPS depth profiles of the different elements within the pretreatment layers are shown in **Figure 3** and **Figure 4**. Over 60 atomic-% of the outermost surface was composed of carbon in both samples. The carbon signal decreased rapidly after mild sputtering, which confirmed that the carbon on the surface was present as a surface impurity. The true carbon signal,

The approximative thickness of the pretreatment layer was significantly higher in the well cleaned sample (**Figure 4**) than in the sample with mild cleaning (**Figure 3**). Also, aluminum was detected only in the latter sample. Since the pretreatment step was identical for the both samples, it can be deduced that the sample with mild cleaning was less reactive than the well cleaned sample. Stellnberger *et al.* [25] showed by electrochemical quartz crystal microbalance measurements that the reactivity of a galvanized steel sample increases with alkaline cleaning. Similar results have been obtained in other pretreatment and coating studies [6] [7] [26]. The investigations are underway to establish a critical level of surface aluminum oxide removal for good coating adhesion.

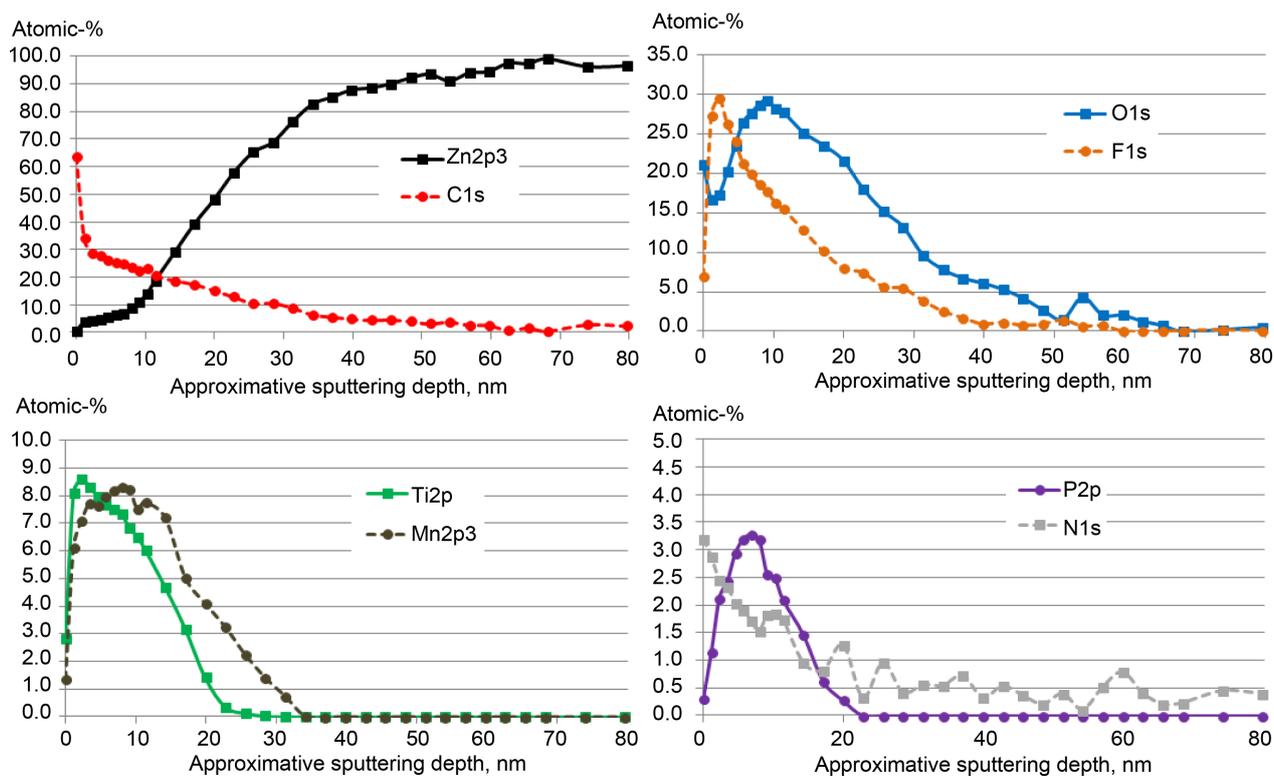
Figure 4. XPS depth profiles of the different elements in the pretreated layer on a non temper rolled hot dip galvanized steel sample (concentration of the cleaning chemical was 4.0 g/L). The results are averages of three parallel measurements. Al was not detected.

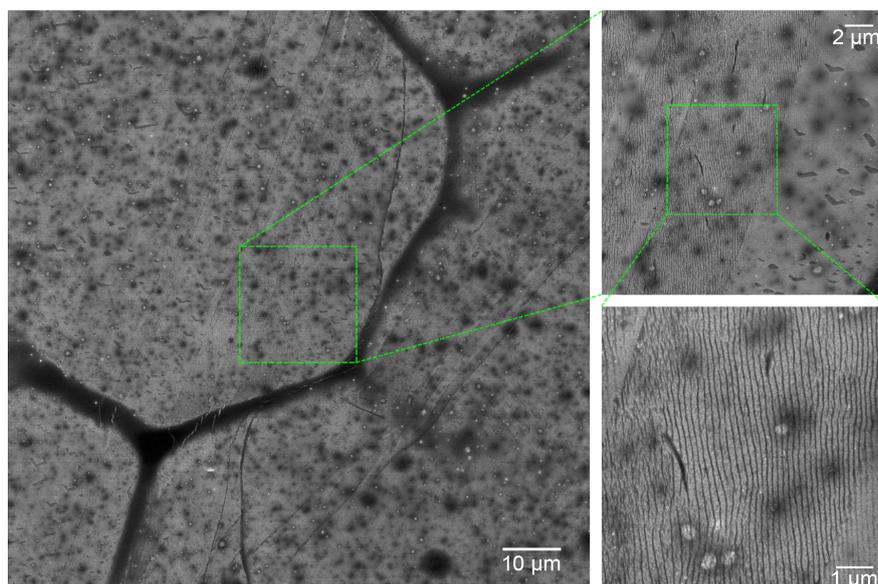
Figure 5. Helium ion microscopy images of a well cleaned (4 g/L), pretreated HDG sample.

Helium ion microscopy images of the pretreatment layer deposited on a sample after alkaline cleaning with a 4 g/L concentration are shown in **Figure 5**. Grain boundaries have a dark appearance, which indicates strong presence of the pretreatment chemical [27]. Inside the grains there are remarkable contrast variations, which have earlier been shown to depend on the microscale thickness variations within the pretreatment layer [28]. Also deformation twinings were seen within the grains. A close-up of the pretreated surface further highlights the microscopic thickness variations in the pretreatment layer, higher concentrations seen as darker spots. Deformation twinings are seen on the surface. The surface of the twinings is composed of wavy lines, and the edges of the twinings are rather sharp. Formation of a deformation twinning is described as a

The origin of the dark appearance of the grain boundaries that was detected with HIM (Figure 5) was further studied with EPMA. Element maps were recorded at a grain boundary of the pretreated sample (cleaning at 4 g/L, followed by pretreatment) (Figure 8). Higher Ti, Mn and O intensities were measured at the grain boundary than at the grain plateaus, confirming higher pretreatment coating weight at the grain boundaries. Greater surface roughness (depressions in a zinc coating) has been proposed to increase the coating weight deposited per unit of the apparent surface area due to increased reactive area during the treatment [38]. However, on the other hand the dendritic valleys and grain boundaries are often populated with high amounts of aluminum and other impurities rejected from the molten zinc during the solidification of the zinc coating [36]. Thus, the higher coating weight of the pretreatment chemical at the grain boundaries may also be a drying effect.

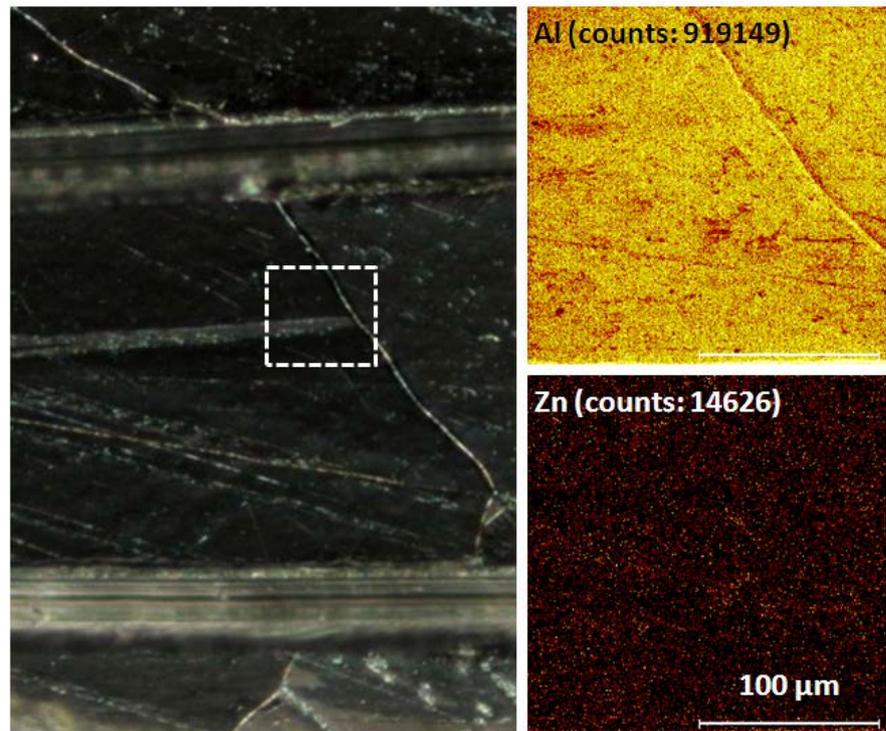
Figure 6. ToF-SIMS element maps of Al and Zn of a deformation twinning close to a grain boundary. Brighter color in the ToF-SIMS maps indicates higher intensity of the element. The sample was cleaned with a 0.2 g/L cleaning solution prior to measurement. Light microscopy was employed for choosing of the imaging spot (image on the left).

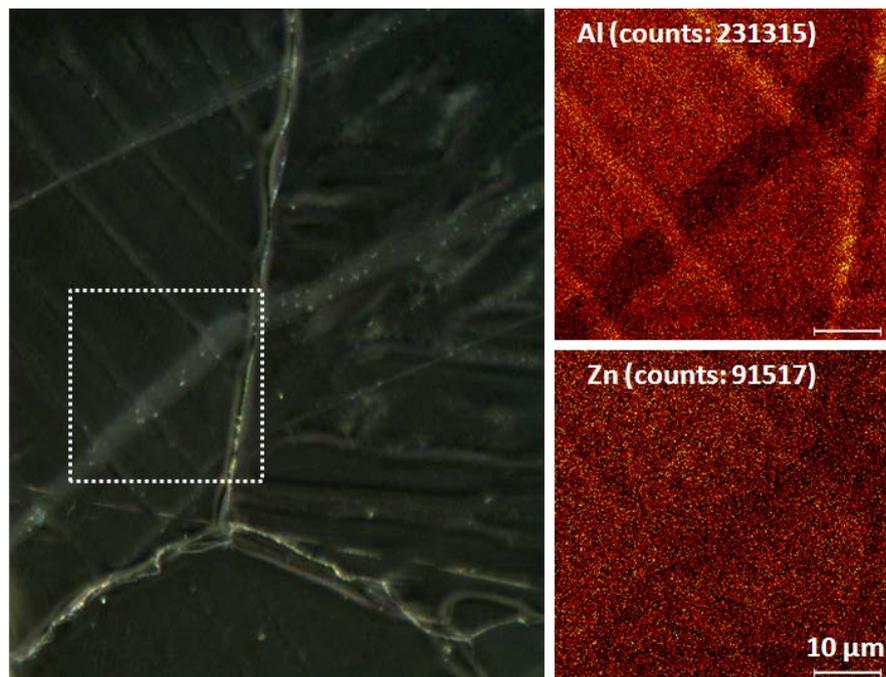
Figure 7. ToF-SIMS element maps of Al and Zn of a deformation twinning close to a grain boundary, intersected by dendrites. Brighter color in the ToF-SIMS maps indicates higher intensity of the element. The sample was cleaned with a 2 g/L cleaning solution prior to measurement. Light microscopy was employed for choosing of the imaging spot (image on the left).

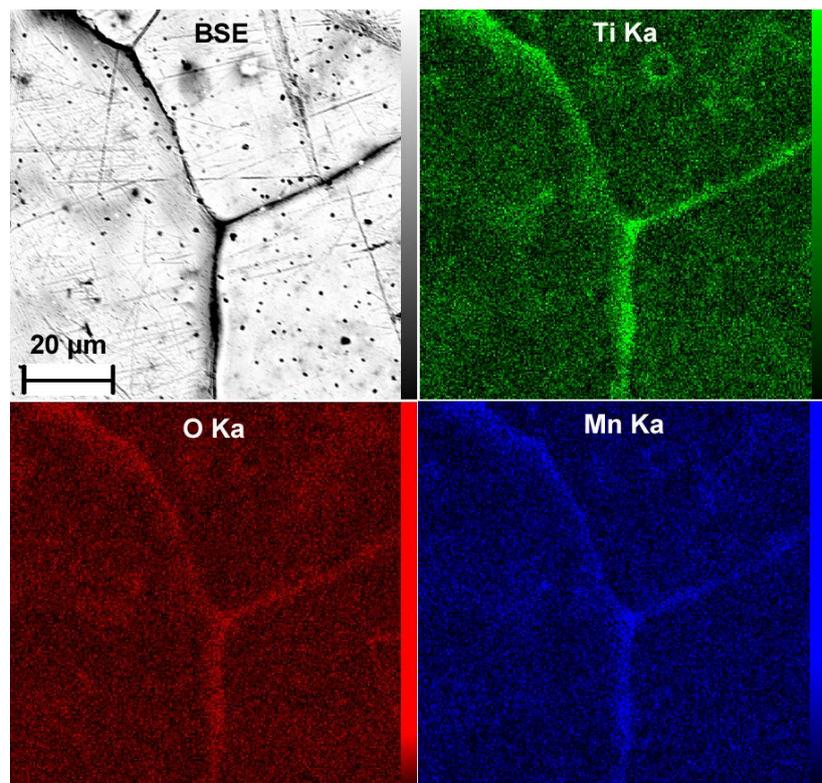
Figure 8. EPMA element maps measured on a grain boundary of a cleaned and pretreated HDG sample (sample treated with a 4 g/L cleaning solution before pretreatment). Brighter color in the maps indicates higher intensity.
