Numerical and Experimental Study on Stiffened Composite Panel Repaired by Bolted Joints under Compressive Load

Jifeng Xu, Yuanpei Lan, Xingming Zhang*, Kui Du

Beijing Key Laboratory of Civil Aircraft Structures and Composite Materials, Beijing Aeronautical Science & Technology Research Institute, Beijing, China

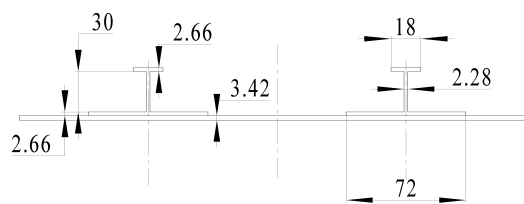
Figure 1. The stiffened composite panels.

Rectangular composite laminates were used in the experiments. The lay-up of the stiffened composite panel is shown in **Table 1**, and the test specimen size is 410 mm by 310 mm, with detailed dimension information shown in **Figure 1**. A hole was machined at the center of the stiffened composite panel to simulate penetrating damage, with the holes' diameters as 12 mm and 20 mm, respectively. The damaged stiffened composite panel was repaired by bolted joints with a metal patch of Ti-6Al-4V.

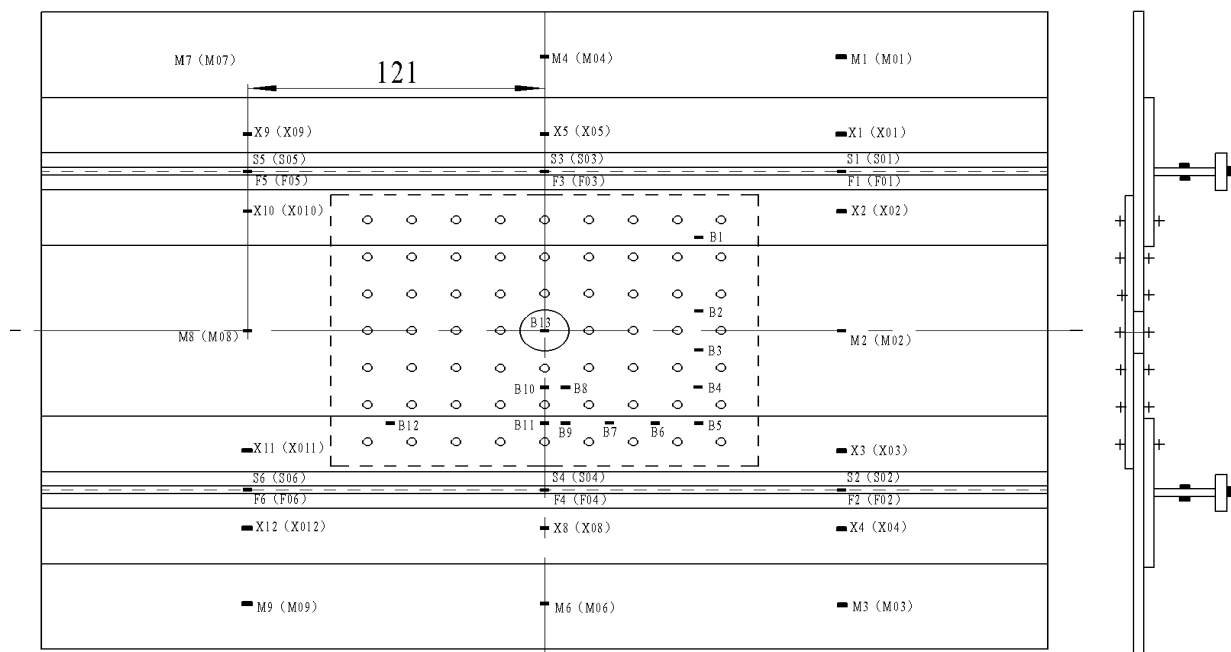
Figure 2. Distribution of strain gages on stiffened composite panels repaired by bolted joints under compressive load.

Strain gages were lapped on specimens to detect whether the load distribution was reasonable during the loading process, and the failure loads were identified and confirmed through the strain-load curves. There were over 100 strain gages arranged on each specimen, numbered S, F, X, M, and B for the upper flange, web, lower flange, skin, and the repaired region, respectively. In addition, the strain gages with numbers outside the parentheses were located on the stiffened side of the stiffened composite panels as shown in **Figure 2**.

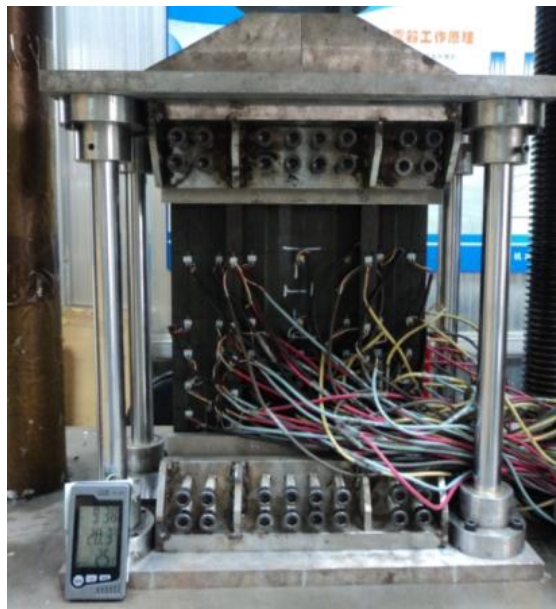
Figure 3. Gripped stiffened composite panels for compressive load experiment.

Special fixture was developed for the experiments. Specimens were placed in the fixture to keep their edges in uniform and tight contact with the bottom face of the fixture. A gripped stiffened composite panel for compressive load experiment is shown in **Figure 3**.

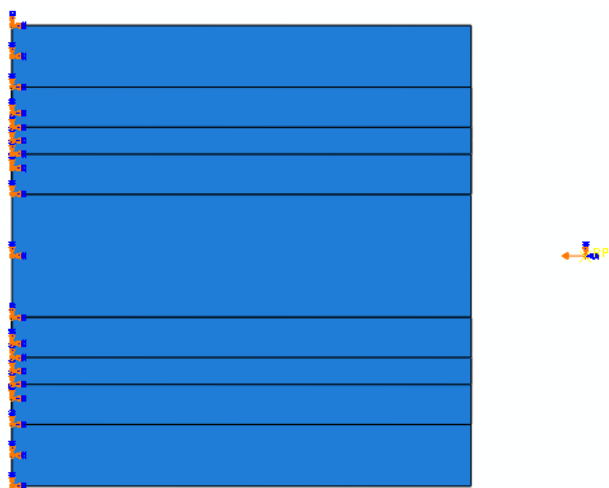
Figure 4. Boundary conditions of stiffened composite panels in the finite element model under compressive load.

To simulate the actual boundary conditions of stiffened composite panels during experiments, one end of stiffened composite panel was fixed, and the other side was restricted by a coupling constraint with reference points. In addition, all

degrees of freedom for reference points were constrained despite of the loading direction. The displacement load was applied on reference points along the loading axis, and the displacement and force on reference points were recorded. Actual boundary conditions for stiffened composite panels in the finite element model are shown in **Figure 4**.

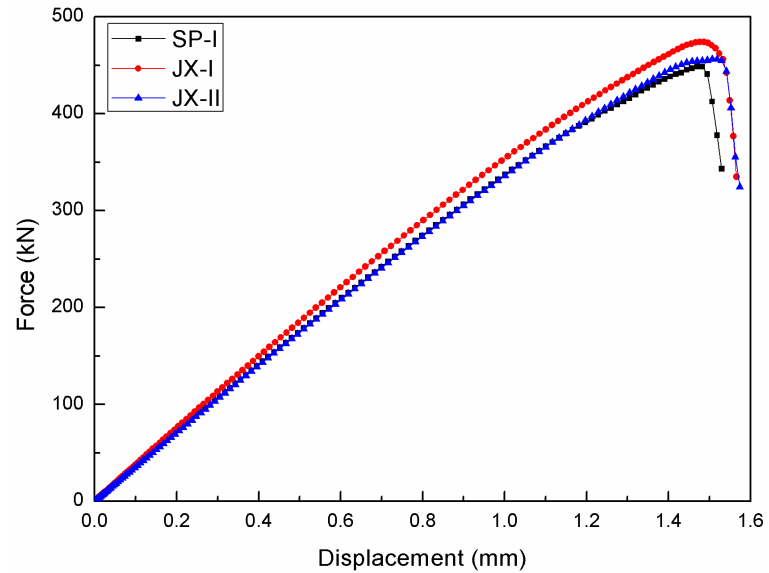
**Figure 5.** Relationship between the displacement and the load for SP-I, JX-I and JX-II.

Failure loads on specimens of repaired and virgin stiffened composite panels under compressive load were analyzed, as shown in **Table 4**. The failure loads of JX-I and JX-II are slightly higher than that of SP-I, and the stiffness of JX-I and JX-II are almost the same as SP-I (**Figure 5**). So the repaired stiffened composite panels had a high strength recovery rate and a high stiffness recovery rate. The

experimental results were consistent with the finite element analysis results, despite of the failure loads of JX-I and JX-II were slight lower due to some manufacturing defects. In addition, the damage hole diameter had little effect on the failure loads in this test.

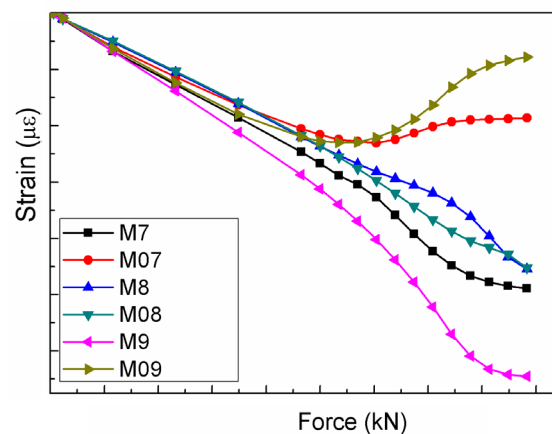
Figure 7. Load-strain curves of JX-I-1 specimen.

The actual load-strain curve of specimen JX-I-1 is shown in **Figure 7**. With increased compressive load, the specimen began to buckle locally, and the strain became bifurcate obviously on the compressive cross of the specimens. The bifurcation points on the load-strain curves of the specimens corresponding to the buckling loads. A Moire interferometry method was introduced to detect the stiffened composite panels buckling in compressive tests. The experimental results for SP-I were the same as those from the finite element analysis. But the
