Very High Cycle Fatigue Behaviors and Surface Crack Growth Mechanism of Hydrogen-Embrittled AISI 304 Stainless Steels

Abstract

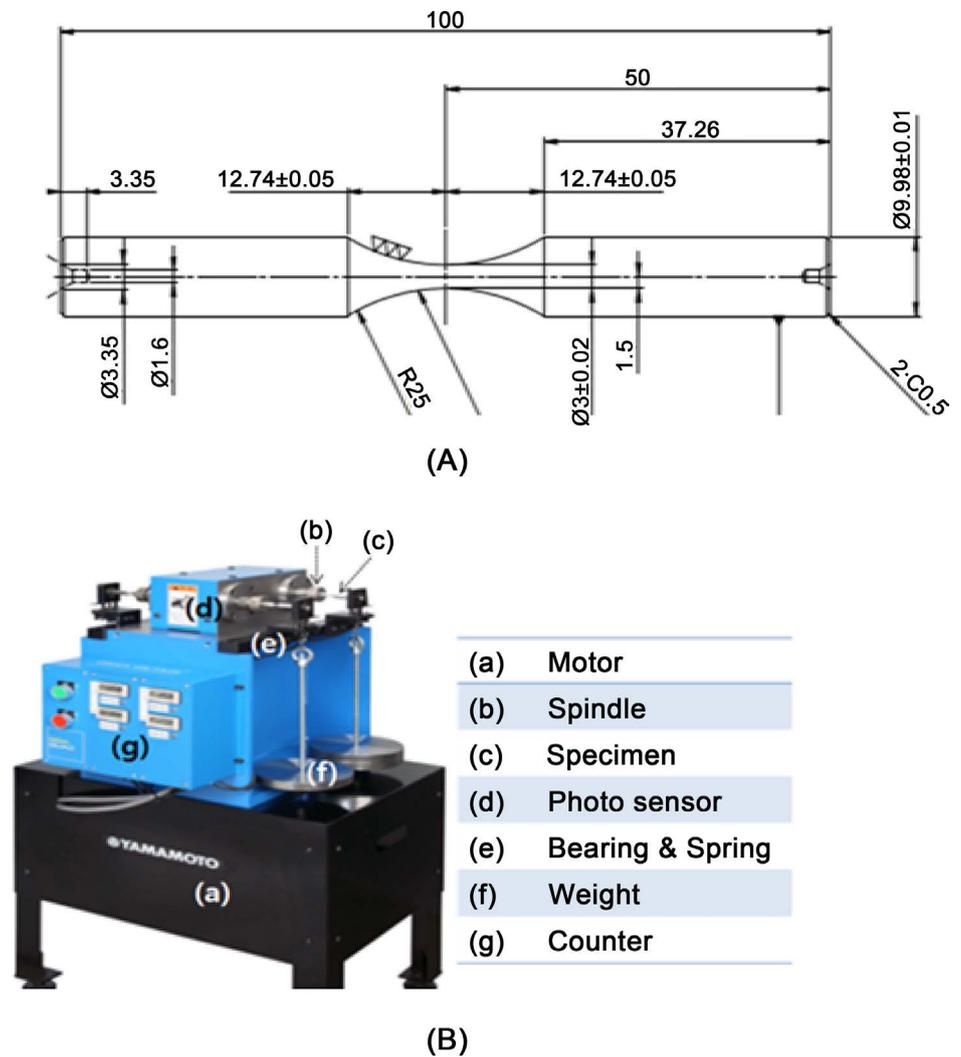
Figure 1. Specimen and fatigue testing machine. (A) configuration of the test specimen (unit: mm), and (B) fatigue testing machine.

An annealed AISI 304 stainless steel with a minimum diameter of 3 mm was used as the fatigue test specimen (**Figure 1(A)**). The chemical composition and mechanical properties of the untreated test specimens are summarized in **Table 1** and **Table 2**, respectively. Specimens were polished using abrasive paper (#100 to #2000). The fatigue life and fatigue mechanism of AISI 304 stainless steels at room temperature were tested using a new cantilevered rotary bending fatigue tester (YRB 200, Yamamoto, Japan), which was simultaneously used for four test specimens, as shown in **Figure 1(B)**. The test was performed at a frequency of 53 Hz and stress ratio of $R = -1$. Further details can be found in Refs. [2] [3] [9] [10].

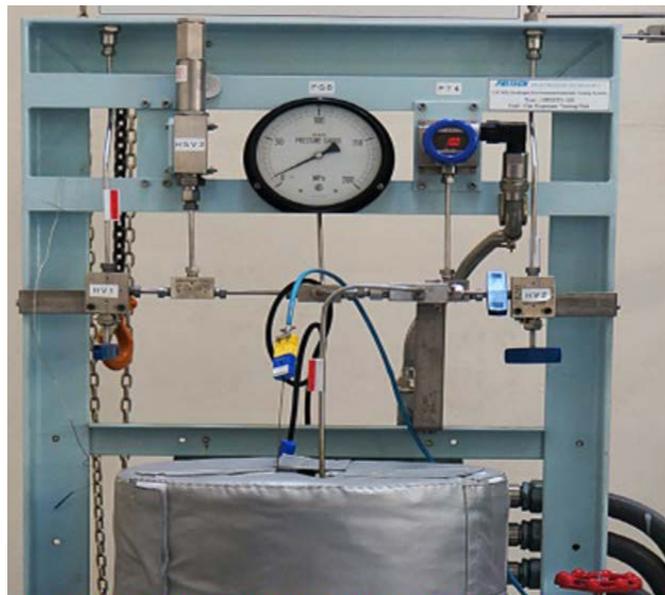
Figure 2. Hydrogen saturation equipment.

Figure 2 shows the ultra-high pressure hydrogen exposure vessel (HPH 2-132V, Pre-Tech Co. Japan) of the specimen. The specimens were subjected to hydrogen saturation at 10 MPa and 300°C for 120 h using this equipment, and were stored in liquid nitrogen and then subjected to tensile and fatigue tests under room temperature.

Figure 3 shows the tensile test results for the AISI 304 stainless steel specimen (gauge length = 25.4 mm, diameter = 6 mm) at room temperature compared with the untreated material. However, this specimen was kept at 300°C and 10 MPa for 120 h in the hydrogen charging vessel as shown in **Figure 2**, and it was used after being embrittled with hydrogen. The yield strength of the saturated material rises slightly more than that for the untreated materials, but the tensile strength decreases by 20.8%. However, the elongation ratio (**Figure 3**), the amount of hydrogen-saturated material decreased to 67.6% compared to the untreated material. The rapid decrease in the elongation ratio indicates that the influence of hydrogen gas is greater than the 39% reduction observed for the stainless steel 316 L material in the previous study [3].

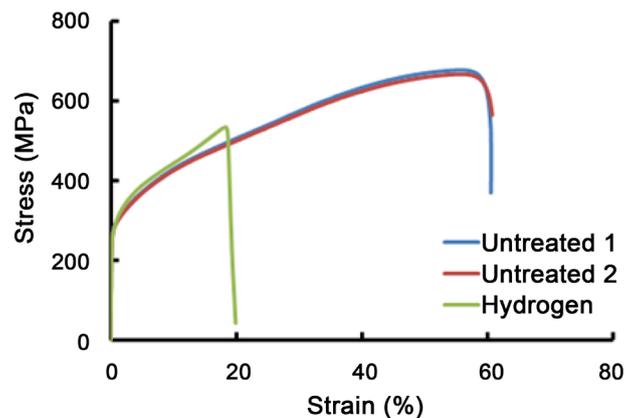
Figure 3. Tensile test results before and after hydrogen-embrittled.

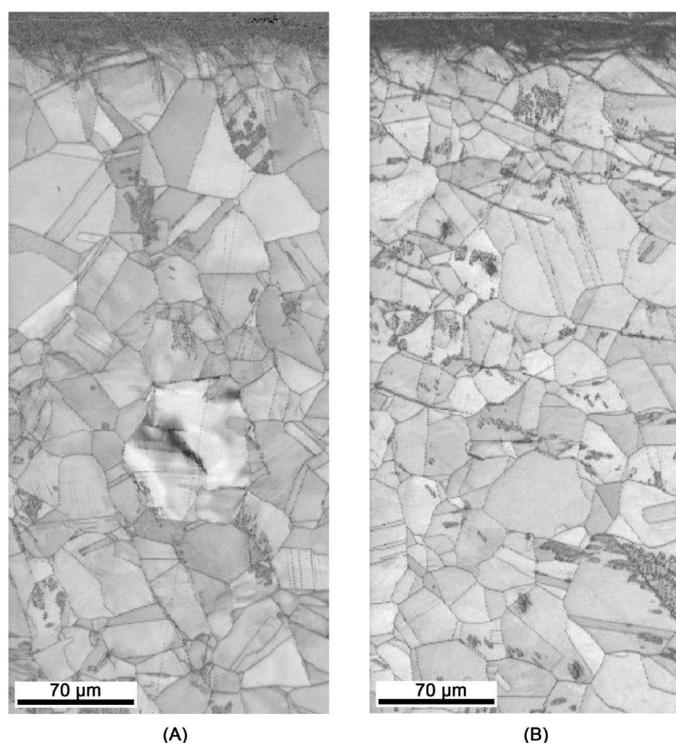
Figure 4. Cross-sectional EBSD analysis of the IQ (image quality) map. (A) Untreated specimen, and (B) hydrogen-embrittled specimen.

section of AISI 304 stainless steel. Specimen (A) in **Figures 4-7** is the raw material (untreated material) of AISI 304 stainless steel, and the average particle size of the microstructure is about 15 μm . Specimen (B) is a specimen in which the material shown in (A) is embrittled with hydrogen at 10 MPa, and 300°C for 120 h. The EBSD measuring device used in this study was a DigiView EBSD Camera, EDAX (USA), and the measurements were performed under the following conditions; acceleration voltage = 18 kV, magnification = 1.0 kx, measurement unit = 1 μm .

Figure 4 shows the sharpness of the electron beam diffraction pattern in the IQ (image quality) map. The black regions indicate a low level of IQ, which is caused by increased crystal lattice distortion because of elastic-/plastic deformation, and by crystal lattice damage because of external contamination. **Figure 4** shows the microstructure of the AISI 304 stainless steel used in this study, which is composed of uniformly sized particle, without directionality.

However, **Figure 4** shows that martensite is generally blacker in the IQ map. Therefore, although the notation is shown on ferrite in **Figure 7**, these regions are judged as martensite and delta ferrite. The hydrogen-embrittled specimen shows less martensite.

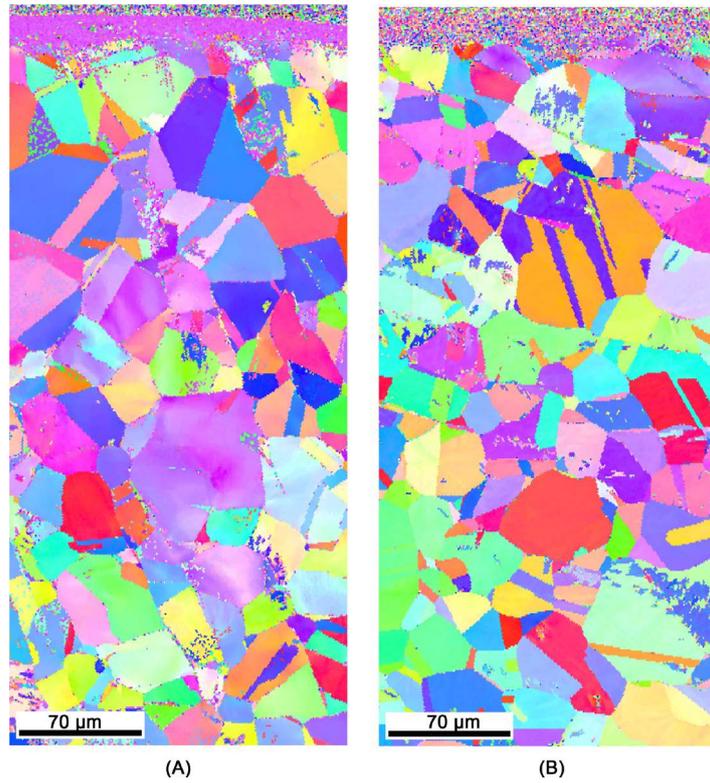
Figure 5. Cross-sectional EBSD analysis of the IPF (inverse pole figure) map. (A) Untreated specimen, and (B) hydrogen-embrittled specimen.

Figure 5 shows the orientation of the crystal grains in an IPF (inverse pole figure) map, but the crystal grains show isotropy in **Figure 5(A)**. The KAM (kernel average misorientation) map in **Figure 6** shows the crystal orientation difference for approximately 1 μm . For crystal grains that are not deformed severely, the value is close to 0; when the deformation is severe, the value increases to 6.

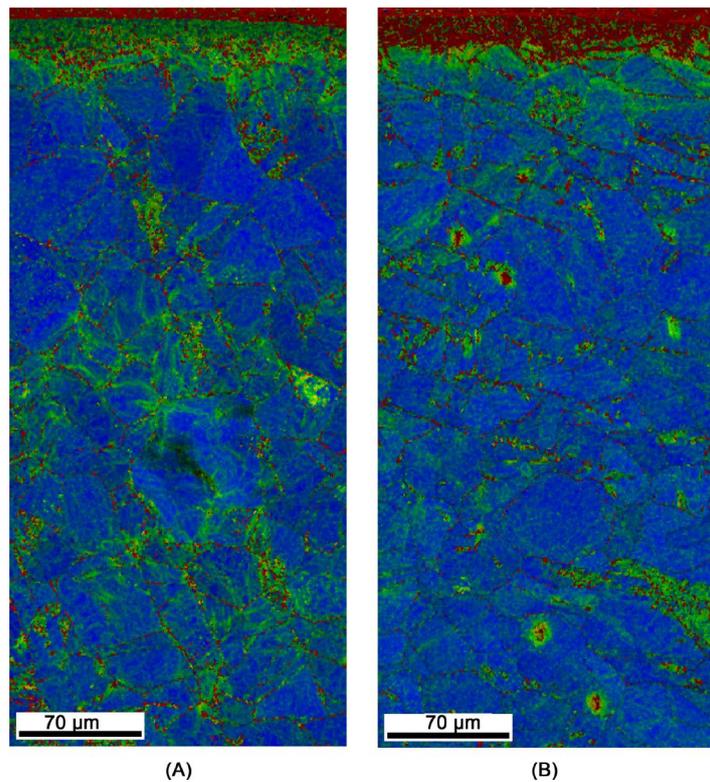
Figure 6. Cross-sectional EBSD analysis of the KAM (kernel average misorientation) map. (A) Untreated specimen, and (B) hydrogen-embrittled specimen.

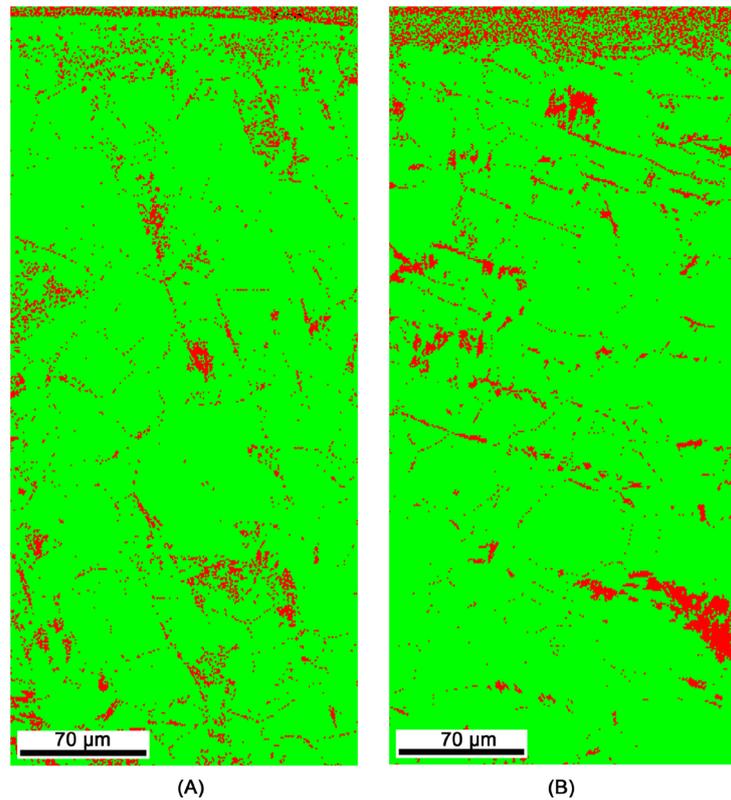
Figure 7. Cross-sectional EBSD analysis of the phase diagram map. (A) Untreated specimen, and (B) hydrogen-embrittled specimen.

Figure 7 shows the result of mapping two phases of ferrite and austenite.

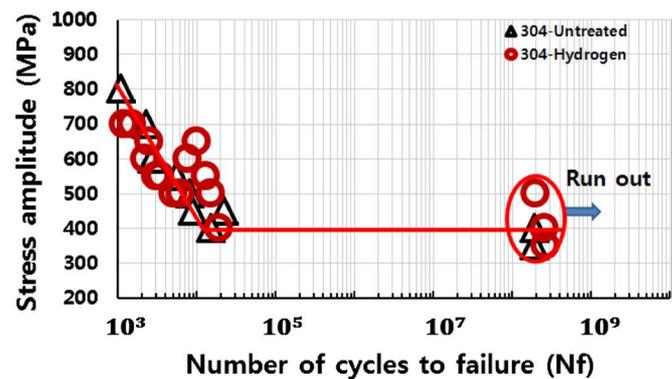
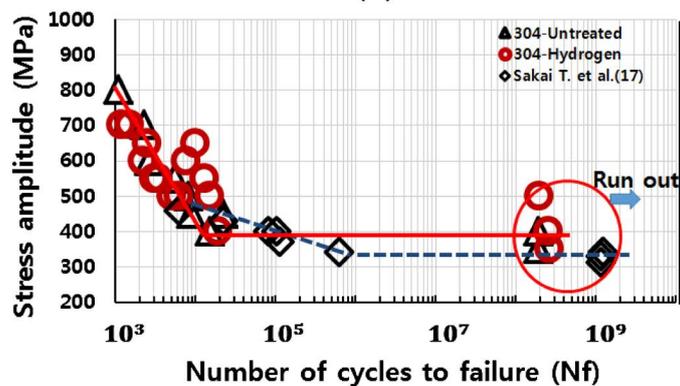
Figure 8. Comparison of the S-N curves for untreated and hydrogen-embrittled AISI 304 with the data obtained by Prof. Sakai [17].

Figure 8(A) and **Figure 8(B)** show the S-N curves of the rotary bending fatigue test conducted for several conditions of AISI 304 stainless steel by characteristic comparison. **Figure 8(A)** shows S-N data obtained from the fatigue test of the untreated material at room temperature, and the fatigue limit is approximately 400 MPa. In addition, **Figure 8(A)** shows S-N data obtained by rotating bending fatigue test of AISI 304 stainless steel with the hydrogen-embrittled specimen (10 MPa, 300°C, 120 h) at the same time. In this figure, the fatigue limit of the hydrogen-embrittled specimen is approximately 400 MPa that which is similar to that for the untreated material. Therefore, the hydrogen-embrittled AISI 304 stainless steel has almost no influence of hydrogen, like the untreated material.

Figure 8(B) also shows the S-N data obtained from the rotational bending fatigue test using Professor Sakai's stainless steel 304. The fatigue limit occurs at 330 MPa and there is a difference of about 17.5%, but the remaining data show a good agreement with the results of this study, despite the difference in the shape of the specimen and the experimenter [17].

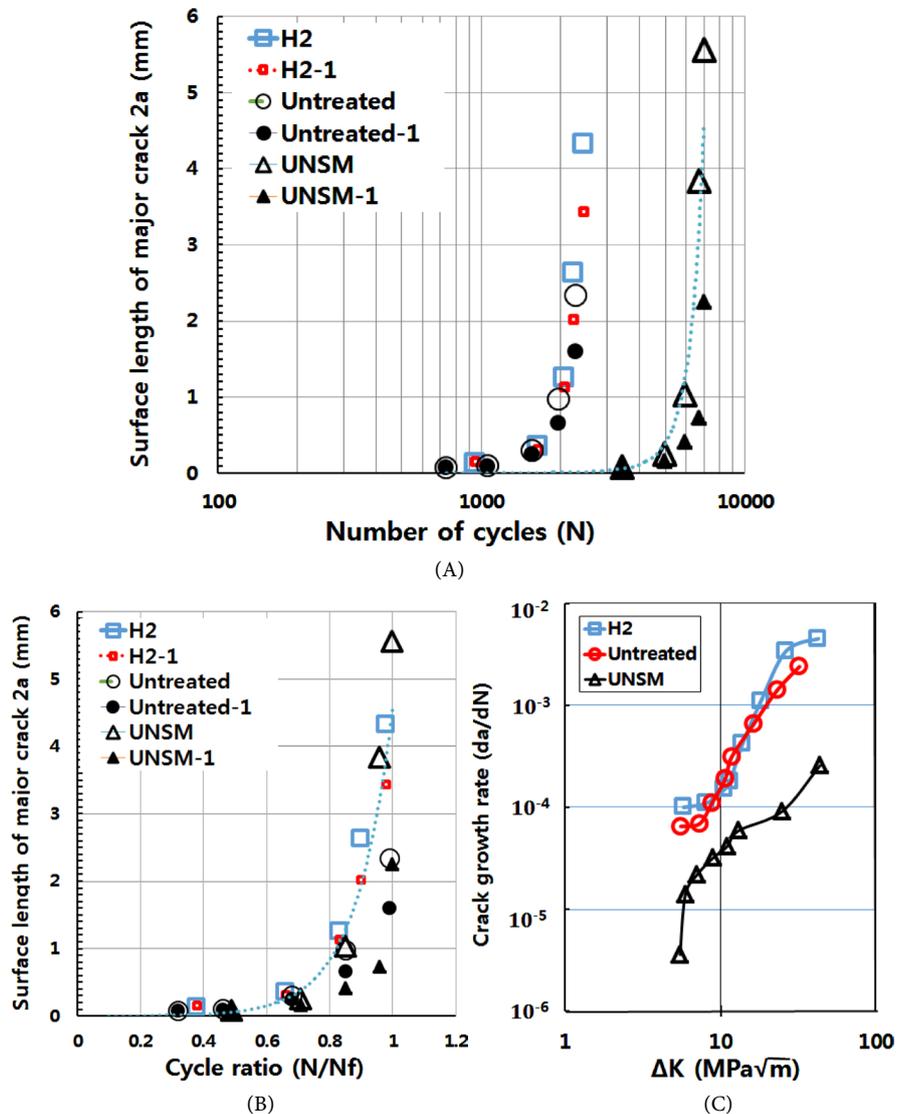
Figure 9. (A) Propagation behaviors of surface fatigue cracks initiated on the smooth-surfaced AISI 304 stainless steel specimen. (B) $2a$ - N/N_f curves on the smooth-surfaced of AISI 304 stainless steel specimens. (C) Da/dN vs ΔK curves of small surface fatigue cracks initiated on smooth specimens.

The growth behavior of surface cracks as measured by optical and SEM (scanning electron microscopy) micrographs of the fractured surfaces and SEM micrographs of the surface of test specimens before and after fracture are shown in **Figures 10-14**. **Figure 9** shows data for the untreated material (700 MPa, 2.3×10^3) and hydrogen-embrittled material (650 MPa, 2.5×10^3).

Figure 9(A) shows the relationship between the length ($2a$) of the surface crack and the number of cycles (N) for the untreated material and hydrogen-embrittled material on a $2a$ - N curve. The data obtained from the curve of **Figure 9(A)** is summarized by the crack length and fracture cycle ratio (N/N_f) in **Figure 9(B)**. Using the growth characteristics of the surface cracks in **Figure 9(A)** and **Figure 9(B)**, the fracture mechanics of the surface crack initiation and growth processes can be analyzed.

In **Figure 9(A)** and **Figure 9(B)**, the surface cracks that occur during the rotational bending fatigue test can be classified into two categories: cracks that occur in the surface, and grow and break into a single crack; and cracks that occur in surface cracks, and grow, break through adjacent small surface cracks by coalescence. The following characteristics were identified:

Figure 9(C) shows the relationship between the growth rate (da/dN) and

stress intensity factor range (ΔK) of small surface cracks. The two specimens show similar fracture lives and stress levels, the influence of hydrogen embrittlement is less in the fatigue life, and shows a similar growth behavior as that for the untreated material. These growth characteristics are closely related to which both the fatigue endurance limits of the untreated material and that of the hydrogen-embrittled material show in the same way.

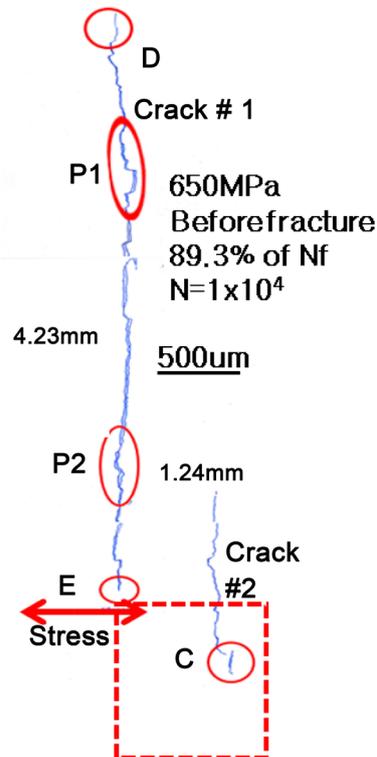
Figure 10. The images were duplicated by tracing the surface crack on the hydrogen-embrittled specimen (650 MPa, $N = 1 \times 10^4$).

Figure 10 shows eight SEM micrographs 100x magnification of the surface of the hydrogen-embrittled specimen (650 MPa, $N = 1 \times 10^4$); subsequently, cracks were created on the surface of the test piece using a sketch technique [19] [20] to

discriminate with the naked eye, is shown in reduced form. In this figure, the major crack (crack # 1) of DE is 4.23 mm long and the small crack (crack # 2) of C is approximately 1.24 mm long.

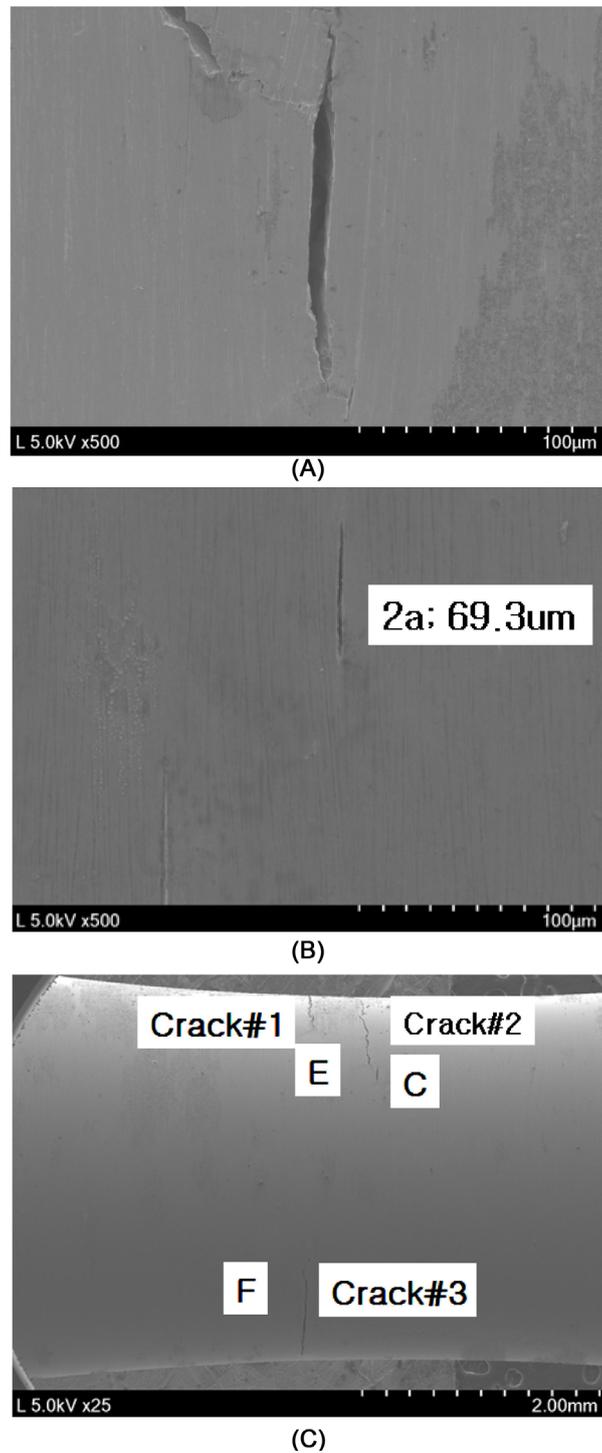
Figure 11. Characteristics of initiation, growth and coalescence of the micro-crack tips. (top) A typical example of initiation and coalescence of a small surface crack (marked as C in Figure 10). (middle) An example of initiation of a small surface crack. (bottom) SEM image of three cracks at 25× magnification before fracture.

Figure 11(A) is 500 times magnified C displayed by circle in **Figure 10**. For clarity, **Figure 12(A)** shows a sketch when $N = 1 \times 10^4$ before breakage of the specimen. This figure shows the merging process of the surface cracks. The diagram explains that the cracks are initiated by shear separation along the slip line, which is indicated by the dotted line in the figure, and the cracks gradually grow and coalesce. In this figure, at the tip of crack, many micro surface cracks initiate, grow, and combine with each other. The schematic diagram in **Figure 12** shows the crack occurrence. **Figure 11(B)** shows the small surface cracks (2a: 69.3 μm) that are initiated in other places. These small surface cracks are observed several times on the entire surface of the specimen.

Figure 11(C) shows a low magnification SEM micrograph (25 \times), before specimen fracture at $N = 1 \times 10^4$ cycles, to grasp the position of the surface crack of the whole test piece, including **Figure 10**. This figure shows two major cracks (labeled by crack # 1 and crack # 3) and one crack (crack # 2). **Figure 14(A)** shows a cross-sectional photograph of a temper colored optical image of the test piece that shows crack # 1 and crack # 3. However crack # 2 did not merge into cracks # 1 and # 3; therefore crack # 2 is not displayed in this optical image. **Figure 10** shows the size and position of crack # 2, and C, E, and F in the figure indicate the crack tips. As described above, many surface cracks are unobservable

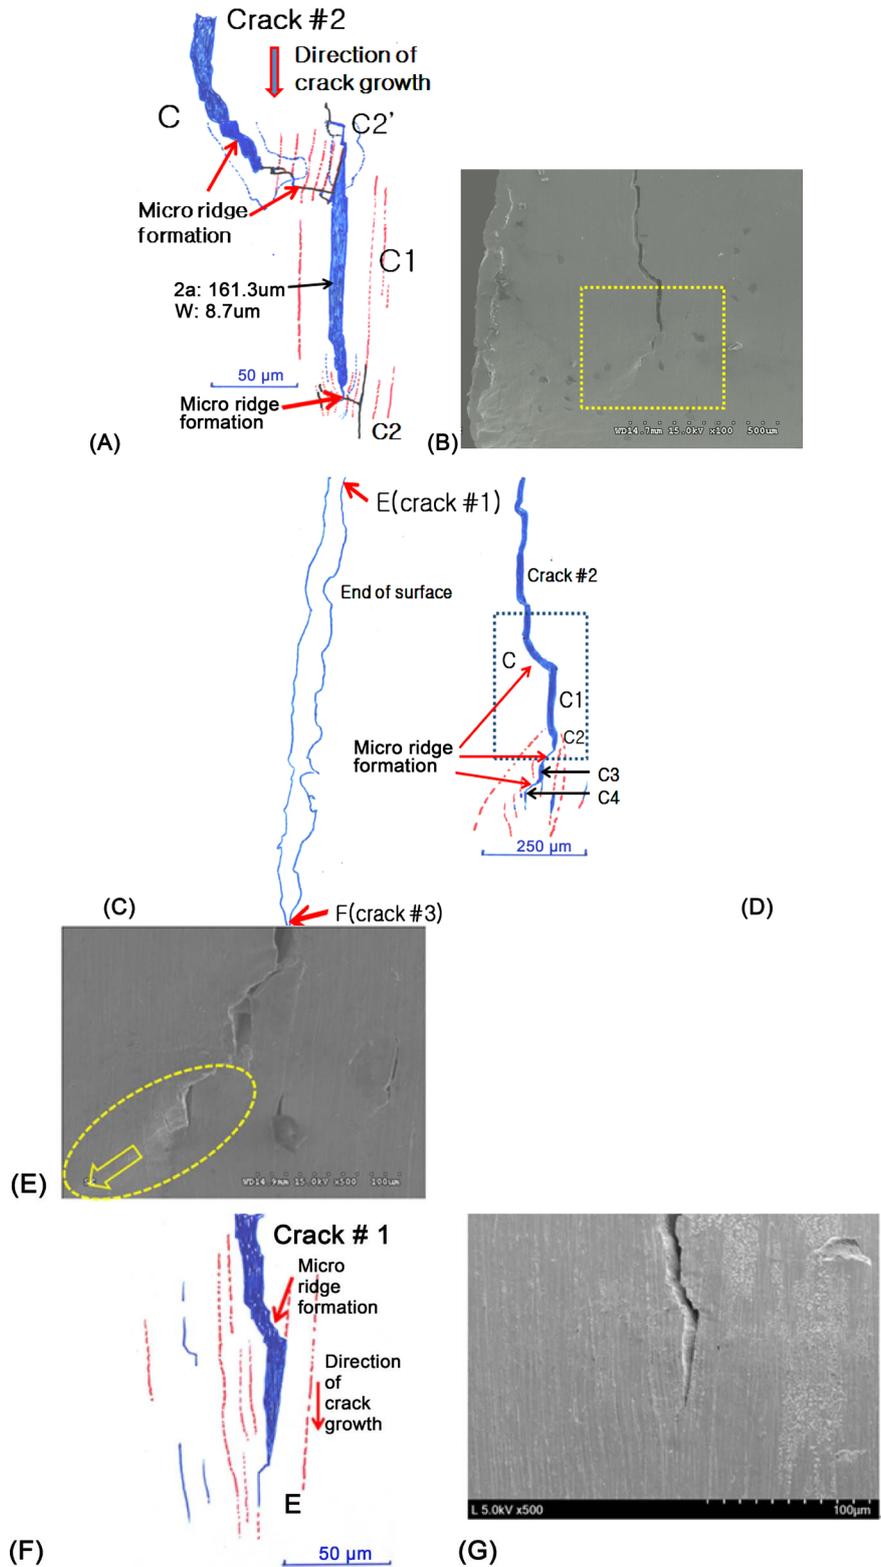
Figure 12. Illustrated figures and SEM images at crack-tips C and E. (A) Sketch of crack C at $N = 1 \times 10^4$ (before fracture), (B) SEM image (100 \times) of the sketch shown in (c), (C) sketch of crack C2 at $N_f = 1.12 \times 10^4$ (after fracture), (D) SEM image (250 \times) of crack C2 at $N_f = 1.12 \times 10^4$, (E) SEM image (500 \times) of crack tips C3 and C4, (F) sketch of crack E at $N = 1 \times 10^4$, and (G) SEM image of figure (F) (500 \times).

Figure 12(A) and **Figure 12(C)** are schematically shown using the sketch technique [19] [20] to determine the initiation, growth, coalescence, and micro ridge formation behavior of surface cracks using SEM micrographs of high magnifications from **Figure 11(A)** and **Figure 12(B)**, respectively.

Figure 12(A) is a sketch of the SEM micrograph using before breakage of the specimen $N = 1 \times 10^4$ (89.3% of N_f). C (2a: 1.24 mm) on this figure is the surface of crack # 2 and sketches the process of merging with the adjacent small surface crack, C1 (2a: 161.3 μm , w: 8.7 μm). This schematic diagram shows that cracks C and C1 coalesce while forming micro ridges. That is, to coalesce with adjacent crack C1, many slip lines (indicated by dashed lines) form between cracks C and C1. The micro-ridge formation and coalescence process of the slip line is shown in **Figure 12(A)**. These micro ridges form the asperity of the fracture surface, and form roughness-induced cracking [21] [22] [23] [24]. After merging of the cracks, the coalesce process of crack tips C2 and C2' of the C1 crack take on a very similar form as that for the coalescence of C and C1. Additionally, the ellipses displayed at P1 and P2 in **Figure 10** adopted the crack coalescence form (like **Figure 12(A)**).

The left two lines in **Figure 12(C)** show the fracture surfaces that formed by combining E (crack # 1) and F (crack # 3). The dotted rectangle in **Figure 12(C)** is the cycles of $N = 1 \times 10^4$ (89.3% of N_f) and this is the same data as that in **Figure 12(A)**. However, the width of crack C increases while forming micro ridges between C and C1 during the rotation 1200 additional cycles. Additionally, C2 in **Figure 12(C)** grows to become larger than C2 of **Figure 12(A)**. The new C3 and C4 micro-cracks are initiated by a slip that occurs at the C2 tip, showing growth and coalescence to form micro ridges. The initiations of two micro cracks are shown by the arrows in the SEM micrograph (**Figure 12(D)**).

Figure 12(D) is an SEM micrograph that shows an enlarged view of the crack tip, which is indicated by the dotted rectangle in **Figure 12(B)**. Features C1 to C4 in **Figure 12(C)** are shown in the same way in **Figure 12(D)**.

The dotted ellipse and the arrow in **Figure 12(E)** show the direction of the large-scale plastic deformation flow and concentration phenomenon for merging

Figure 12(F) shows a sketch of the enlarged E portion of the major crack when $N = 1 \times 10^4$. **Figure 12(F)** also shows that the surface crack initiates, grows, and coalesces, as shown in **Figure 12(A)** and **Figure 12(C)**, and forms micro ridges. **Figure 12(G)** shows a SEM image of the region in **Figure 12(F)**.

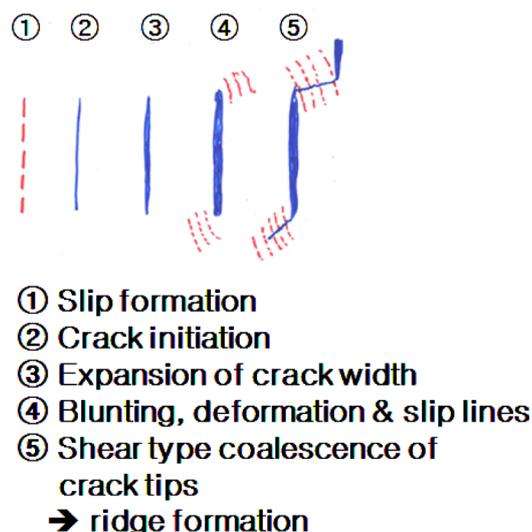
Figure 13. The surface crack initiation, growth, coalescence, and ridge formation model proposed in this research.

We propose a surface crack initiation, growth, coalescence, and micro ridge formation model as a diagrammatic view of the series of surface observations after fracture and before fracture of the specimen (**Figure 13**). 1) A slip line like a dotted line is formed perpendicular to the principal stress; 2) a slip line becomes micro-crack from tearing. 3) The width of this crack increases and the crack tip becomes blunted while growing. 4) The blunted crack tip re-forms a slip line because of deformation in the shear direction around the crack tip. 5) Then, the crack grows in the shear direction, forms micro ridges, and merges with adjacent cracks. The actual models of the initiation, growth, coalescence, and micro ridge formation processes of these small surface cracks are shown in **Figure 12**, and micro ridges are formed at the time of coalescence. The initiation of surface cracks, such as $C \Rightarrow C 1 \Rightarrow C 2 \Rightarrow C 3 \Rightarrow C 4$, and the process of growth and coalescence while forming micro ridges are repeated continuously, and the specimen reaches rupture cycles.

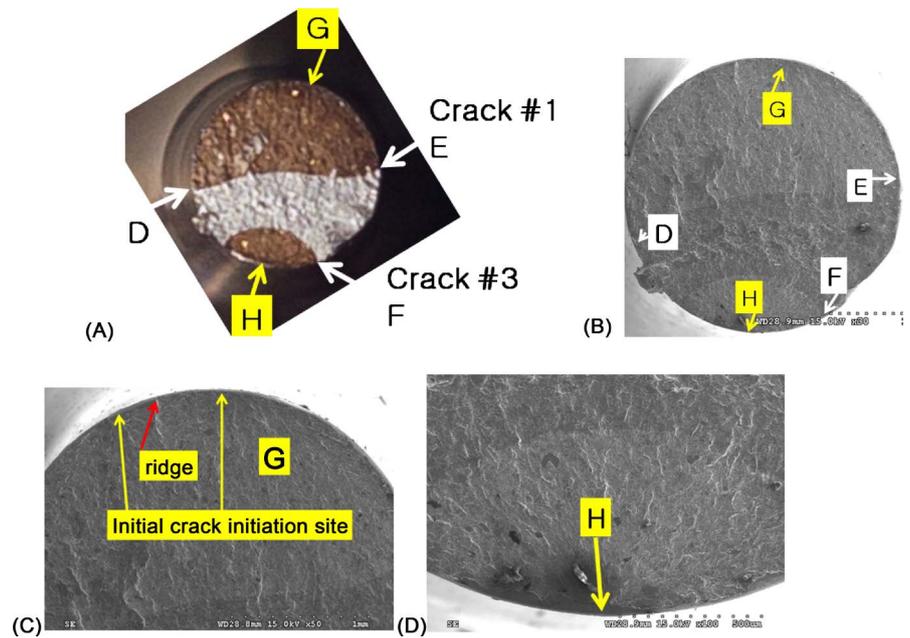
Figure 14. The fractography of a small surface crack on the hydrogen-embrittled specimen (650 MPa, $N_f = 1.12 \times 10^4$). (A) Optical image, (B) SEM image (30 \times), (C) SEM image (50 \times) of G, and (D) SEM image (100 \times) of H.

Figure 14(A) is a close-up micrograph that characterizes small surface cracks in the inner direction just before fracture of the specimen (89.3% of the fracture life). To observe surface and depth shapes of the small surface cracks, the specimens show **Figures 10-12** were temper color treated at 550°C for 2 h and photographed using an optical camera with a macro lens. In this photograph, the characteristics of the initiation position of crack # 1, crack # 3, and the well-grown

fracture surface are represented by the tempering color method. The two arrows for crack #1 and one arrow for crack #3 show the growth position of each crack in the image. Points E and F in this image correspond to points E and F in **Figure 11(c)**. Additionally, D indicates the same crack tip that shown in **Figure 10**.

Figure 14(B) shows a SEM micrograph at a low magnification (25 \times), which is the same object as that shown in **Figure 14(A)**. The shape of the depth direction of the crack growth can be distinguished in the optical image after the temper color treatment (**Figure 14(A)**); however it is impossible to identify these features in the SEM micrograph (**Figure 14(B)**). The main locations (D - H) of each crack are also shown in this SEM micrograph (**Figure 14(A)**).

Figure 14(C) shows an expanded display of the origin of crack #1 (marked as G), and the two points indicated by arrows are the origin of the major crack. In addition, a small, nearby crack is also initiated, and the cracks initiate, grow, coalesce and form micro ridge as in the model of **Figure 13**. **Figure 14(D)** is an enlarged view of the origin of crack #3 (marked as H). One point indicated by the arrow is the origin of the main crack and it has grown and coalesced.
