# Investigation of the Relation between Rolling Contact Fatigue Property and Microstructure on the Surface Layer of D2 Wheel Steel

D2 Wheel Steel, Rolling Contact Fatigue Property, Microstructure Evolution of the Surface Layer, The Formation and Propagation of Contact Fatigue Cracks

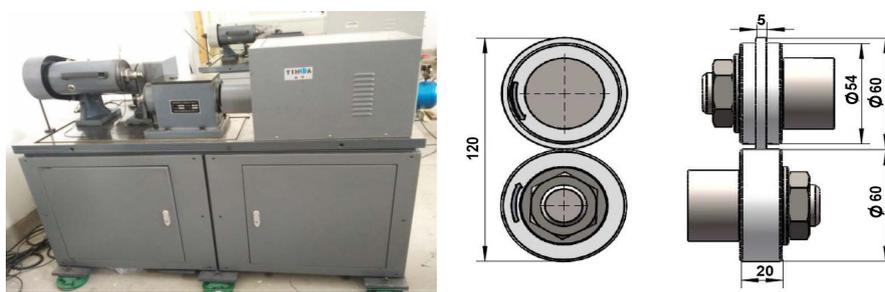
**Figure 1.** GPM-30 rolling contact fatigue tester and the contact mode of the main and accompanying specimens.

The experimental material was D2 wheel steel. Its main chemical compositions were as follows: 0.53% C, 1.0% Si and 1.0% Mn. The experiment was performed on the GPM-30 rolling contact fatigue tester. The actual wheel-rail contact state was simulated by rolling the two-disc specimens, which followed the procedures in YB/T 5345-2014 Metallic Materials-Rolling Contact Fatigue Test [19]. The outer diameters of the main and accompanying specimen were both 60 mm, the width and the height of the protruding part of the main specimen were 5 mm and 3 mm respectively, while the width of the accompanying specimen was 20 mm, seen in **Figure 1**.

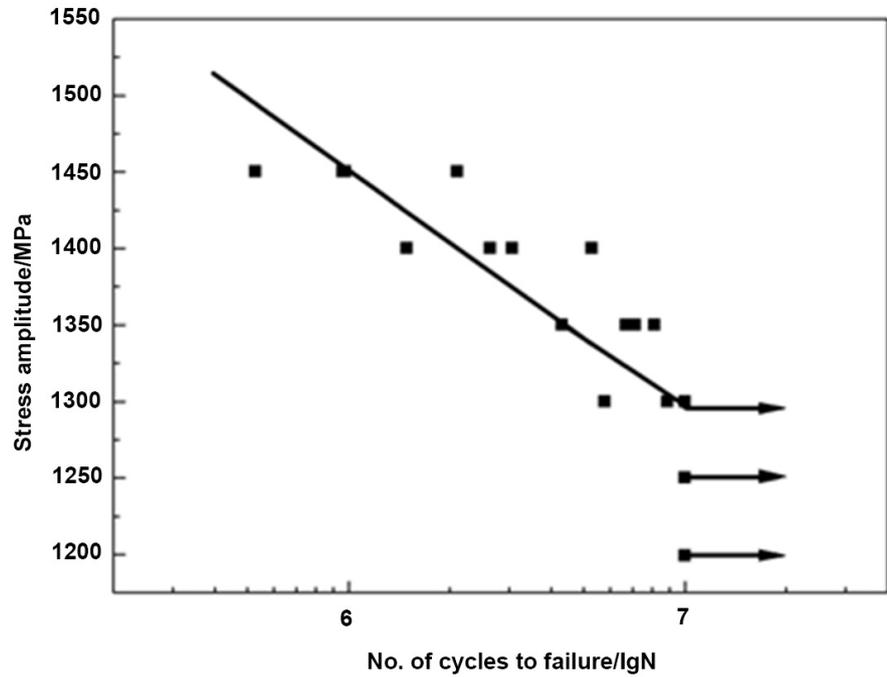
**Figure 2.** S-N curve of D2 wheel steel.

**Figure 2** displayed the relation between the contact stress and the fatigue life in the logarithmic coordinate system. The least-square method was adopted to calculate the fitting curve equation with the data, through which the S-N curve of D2 wheel steel was acquired:

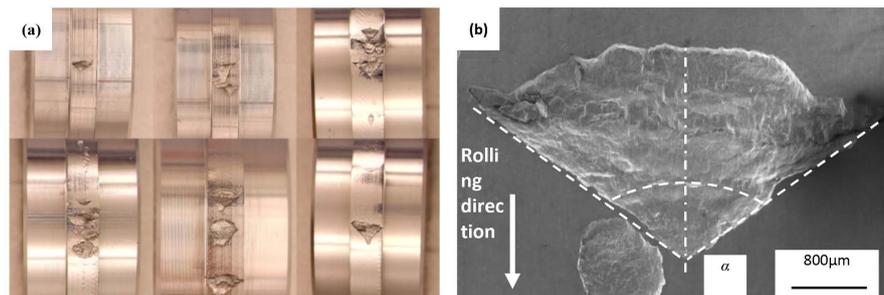
**Figure 3.** Macrographs of contact fatigue specimen.

Macroanalysis was initially conducted on the fatigue spalling of the specimen surface under contact fatigue. The results indicated that great amounts of V-shaped spalling appeared on the specimen surface and small amounts of pox-like or irregular-shaped spalling also existed, shown in **Figure 3**. V-shaped spalling was also known as arrow-shaped spalling, whose apex angle oriented towards the rolling direction of the specimen. Through statistics, the degree of the apex angle was between  $70^\circ$  and  $140^\circ$ . According to the morphology of the fracture surface, the fatigue cracks radiated from the V-shaped tip and propagated towards the opposite to the rolling direction. Then the specimen was cut from the center of the V-shaped spalling along the rolling direction of the specimen, and what was found was that the depth of the cracks reached about 1.2 mm. According to the results of the experimental statistics, the angle between the propagation direction of this type of main fatigue cracks and the surface was between  $30^\circ$  and  $45^\circ$ . On the side of the main cracks close to the worn surface, the secondary cracks almost perpendicular to the main cracks were initiated and expanded towards the contact surface, resulting in fatigue spalling after they reached the surface, shown in **Figure 4**.

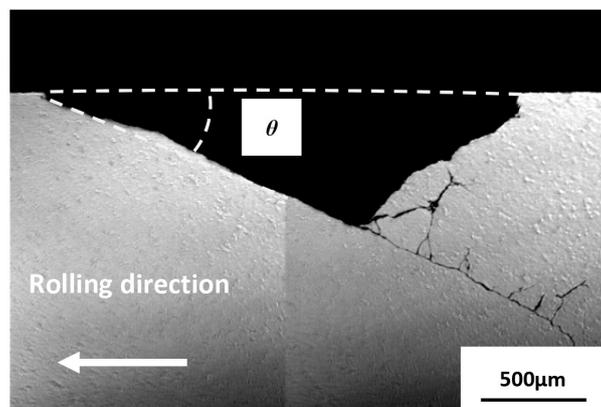
**Figure 4.** Cross section macrographs of V-shaped fatigue spalling.

Through comprehensive analyses of morphology variations of the specimen surface with fatigue spalling and careful observation of the cross section and longitudinal section under microscope (shown in **Figure 4**), the formation and propagation process of fatigue cracks could be divided into four stages: the first stage was featured by the appearance of microcracks and small spalling pits on the surface (**Figure 5(b)**); the second stage was that, under the combined action of the contact stress and the hydrodynamic pressure of lubricating oil, these cracks would propagate along the direction parallel to the surface damage layer caused by mechanical processing and then formed the shallow spalling (the depth was commonly about 1  $\mu\text{m}$ ), and even turned into deep cracks that formed certain angles with the contact surface (shown in **Figure 5(c)**); the third stage was that the deep cracks further propagated and formed the typical V-shaped cracks on the surface (**Figure 5(d)**); the fourth stage was that after the formation of V-shaped cracks, the secondary cracks along the direction roughly perpendicular to the main cracks were formed, then propagated towards the surface and finally caused V-shaped spalling (**Figure 5(e)**).

roughness was diminished (seen in **Figure 5**), regional spalling would take place on this thin layer and finally became the crack source under the combined impact of contact stress and additional hydrodynamic stress from liquid medium. Once the crack source formed, it would propagate towards the depths [5] [6] [7] [30] [31] [32] along the direction at a certain angle with the contact surface (about 30° - 45°) under the above-mentioned stresses (displayed in **Figure 4**).

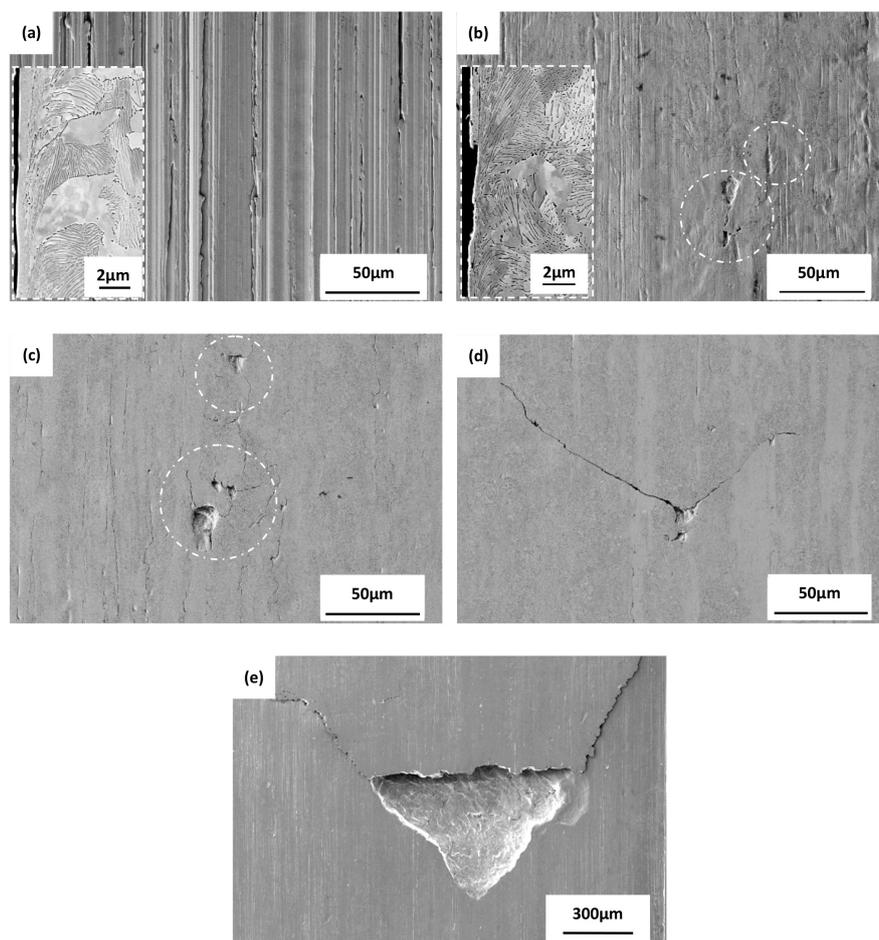
**Figure 5.** The Damage Process of the Rolling Contact Fatigue Surface. (a) The Surface of the Original Mechanically-processed Specimen and the Metallography of the Longitudinal Section; (b) Surface Micro-damage of the Fatigue Specimen and the Metallography of the Longitudinal Section; (c) The Initiation Stage of Fatigue Cracks; (d) The Propagation Stage of Fatigue Cracks; (e) The Formation of Fatigue Spalling.

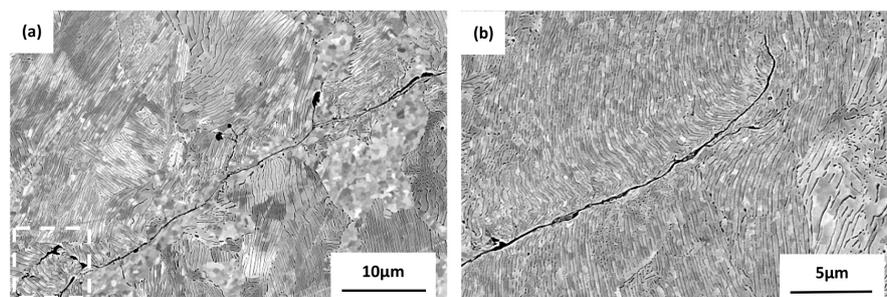
**Figure 6.** The Microstructure at the Tip of Crack Propagation in ferrite (a) and in pearlite (b).

In the analysis of the path along which the cracks propagated, it was discovered that fatigue cracks preferentially grew towards the proeutectoid ferrite, and then propagated along the interface between the proeutectoid ferrite and pearlitic colony (**Figure 6(a)**). In certain areas where cracks penetrated pearlite, what could be observed was that pearlite on both sides of the cracks was twisted due to plastic deformation.

standard must be larger than the observed one (0.5 - 1.5  $\mu\text{m}$ ) in this article. Therefore, the actual microhardness of this layer of ultrafine microstructure should far exceed the one measured in the experiment, which is related to the actual microhardness of the surface layer, the combining force between the surface layer and the matrix and the hardness of the matrix [23] [24]. Based on the fact that the matrix hardness of the material in the experiment was relatively low, it could be speculated that the actual hardness of this layer induced by mechanical processing would be extremely high, exerting negative impacts on fatigue properties [25]. During this investigation, it was found that this thin layer was inclined to crack and spall (seen in **Figure 6**), indicating that it possessed relatively high hardness.

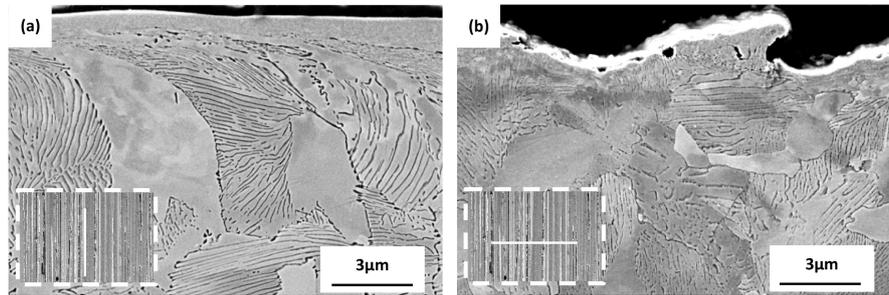
**Figure 7.** The morphology and microstructure on the contact surface of the original mechanically-processed specimen (a) The microstructure of the longitudinal section and the surface morphology of the original mechanically-processed specimen, (b) The microstructure of the cross section and the surface morphology of the original mechanically-processed specimen.

In order to investigate the formation of contact fatigue cracks on the surface and its relationship with the surface microstructure, slight polishing and etching was firstly conducted on the surface of the original mechanically-processed specimen and the surface of the failure specimen, and then SEM was employed to observe both of them. **Figure 7(a)** and **Figure 7(b)** displayed the surface morphology and the microstructure on the surface layer of the original mechanically-processed specimen. It could be found that the surface of the original mechanically-processed specimen was characterized by the rough morphology like peaks and valleys. Inside the microstructure from the longitudinal and cross sections on the surface, what could be spotted was that on the mechanically-processed surface did exist a layer of ultrafine microstructure, with the thickness of 0.5 - 1.5  $\mu\text{m}$ . The thickness of the layer at the peak of the surface was higher than that of the layer at the valley (displayed in **Figure 7(b)**).

From the observation of the microstructure on the surface in **Figure 7**, it could be found that a thin layer of ultrafine microstructure with the thickness of  $0.5 - 1.5 \mu\text{m}$  existed on the surface layer, generated by mechanical process where the material of the surface layer underwent severe plastic deformation. The microhardness measured under the external force of  $25 \text{ g}$  in the research was only about  $400 \text{ HV}$ . Although it is much higher than that of the matrix microstructure ( $255 \text{ HV} - 265 \text{ HV}$ ), the thickness of the hardened layer at least should be higher than  $4 \mu\text{m}$  under the load of  $25 \text{ g}$  based on the measurement standard of microhardness (GB/T4340.1-2009) [22]; even through the use of the minimum load of  $10 \text{ g}$  to measure microhardness, the minimum thickness required by this

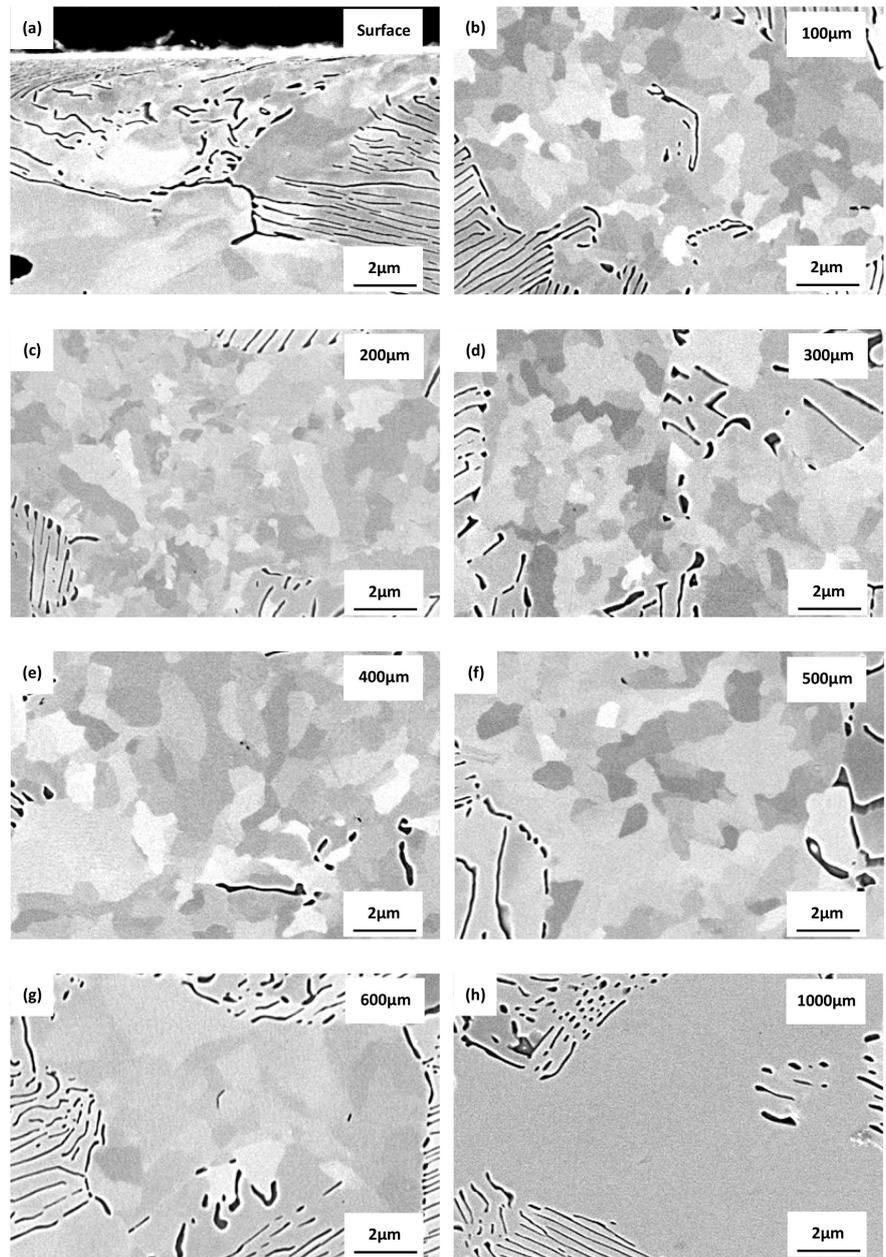
**Figure 8.** Microstructure Variations of Proeutectoid Ferrite at different depths from the surface of the specimen with contact fatigue (After  $1 \times 10^7$  r under the load of 1200 MPa).

varied obviously with the increasing depths: as depths increased, grains were refined step by step; when the depth reached about 200  $\mu\text{m}$ , the grains were the smallest, and then gradually recovered to the size of the original microstructure again, as was seen in **Figure 8**. **Figure 9** showed the microstructure at the depth 200  $\mu\text{m}$  from the surface of the specimen on which contact fatigue failure did not appear after  $1 \times 10^7$  r under the load of 1200 MPa. It could be seen that compared with the original central microstructure, proeutectoid ferrite was refined obviously, while the contrast between ferrite subgrains inside lamellar pearlite was enlarged—signifying that the misorientation between each subgrain was increased and the refinement of ferrite subgrains was not that obvious.

From the results in **Figure 8** and **Figure 9**, it could be seen that even fatigue failure specimens did not appear in the operation under laboratory conditions, the microstructure in the surface layer underwent refinement and the hardness of the surface layer was also increased, shown in **Figure 10**. Additionally, this type of refinement and hardening process accorded with the variation law of the shear stress calculated (displayed in **Figure 11**, **Figure 12** and **Figure 13**). This meant that under the impact of contact stress, obvious plastic deformation occurred in the surface layer and dislocations inside ferrite began to be released, continually increasing the amount of dislocations. Not only could the increasing amount of dislocations elevate hardness, but could enlarge the misorientations between subgrains—eventually evolving into high angle grain boundary and refining grains. The refinement of grains also would cause hardness to increase. This evolution of dislocation structure and microstructure was immensely similar to the nanocrystallization of the mechanically-processed surface investigated by Ke Lu and others [26] [27]—only the size of the grains during the experiment was far from being nanoscale.

Meanwhile, it could also be discovered from **Figure 8** that even under fatigue limit, when proeutectoid ferrite was refined, ferrite subgrains inside pearlitic colonies underwent transformations as well—the contrast between each subgrain was enlarged, which meant that the misorientation between ferrite subgrains was increased. This phenomenon could be attributed to the theory similar to that of the refinement of ferrite subgrains: under the impact of contact stress, the ferrite inside pearlite underwent plastic deformation, dislocations inside the ferrite began to be released, and dislocations constantly moved to the subgrain boundary, enlarging the misorientation between subgrains. Since the yield strength of proeutectoid ferrite is approximately 100 - 170 MPa and the yield strength of pearlite is about 600 MPa [28], under the impact of contact stress, proeutectoid ferrite preferentially underwent plastic deformation and dislocation accumulation constantly drove the increment of dislocation density, which gradually refined grains. Nevertheless, in that the ferrite inside pearlite was limited by the enhancement of lamellar cementite, the ferrite was not inclined to deform and did not reach the limit of grain refinement—but only increased the misorientation between ferrite subgrains inside pearlitic colonies.

Besides, the contact fatigue experiment conducted under the condition below fatigue limit indicated that even though fatigue cracks did not appear after  $1 \times 10^7$  rotations, the microstructure and the hardness at certain depths inside the surface layer did experience changes (seen in **Figure 8** and **Figure 10**). The process of these changes could also be understood through the assistance of material regional properties proposed by Johnson and others [33]. Under the load of 1200 MPa and 1250 MPa, though the surface and the surface layer both experienced plastic deformation, they were roughly in the shakedown limit and did not reach the extent of fatigue failure; nonetheless, when the load was higher than 1300 MPa, the surface of the material had already entered the stage of ratcheting effect, causing plastic deformation to accumulate continuously and further resulting in the formation of fatigue cracks.

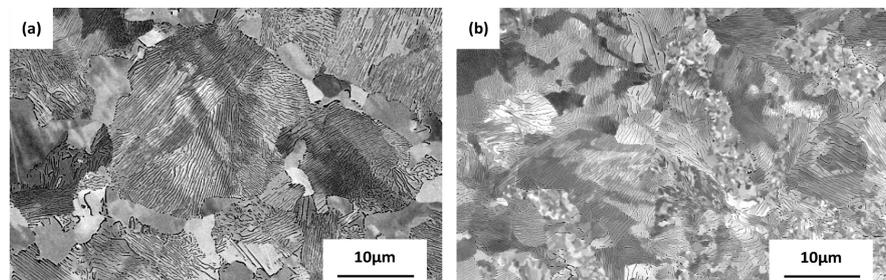
**Figure 9.** The Original Microstructure (a) and the Microstructure of the Specimen's Surface Layer (b) after  $1 \times 10^7$  r with the load of 1200 Mpa.

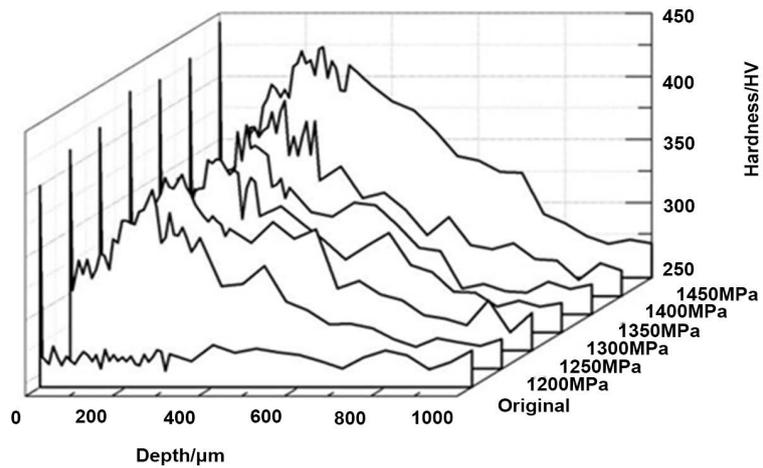
**Figure 10.** Hardness distribution of the surface layer.

Microhardness measurements were done from the surface to the central part of the original mechanically-processed specimen and the specimens that had gone through the contact fatigue experiment under different contact stresses, and the results were shown in **Figure 10**. From **Figure 10**, it could be concluded that on the surface layer of the original mechanically-processed specimen existed a thin layer of ultrafine microstructure (seen from **Figure 7**), with the thickness of approximately 0.5 - 1.5  $\mu\text{m}$ . The hardness of the surface was about 400 - 450 HV, apparently higher than that of the central part (255 - 265 HV). Under different contact stresses, the materials at certain depths from the surface were hardened with different degrees; however, the hardening laws were the same—the maximum hardness appeared in the subsurface (approximately 200  $\mu\text{m}$  from the surface); with the increment of contact stress, both of the depth at which the maximum hardness appeared and the depth of hardening layer were increased, and the hardening degree was also on a rise. When contact stress rose from 1200 Mpa to 1450 Mpa, the maximum hardness of the subsurface changed from 382 HV to 420 HV, respectively located at the depth of 190  $\mu\text{m}$  and 240  $\mu\text{m}$ ; at the same time, the depth of the hardening layer gradually increased from 650  $\mu\text{m}$  to 1000  $\mu\text{m}$ . Additionally, it was rather remarkable that although the specimens had

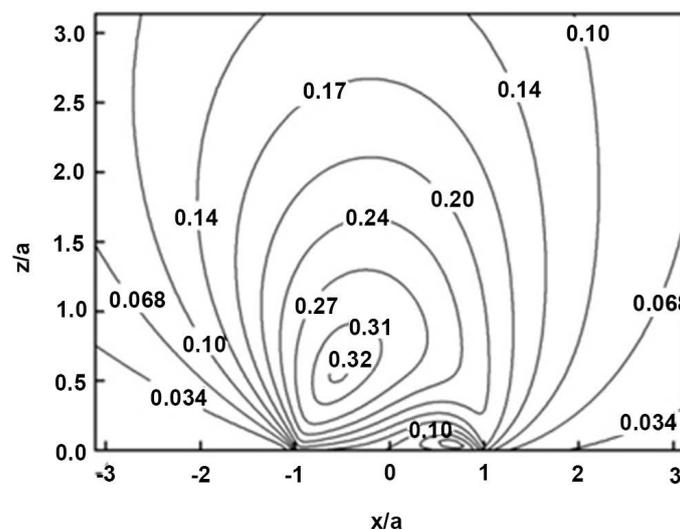
**Figure 11.** The contour line of the shear stress on the xz plane.

Put parameters  $m$  and  $n$  in formula (8) and the friction parameter  $\mu = 0.1$  into formula (7), and then stress components generated by the positive force  $p$  and the tangential force  $q$  were acquired. Subsequently, put the stress components into formula (6) in order to get  $\sigma_x$ ,  $\sigma_y$ ,  $\tau_{xz}$ ; finally, put  $\sigma_x$ ,  $\sigma_y$ ,  $\tau_{xz}$  into formula (5), and gained the distribution function of the shear stress  $\tau_1$  on the X-Z plane. **Figure 11** displayed the contour line of the shear stress on the X-Z plane, signifying that the maximum of the shear stress was  $0.321 P_0$  at the depth of  $0.6a$ .

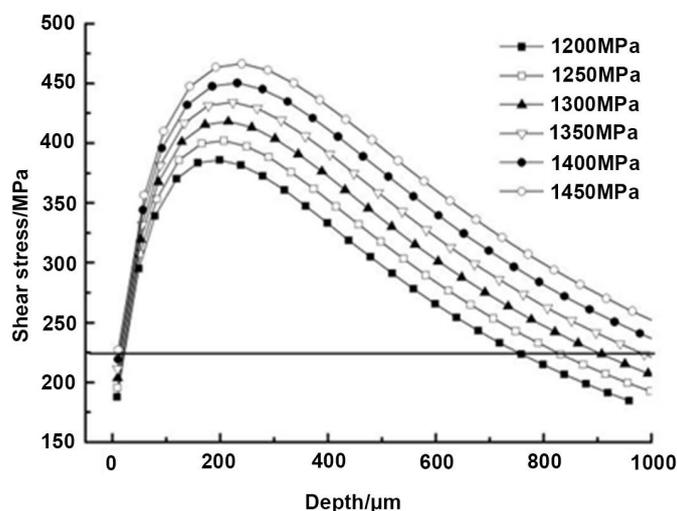
**Figure 12.** The relation between the shear stress and the depth under different contact stresses.

In order to better observe the variations of shear stress with depths under different contact stress, shear stresses at different depths were projected onto the Y-Z plane, and then the variations of shear stress with the depths were gained, shown in **Figure 12**. It was discovered that the variation tendency of shear stress from the surface to the central part of the specimens was the same as the variation tendency of hardness measured: under different contact stresses, the depth of the subsurface maximum hardness from the surface corresponded quite well to that of the maximum shear stress calculated.

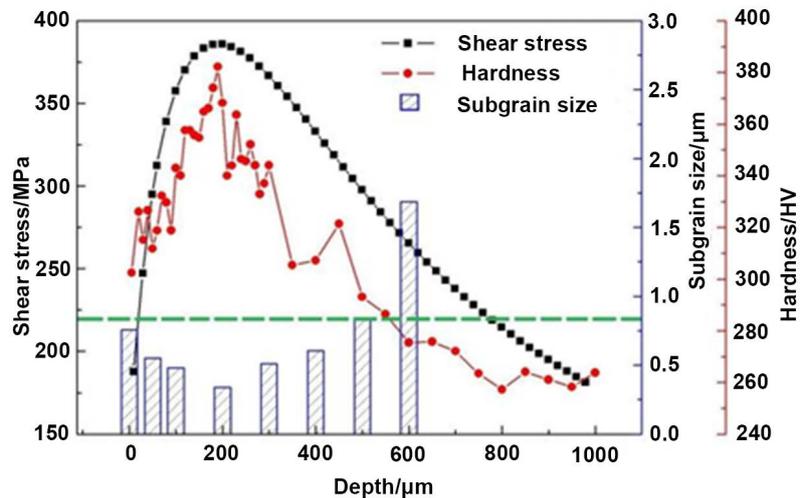
**Figure 13.** The relationship between the shear stress, the microhardness distribution and the subgrain size of proeutectoid ferrite on the surface layer.
