Corrosion Behaviour of Aluminium Engine Block in 3.5% NaCl Solution

Abstract

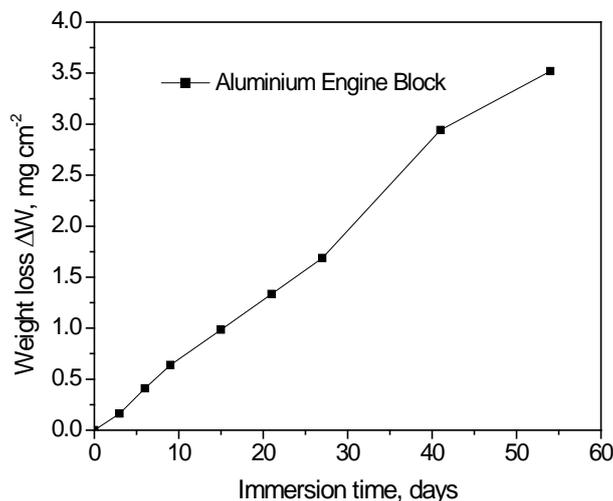
Figure 1 depicts the change of weight loss ΔW , $\text{mg}\cdot\text{cm}^{-2}$, calculated using Equation (1) as a function of immersion time for aluminium alloy engine block immersed in 3.5% NaCl solution. It is clearly seen from **Figure 1**

Figure 1. The variation of the weight loss (mg/cm^2) as a function of immersion time (days) curve for aluminium alloy engine block immersed in 3.5% NaCl solution.

that the value of ΔW for the alloy in Cl^- solutions increased with increasing immersion time. This is due to the continuous dissolution under the aggressiveness action of the chloride ions to the alloy surface. Although Al forms Al_2O_3 and $\text{Al}(\text{OH})_2$ on its surface, its dissolution rapidly increases with increasing exposure time. This is due to the fact that these forms are not compact and not protective and allow the aggressive ions from NaCl solutions to attack the Al surface. The values of K_{Corr} , which were calculated from weight-loss tests using Equation (2) for Al alloy in 3.5% NaCl solutions, are plotted against time as shown in **Figure 2**. It can be seen that, the K_{Corr} values increased quite abruptly initially until immersion time of 10 days. Afterwards, the K_{Corr} value decreased with time and attained roughly a constant value. This is due to the accumulation of corrosion products including aluminium oxide and hydroxide, which cover up the surface leading to decrease its uniform corrosion rate.

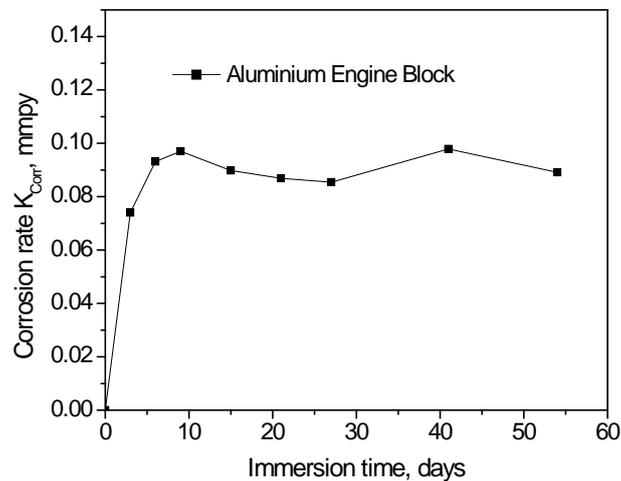
Figure 2. The change of corrosion rate (mmpy) as a function of immersion time (days) for aluminium alloy engine block immersed in 3.5% NaCl solution.

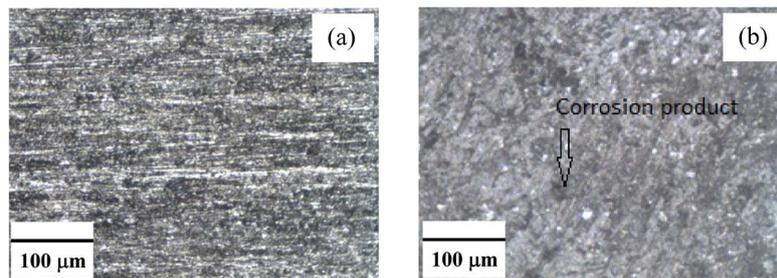
Figure 3(a) shows the optical micrograph of polished aluminium engine block alloy before immersion into the corrosion medium. The sample has a microstructure characterized by an Al-rich dendritic matrix, α -Al phase and a eutectic mixture in the interdendritic region formed by silicon particles, which are coarse and distributed in plate-like morphology, set in an Al-rich phase [6] [8]. In this type of image the precipitates of Al (Mn, Fe, Cu) are those that appear in the dark tone while those of Al (Si, Mg) appear in a lighter tone. In **Figure 3(b)** after removing the samples from the corrosion medium, severe corrosion was observed. These findings primarily suggested that 3.5% NaCl can be an aggressive medium to induce corrosion in the aluminium alloy. In order to identify the various types of intermetallic compounds present in the alloy, the samples were studied using SEM and EDX spectroscopy.

Figure 3. Optical micrograph of polished aluminium alloy engine block (a) before corrosion and (b) after corrosion in 3.5% NaCl solution for 54 days.

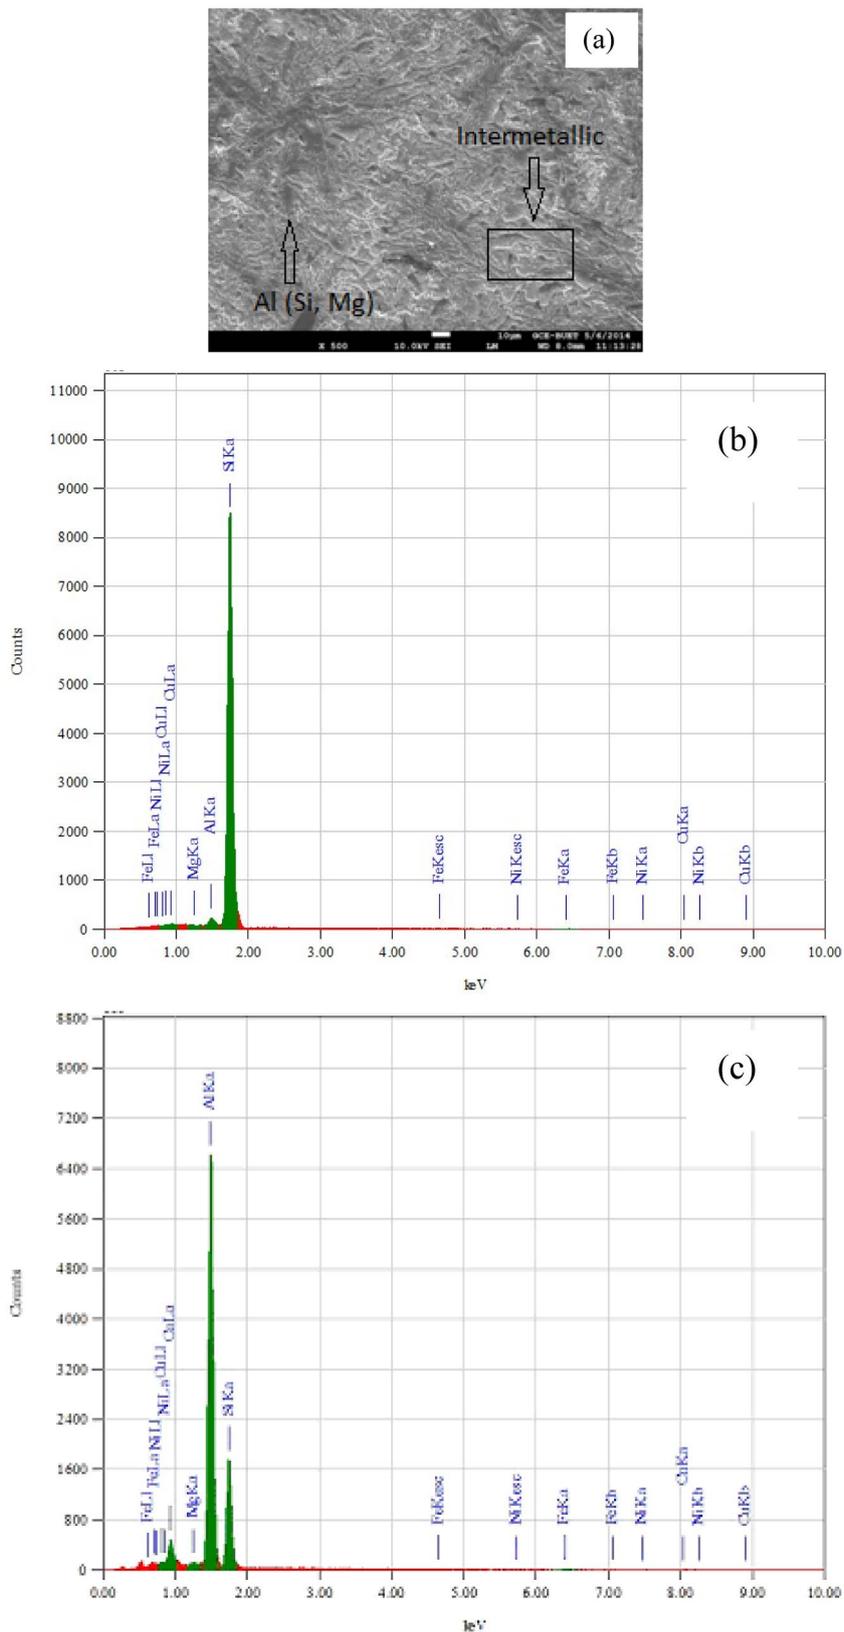
The SEM photomicrographs in **Figure 4(a)**, show the typical microstructure of the aluminum alloys before the corrosion test. It can be noticed from the figure that Si is present in dendritic form and mixed homogeneously in Al matrix.

The EDX profile of Al (Si, Mg) and intermetallic are shown in **Figure 4(b)** and **Figure 4(c)**, the weight percentage of the elements found in the selected areas were 1.22% Al, 98.08% Si, 0.45% Ni, 0.26% Cu and 0.18% Mg, 65.87% Al, 29.18% Si, 1.62% Fe, 3.15% Cu.

Figure 4. (a) SEM image and (b) and (c) EDX spectra recorded for different intermetallics identified in etched samples of aluminium alloy engine block before corrosion.

A number of voids and cavities can be seen in the microstructure of the alloy. The alloy contains the Al (Mg, Si) and AlFeSiCu intermetallic phases. The presence of the AlFeSiCu intermetallic with needle-like morphology only was detected during the characterization by SEM and EDX, suggesting that its amount was not detectable by X-ray diffraction. Fe impurities contained in the aluminum account for the formation of this intermetallic phase [8]. The composition of these was then determined by EDX spectroscopy. The results obtained indicate that, particles mainly contain of Al (Si, Mg), some Al-Mg intermetallic and few Fe-rich intermetallic phases.

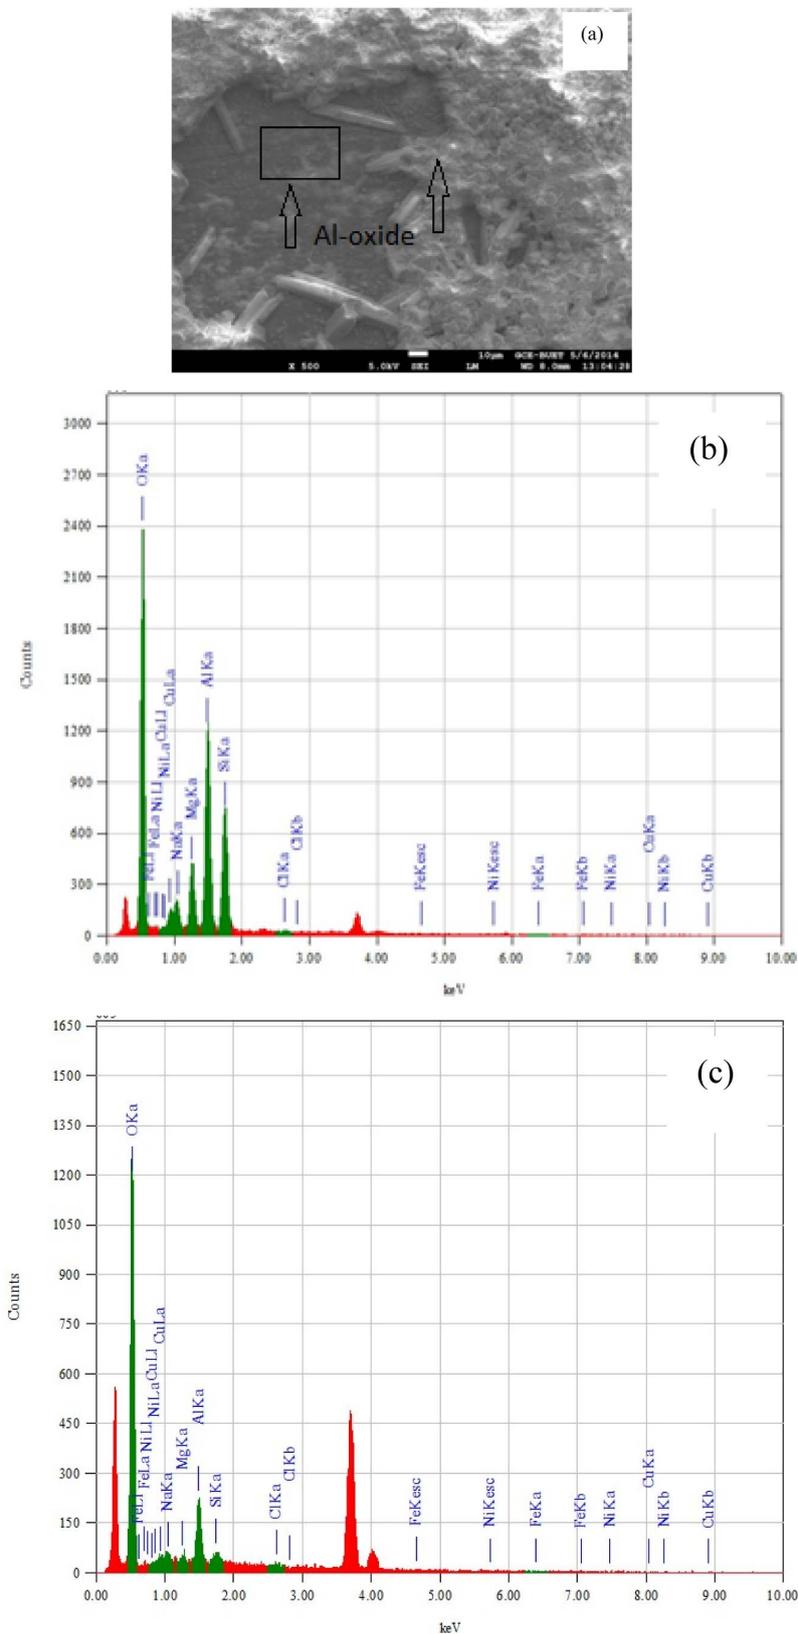
The SEM image in the aluminium piston block of the surface after 54 days of prolonged exposure in 3.5% NaCl solution as shown in **Figure 5(a)**, indicates that the surface composes of two regions. One is covered with grass like corrosion products from which the mushrooms were formed and the other area is covered with a thin layer of corrosion products. The corresponding EDX profile analysis for the selected arrow point and square area of the SEM are shown in **Figure 5(b)** and **Figure 5(c)** respectively. The weight percentage of elements found in these areas were 56.38% O, 1.84% Na, 5.67% Mg, 19.72% Al, 14.49% Si, 0.26% Cl, 0.53% Fe, 1.11% Cu and 82.36% O, 1.42% Na, 1.31% Mg, 11.01% Al, 1.71% Si, 0.49% Cl, 0.73% Ni, 0.96% Cu. After 54 days of prolonged exposure in 3.5% NaCl solution, it can be observed that the sample has been descaled as a consequence of fracturing of the surface film. The surface oxide film was observed to develop at an early period and increased in area and in thickness with the passage of time [5]. The development of this oxide film did not prevent the formation of cavities and large number of hemispherical micropits during prolonged exposure; these extends over a high proportion of the surface area.

Figure 5. (a) SEM images and (b) and (c) EDX spectra obtained for samples of aluminum alloy engine block after exposure in a 3.5% NaCl solution for 54 days.

The results obtained that, the aluminium alloy engine block in a 3.5% NaCl solution suffers a process of localized corrosion. This process affects the zones of the matrix in contact with the intermetallics. The phenomena appears from the first day of exposure. It can be proposed that the presence of metallic inclusions more noble than the matrix reduces the resistance of the alloy to corrosion. These inclusions promote a process of anodic dissolution in the surrounding matrix by acting as cathode. The effect of the presence of Al_3Fe inclusions on the corrosion behavior of the alloys revealed that the presence of Al_3Fe precipitates increases the susceptibility of the alloy to pitting corrosion [9]. The behavior was attributed to the local increase in pH which is produced as a
