A Study on Health Monitoring of Structural Damages for Two Stories Model by Using Vibration Test

Many structures in Japan were built after the war at a revival term or rapid economic growth. These structures have been reached a life in recent years and it is economically not affordable to conduct repair and reconstruct these structures only with a possibility of being damaged. This paper presents an approach to detect the structural damages for two degrees of freedom (2DOF) model. In this study, we conducted Microtremor measurement, free vibration test and vibration test. The 2DOF model was demonstrated the feasibility of using the proposed approach to damage detection of structural member.

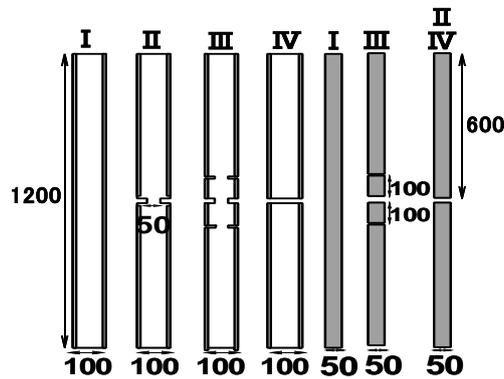
Figure 1. Damage pattern (Unit: mm).

The measurements were performed for twelve test configuration cases. All test configurations were conducted at the full amplitude forced vibration levels. Furthermore, 1/3 amplitude was applied in the work, but the obtained strain was not satisfactory for the considered 1/3 scale and 1/3 amplitude, thus we believe that full amplitude forced vibration could give us more clear results, thus despite of 1/3 scale, full amplitude is considered. In addition to the forced vibration test, free vibration test and microtremor measurement were performed for each case. The damage in each case was introduced by cutting a fracture on the elements or disconnecting beam-column or base-column bolted connections. The damage pattern of column is shown in **Figure 1**. Experimental cases are presented in **Figure 2**.

Case 2: The damage was introduced to the frame by cutting a fracture on the middle of the profile up to 50% width of the both sides. The damaged column was considered at the first floor and as shown in Figure 2, indicated with number 2 of the damage pattern.

One of the disadvantages of the shaking table measurements is the scale of structures which means that we cannot put desired structures on the shaking table, thus microtremor would be a handy method in order to measure dominant waves and amplifications. Microtremor measurement was performed by using six Microtremor-meters. The meters were set up in 2 directions on the beam of the second floor, first floor and the base level. **Figure 1** shows a typical meter layout of the locations and directions on each floor level.

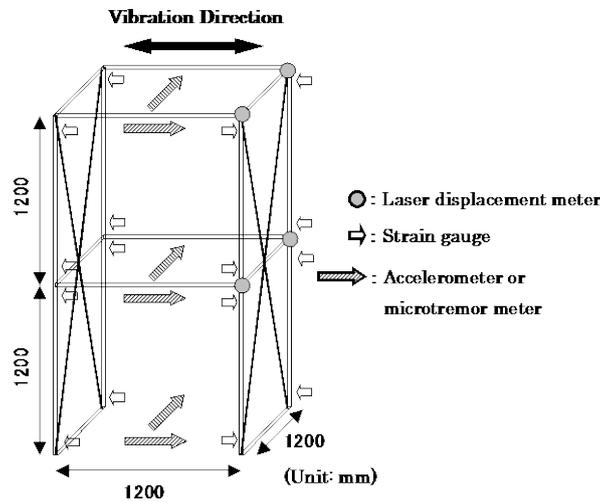
Figure 3. Experimental model.

Free vibration test was performed to evaluate dynamic properties of the model structures. Free vibration was made by applying and then sudden releasing of a static force on the beam of the roof level by the manpower [11]-[13]. **Figure 3** also shows locations layout of accelerometers and directions of accelerometers.

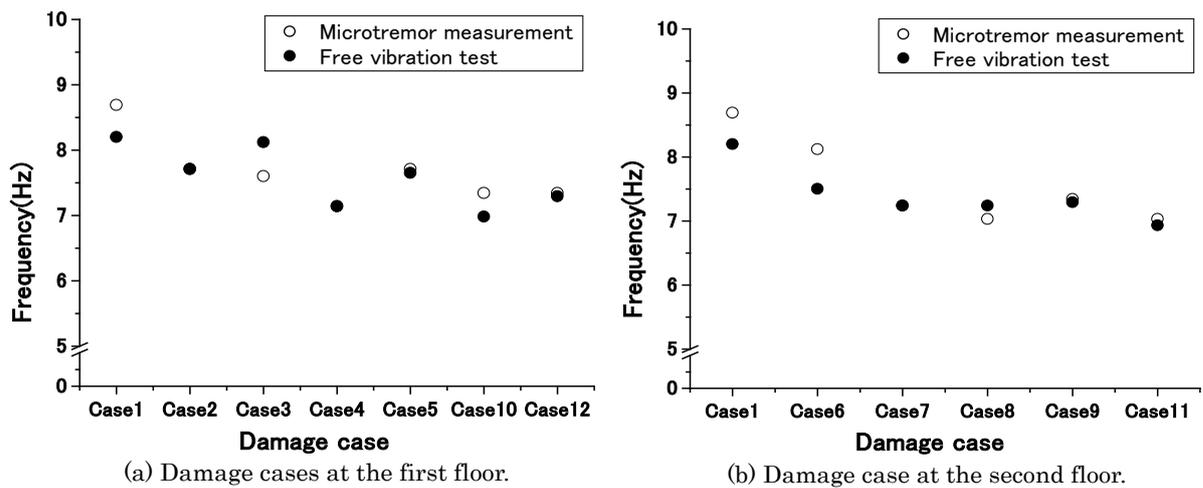
Figure 4. Relationships between damage cases and natural frequency.

The natural frequency in the lateral direction was estimated using the microtremor measurements and vibration tests [14]. The data was analyzed in the frequency domain by using FFT analyses [14]-[17]. The results of natural frequency for all damage cases in the free vibration test and microtremor measurement are shown in **Figure 4**. This figure shows the natural frequencies of undamaged and damaged steel frame. The natural frequencies of

microtremor measurements of the structure are same as those obtained by the free vibration test. This figure was categorized by the results at the first floor and the second floor. The values of natural frequencies of damage cases decrease in comparing with undamaged one. As mentioned above, it is possible to have an estimation of the sensitivity in the model and member properties. As a result we can say that, damage evaluation of the whole model from natural frequency is possible. However, it is obvious that damage evaluation of model in details is difficult.

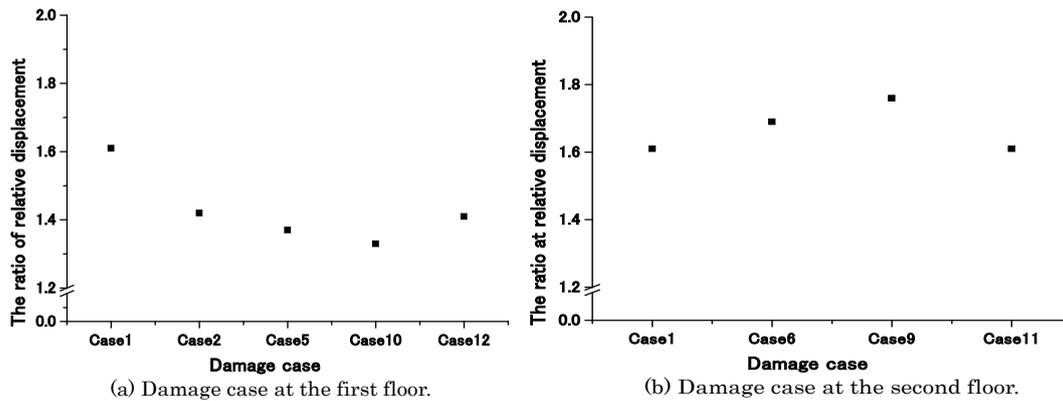
Figure 5. Relationships between damage cases and the ratio of relative displacement.

The ratio of relative displacement in the first and second floors was defined as the index to detect the damaged floor. **Figure 5** shows the comparison between these values with damage cases. As we can see in case of the first floor, the ratios become low according to the fracture scale of the frame (Cases 2, 5, 10). In the second floor same as the first floor, the ratio also increases according to the fracture scale of the frame (Cases 6, 9). However, in the damage cases by disconnecting the beam-column connection in the second floor in Case 11 and the base-column connection in Case 12, we cannot find damage detection by using this presented ratio because, it is difficult to evaluate the change of dynamic behavior by disconnecting the connection.

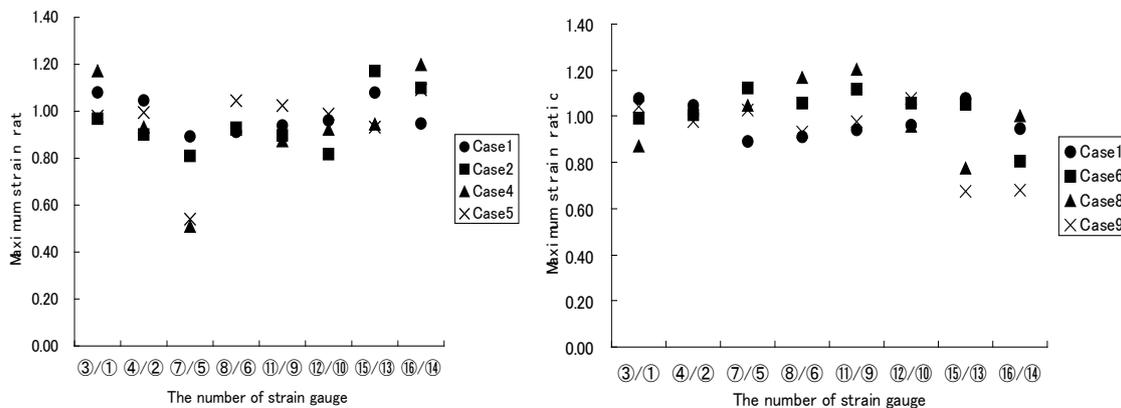
Figure 6. Relationships between damage cases and maximum strain ratio.

frame to undamaged frame was used to detect the member of damaged frame. The relationship between the ratios and damage cases in the forced vibration tests was shown in Figure 6. The tendency in the results has a characteristic in which strain of the column with damage becomes small. The location and number of the strain gauges and the calculation method of the strain ratio were shown in Figure 7. The difference of the maximum strain ratio in two columns become large as damage grade becomes larger. The maximum strain ratio of the undamaged frames is close to 1. The similar trend also was appeared at the second floor. In the disconnection cases, the ratio of No. 8/6 located at the base level becomes low, if the damage occurs at another member of the frame. Therefore, this method was used as benchmark for comparison the damaged model to detect the damage.
