A Study on Health Monitoring of Structural Damages for Two Stories Model by Using Vibration Test

Abstract

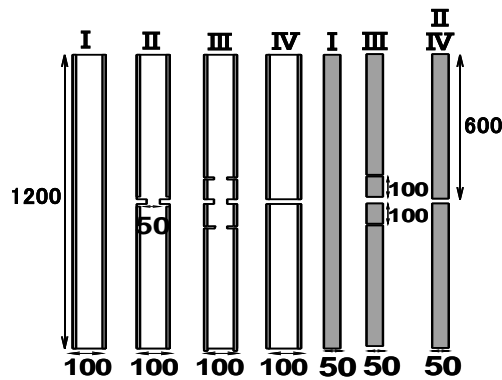
Figure 1. Damage pattern (Unit: mm).

The measurements were performed for twelve test configuration cases. All test configurations were conducted at the full amplitude forced vibration levels. Furthermore, 1/3 amplitude was applied in the work, but the obtained strain was not satisfactory for the considered 1/3 scale and 1/3 amplitude, thus we believe that full amplitude forced vibration could give us more clear results, thus despite of 1/3 scale, full amplitude is considered. In addition to the forced vibration test, free vibration test and microtremor measurement were performed for each case. The damage in each case was introduced by cutting a fracture on the elements or disconnecting beam-column or base-column bolted connections. The damage pattern of column is shown in **Figure 1**. Experimental cases are presented in **Figure 2**.

Case 2: The damage was introduced to the frame by cutting a fracture on the middle of the profile up to 50% width of the both sides. The damaged column was considered at the first floor and as shown in Figure 2, indicated with number 2 of the damage pattern.

One of the disadvantages of the shaking table measurements is the scale of structures which means that we cannot put desired structures on the shaking table, thus microtremor would be a handy method in order to measure dominant waves and amplifications. Microtremor measurement was performed by using six Microtremor-meters. The meters were set up in 2 directions on the beam of the second floor, first floor and the base level. **Figure 1** shows a typical meter layout of the locations and directions on each floor level.

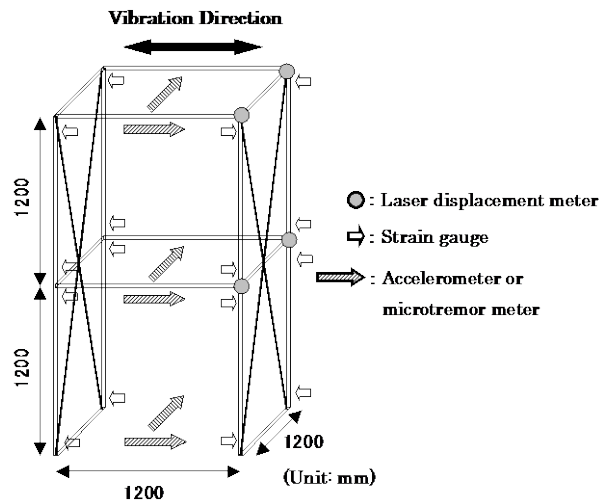
Figure 3. Experimental model.

Free vibration test was performed to evaluate dynamic properties of the model structures. Free vibration was made by applying and then sudden releasing of a static force on the beam of the roof level by the manpower [11]-[13]. **Figure 3** also shows locations layout of accelerometers and directions of accelerometers.

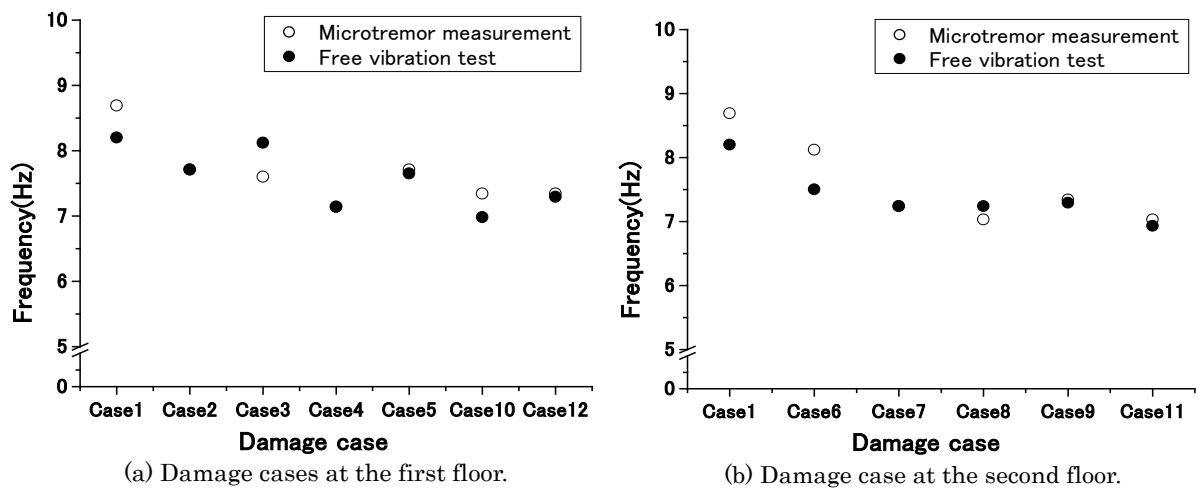
Figure 4. Relationships between damage cases and natural frequency.

The natural frequency in the lateral direction was estimated using the microtremor measurements and vibration tests [14]. The data was analyzed in the frequency domain by using FFT analyses [14]-[17]. The results of natural frequency for all damage cases in the free vibration test and microtremor measurement are shown in **Figure 4**. This figure shows the natural frequencies of undamaged and damaged steel frame. The natural frequencies of

microtremor measurements of the structure are same as those obtained by the free vibration test. This figure was categorized by the results at the first floor and the second floor. The values of natural frequencies of damage cases decrease in comparing with undamaged one. As mentioned above, it is possible to have an estimation of the sensitivity in the model and member properties. As a result we can say that, damage evaluation of the whole model from natural frequency is possible. However, it is obvious that damage evaluation of model in details is difficult.

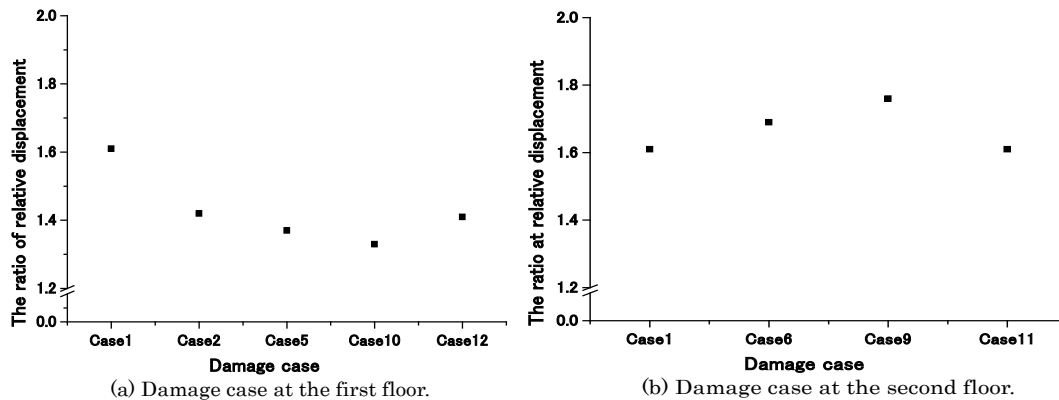
Figure 5. Relationships between damage cases and the ratio of relative displacement.

The ratio of relative displacement in the first and second floors was defined as the index to detect the damaged floor. **Figure 5** shows the comparison between these values with damage cases. As we can see in case of the first floor, the ratios become low according to the fracture scale of the frame (Cases 2, 5, 10). In the second floor same as the first floor, the ratio also increases according to the fracture scale of the frame (Cases 6, 9). However, in the damage cases by disconnecting the beam-column connection in the second floor in Case 11 and the base-column connection in Case 12, we cannot find damage detection by using this presented ratio because, it is difficult to evaluate the change of dynamic behavior by disconnecting the connection.

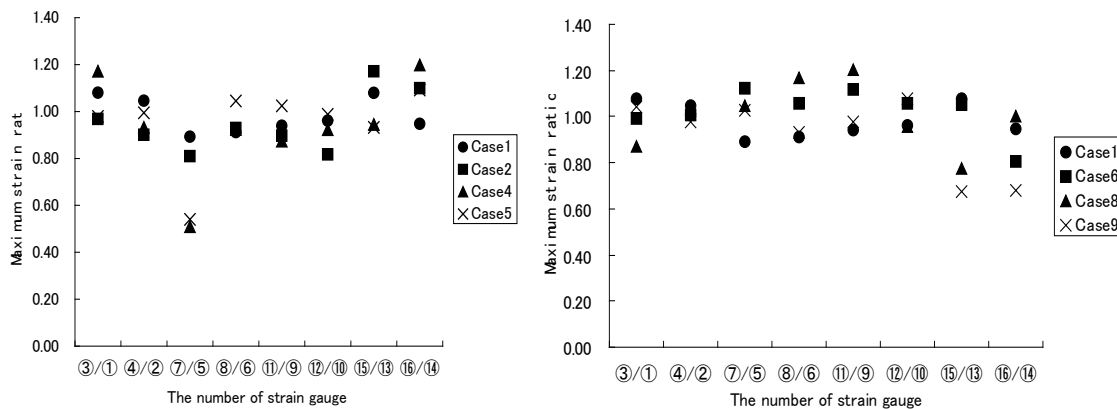
Figure 6. Relationships between damage cases and maximum strain ratio.

frame to undamaged frame was used to detect the member of damaged frame. The relationship between the ratios and damage cases in the forced vibration tests was shown in Figure 6. The tendency in the results has a characteristic in which strain of the column with damage becomes small. The location and number of the strain gauges and the calculation method of the strain ratio were shown in Figure 7. The difference of the maximum strain ratio in two columns become large as damage grade becomes larger. The maximum strain ratio of the undamaged frames is close to 1. The similar trend also was appeared at the second floor. In the disconnection cases, the ratio of No. 8/6 located at the base level becomes low, if the damage occurs at another member of the frame. Therefore, this method was used as benchmark for comparison the damaged model to detect the damage.
