# Impact of the Condition of Drinking Water Supply Networks on the Quality of Water Intended for Consumption: The Case of the Network in the Commune of Daloa (Central West of Côte d'Ivoire)

Pipe, Water Supply Network, Drinking Water, Daloa

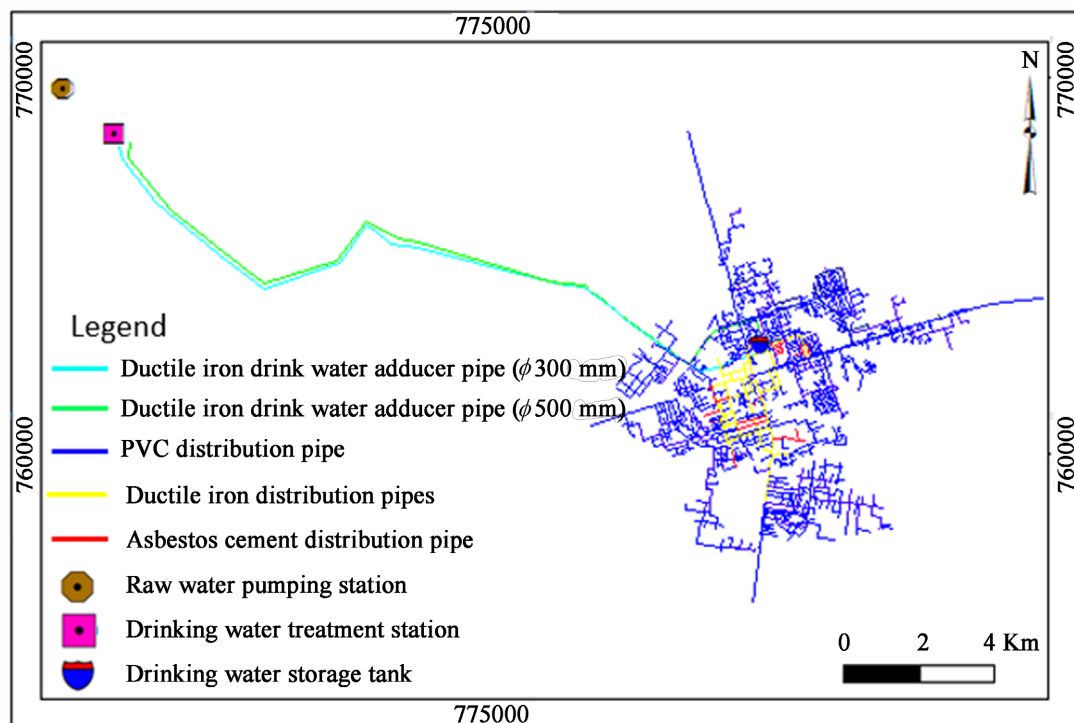
Figure 1. Presentation of the drinking water supply network of the municipality of Daloa.

Daloa's drinking water supply network is fed by a weir built on the Lobo River, a tributary of the Sassandra River [12]. Daloa is the third largest city in Côte d'Ivoire. The reservoir is located 25 km from the town of Daloa [13], on the Daloa-Zaïbo road (Figure 1). The reservoir was commissioned in 1976 and is the main source of drinking water for the population of Daloa. The average quantity of water drawn from the reservoir is 16,200 m<sup>3</sup>/day. The average depth of the reservoir is 3.5 m, with an average width of 74 m, a length of 4.3 km and a surface area of 30.3 ha. Volume at normal elevation (231.033 m) is 380,000 m<sup>3</sup> [14]. The river rises in the locality of Séguéla at an altitude of 340 m. The drinking water production plant is located 1 km from the mine. Here, the raw water is potabilized before being conveyed to the storage reservoir (25 km away) via two cast-iron feeder pipes with diameters of 500 and 300 mm. The climate in the study area is a mild transitional equatorial type, with a rainy season from March to October and average annual rainfall of around 1150 mm [14].

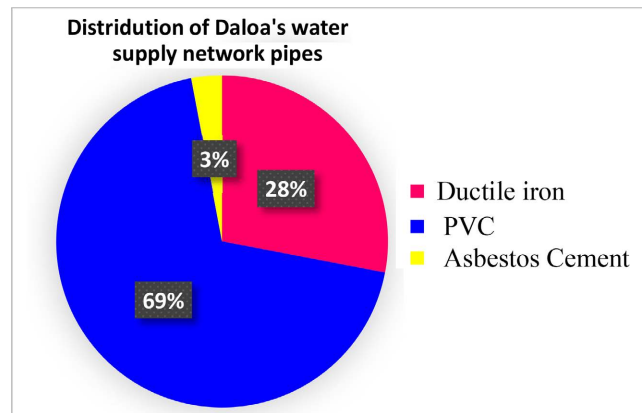
**Figure 2.** Material distribution on Daloa's drinking water supply network.

With a total length of 264,440.61 meters, Daloa's distribution network is made up of three types of material. Polyvinyl chloride (PVC) pipes account for 69% of the total length, ductile cast iron pipes for 28% and asbestos cement pipes for 3% (Figure 2).

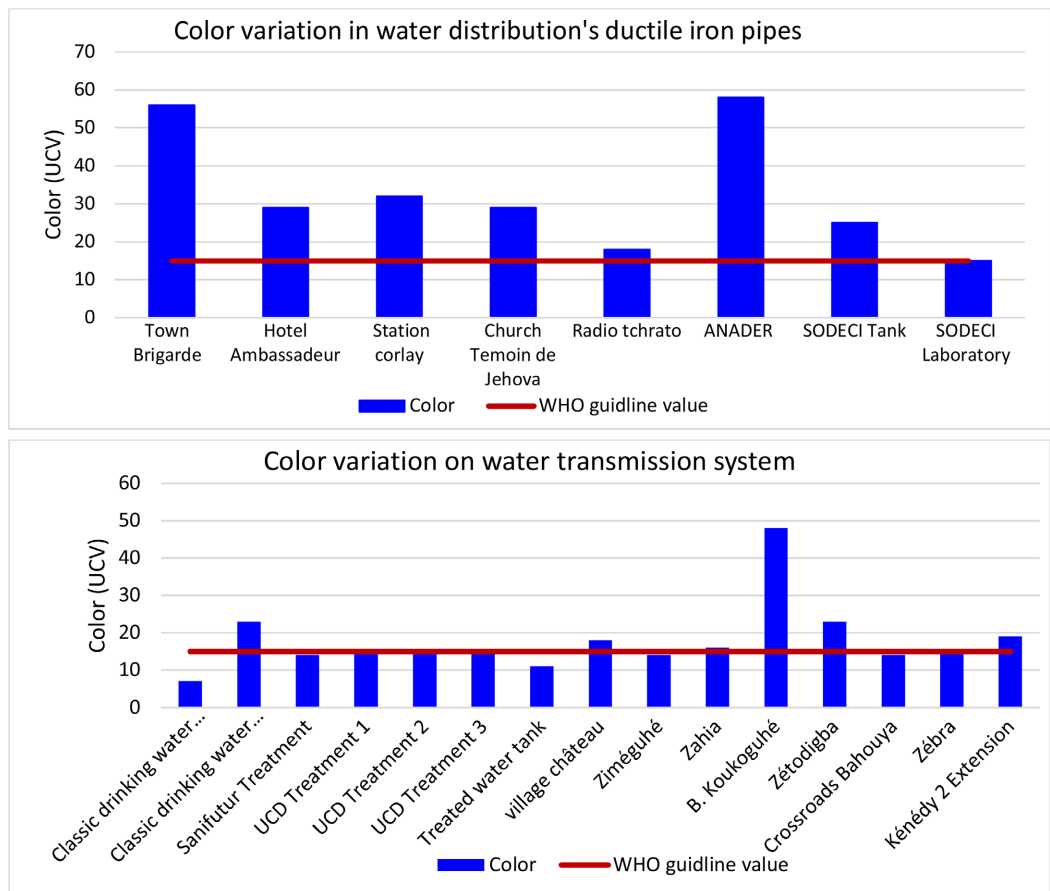
Figure 14. Color variation in ductile iron pipes.

Figure 14 and Figure 15 show that water color values are above the WHO guide value throughout the supply network in cast-iron and PVC pipes. On the other hand, asbestos cement pipes show values both above and below the WHO standard.
