Research on Surrounding Rock Stability Test of Tunneling Roadway under Complex Geological Conditions

Abstract

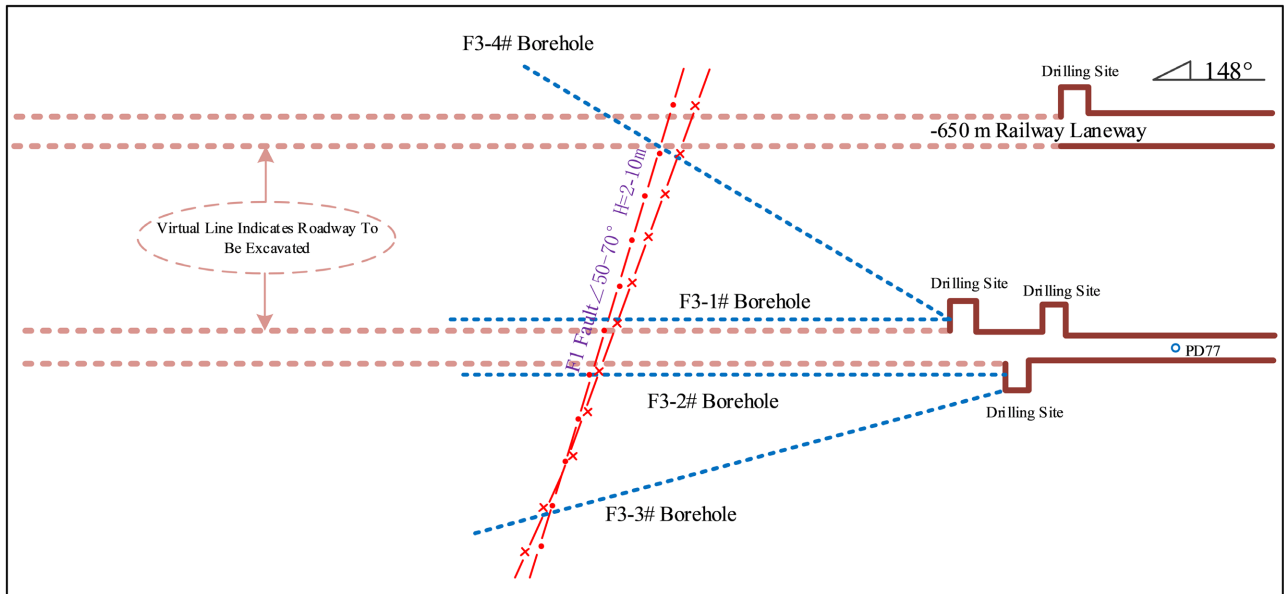
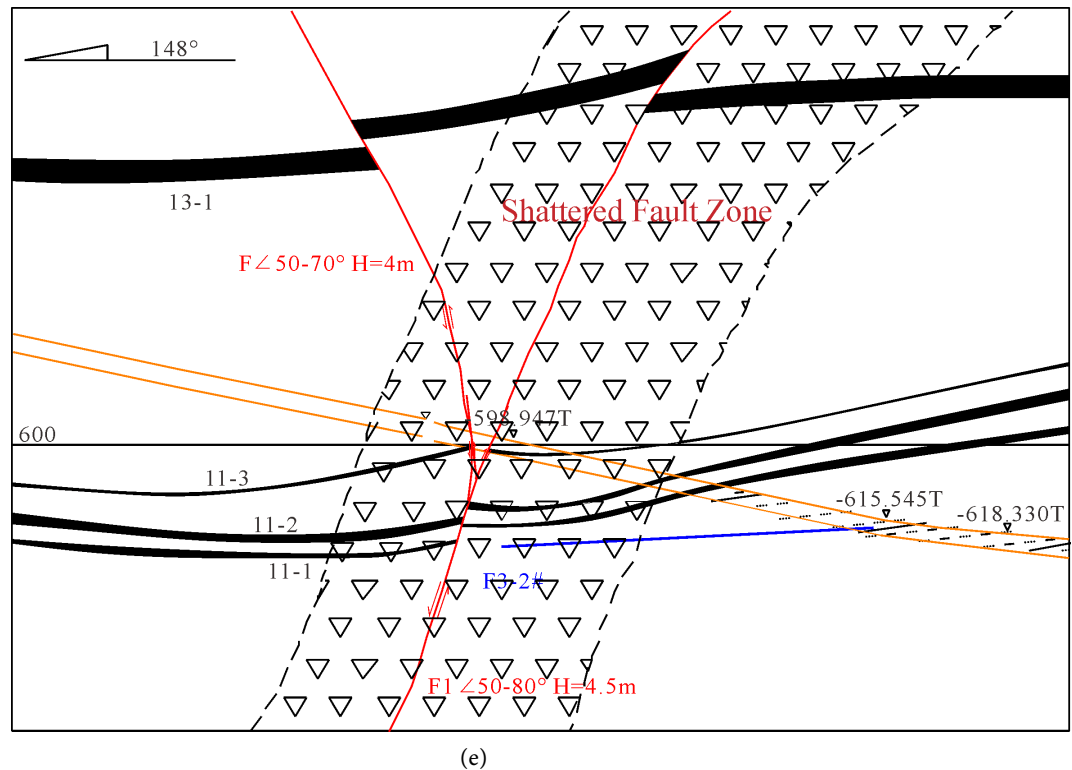
Figure 1. Schematic diagram of F1 fault monitoring borehole in -530 - -650 m belt conveyor inclined roadway. (a) Plane position map of monitoring hole; (b) Location map of F3-1 monitoring hole; (c) Location map of F3-4 monitoring hole; (d) Location map of F3-3 monitoring hole; (e) Location map of F3-2 monitoring hole.

Based on the investigation tasks and actual conditions, a borehole monitoring system encompassing devices based on the BOTDR and electrical methods was deployed in -530 - -650 m belt conveyor inclined roadway. The monitored cross section was located near the 38 m ahead of the PD77 point in the inclined roadway excavated by the belt conveyor, and the testing systems were respectively installed on both sides of the roadway from the drilling field. The boreholes are shown in **Figure 1**. When testing was conducted, monitoring sites were deployed on the cross section to research the effect of inclined roadway excavated by belt conveyor on the rock strata of the F1 fault zone. As shown in **Figure 1(b)**, the 4 boreholes on the two cross sections were deployed at a certain depth of the F1 fault-fracture zone. As such, the boreholes at 4 different directions formed up a 3-dimensional monitoring space capable of robustly evaluating the structural stability of the F1 fault-fracture zone near the same section of inclined roadway excavated by the belt conveyor.

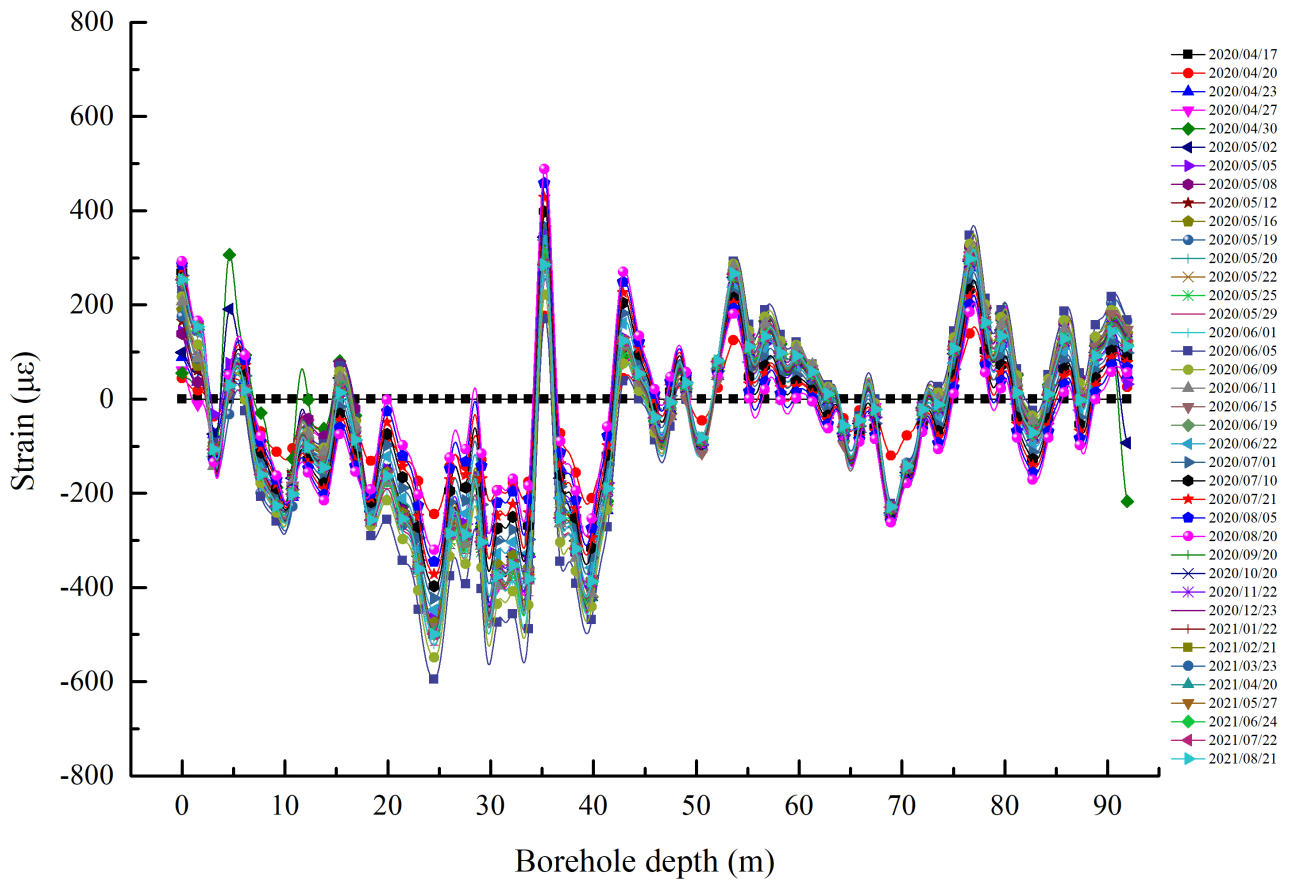
Figure 2. Strain distribution of F3-3# borehole

Given limited length of this paper, data of F3-3# borehole was focused despite a large body of monitoring data collected from the test site. From April 17, 2020 to August 21, 2021, a total of 95 groups of strain deformation data by the BOTDR method were collected. Based on the analysis of the results of the BOTDR tests at different depths of the monitoring borehole, the observational data of surrounding rock deformation within the control range of the borehole in the monitoring cycle was obtained. On that basis, the stability of rock in F1 fault within the control range of the borehole was analyzed, followed by an evaluation of the grouting reinforcement from ground surface and monitoring of the stability of surrounding rock in the F1 fault during roadway construction and post-construction utilization stage. **Figure 2** shows the strain distribution based on the BOTDR method in the F3-3# borehole during the monitoring period. As can be seen, BOTDR-measured strain exhibited different strain characteristics, including both tensile and compressive strain, for different locations of borehole during the monitoring periods. The compressive strain was dominant and had relatively small amplitudes with the largest strain not exceeding 600 $\mu\epsilon$, indicating a small rock strata deformation within the control range of the borehole and relative stability in fault-fracture zone.

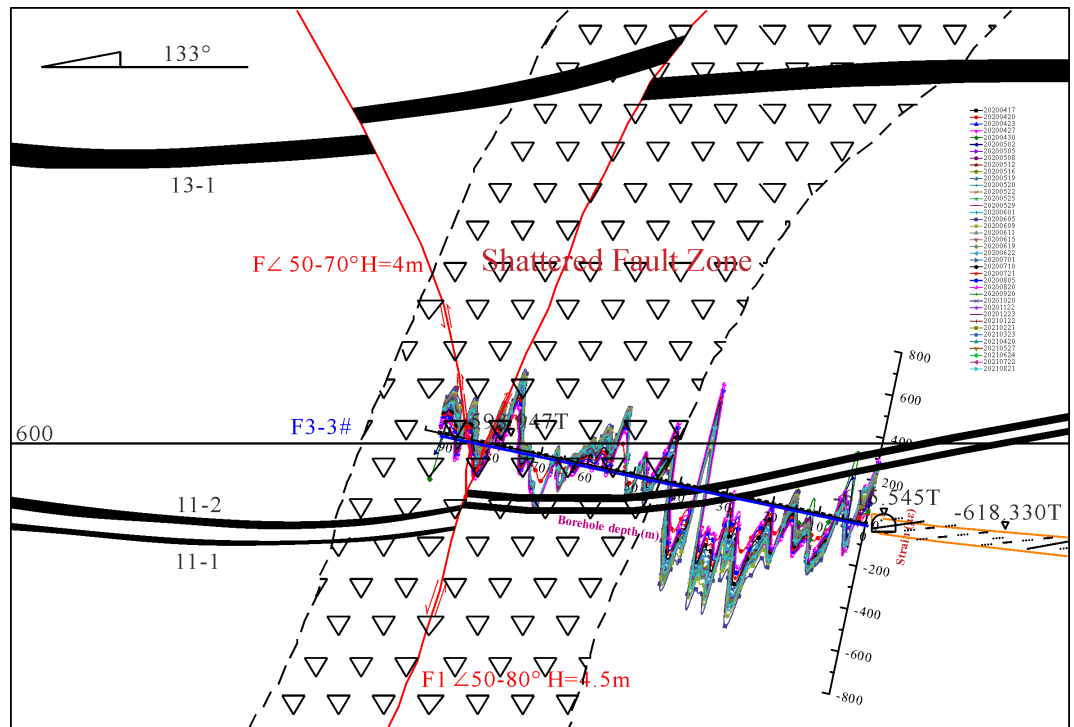
Figure 3. Strain curve change of rock stratum in F3-3# borehole.

To better analyze deformation and damage of rock strata within the control range of borehole, the strain curve and geological profile were combined to comprehensively analyze rock strata deformation, as shown in **Figure 3**. The

control range of borehole mainly encompassed two geological bodies: First, the F1 fault-fracture zone; second, the normal lithologies like coal seams and sandy mudstone. Distinct difference in strain changes of the two geological bodies was observed. Specifically, grouting reinforcement of the F1 fault-fracture zone changed the original properties of fractured rock strata, which were dominated by concrete blocks with significantly increased elasticity modulus. Thus, the magnitude of strain change was relatively small compared with coal seam and sandy mudstone with normal lithology. This indicates that the integrity of rock strata in F1 fault-fracture zone was improved by grouting reinforcement from ground surface, and the mechanical properties of rock, including compressive and tensile strengths, were significantly increased.

As can be seen from **Figure 3**, there was a significant difference in strain changes between areas of normal lithology and fault-fracture zone. Prior to roadway penetration, the strain within the range of the fault-fracture zone controlled by the F3-3 borehole was dominated by tensile strain, and extreme values of tensile and compressive strengths in borehole appeared in certain periods before roadway penetration. However, with roadway excavation and its subsequent operation upon completion, the BOTDR-measured strain within the control range of the borehole was in a stable state. This indicates that in the roadway operation stage, the activation degree of the F1 fault-fracture zone was low and basically stabilized.
