Test a Queue Detection System for Special Events in Nevada

Hualiang (Harry) Teng¹, Xuecai Xu², Venkatesan Muthukumar³, A. Reed Gibby⁴

Queue detection systems have been used in traffic management in work zones and have also been recommended for traffic control for special events like sports and conventions. However, they have not been tested in the field. This paper presents the results of tests for a queue detection system at two special events in Las Vegas, Nevada. The system consisted of two vision detectors, radio frequency communications and one changeable message sign. Two aspects of the system were evaluated: the effectiveness of the system in reducing speeds and the cost and effectiveness of its deployment. In the tests, traffic data such as queue length and vehicle operating speeds were collected and analyzed to see whether motorists respond congestion related message on the changeable message sign when they did not perceive the congestion. By this approach, the motorists' true responses to the system were identified. The results indicated that motorists did make positive responses to the messages provided by the system. However, it was found that the system may not be co

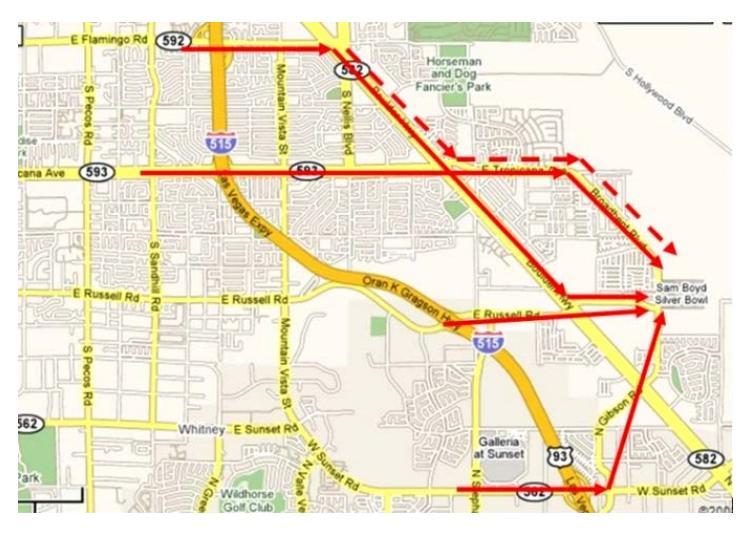
Figure 1. Access to Sam Boyd Silver Bowl (Google map).

Figure 1 displays several access routes to Sam Boyd Silver Bowl. The formal address for this facility posted on its website was: 7000 E Russell Rd, Las Vegas, Nevada 89122-8338. Thus, this facility was mostly accessed from Tropicana Avenue and Russell Road. Since Russell Road exit was suggested as the best candidate for testing the technology, the system was set up over there. Another condition making this site feasible for testing the system was that there were facilities on which the cameras and antennas can be mounted.

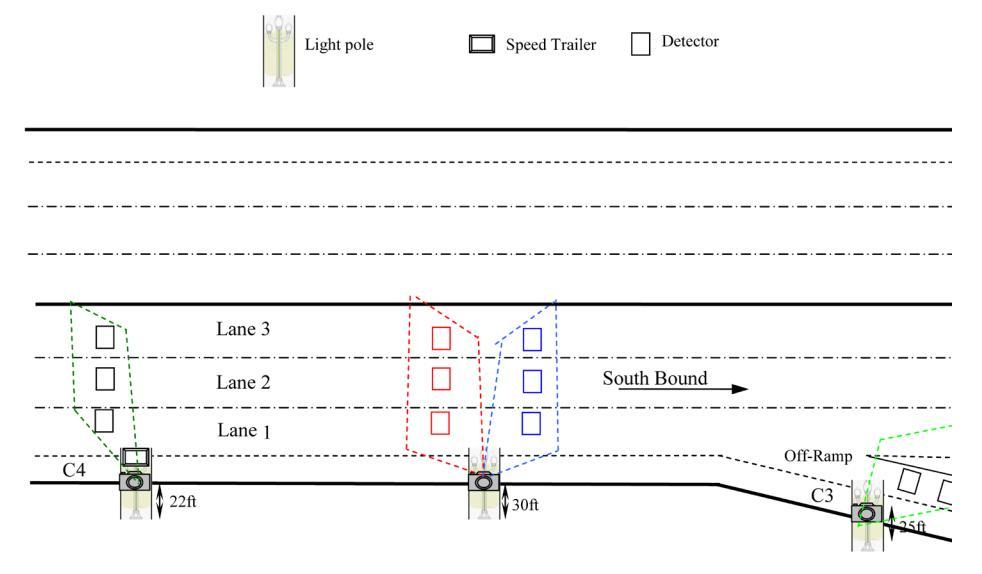
Figure 2. System layouts and evaluation equipment at Russell Rd. off-ramp.

Figure 2 displays the configuration of the system at the site. Cameras 2 and 3 were part of the vision detection system. Two Autoscope image processors were connected to these two cameras (one for each of Cameras 2 and 3, respectively) to collect traffic data such as speed, occupancy, and volume. **Figure 3** shows utility pole where Camera 2 was mounted. One antenna was also installed jointly with the camera and the image processor at each of these two locations. These antennas were used to transmit the traffic data to a RF at the location where a CMS was deployed. **Figure 3** also presents the plastic pole carrying the RF that was attached to the CMS. The RF was connected to a computer as a controller. A program was written in the controller to determine the ap-

propriate messages to be displayed based on analyzing the traffic data received from the RF transmissions. The space between the RF at CMS and the RFs at the other two locations were clear and an eye sight between them was available for communications. There are two more cameras at the site: Camera 4 at CMS and Camera 1 at the location where Camera 2 was mounted. They were used to record traffic, which was then processed to derive the performance measures for evaluating the performance of the queue detection system.

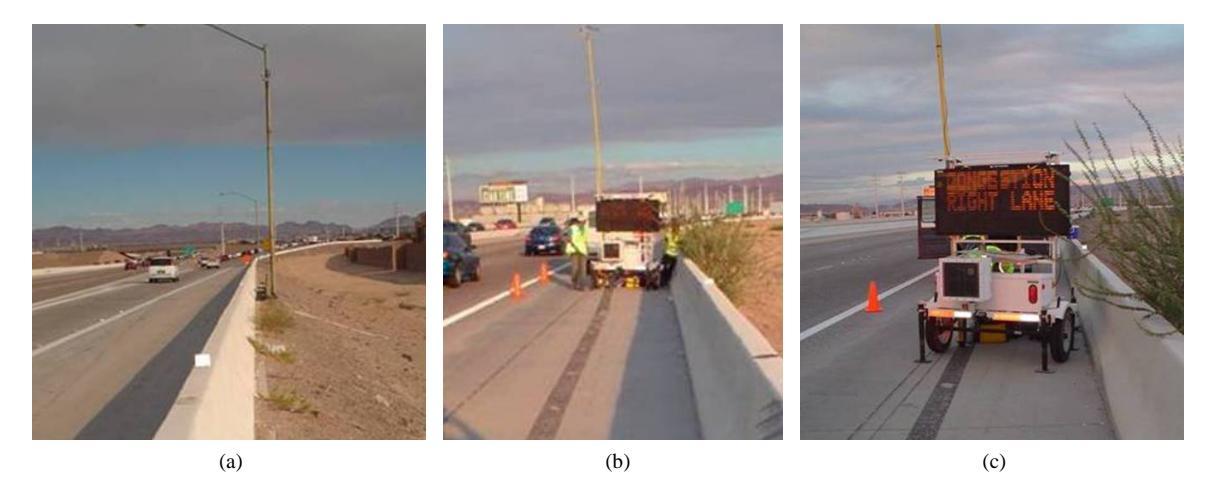
Figure 3. Components of the queue detection systems in the field. (a) Plastic pole attached to a utility pole carried Cameras 1 and 2 and a RF. (b) Camera mounted on a plastic pole attached to the CMS trailer. (c) CMS displaying "congestion right lane".

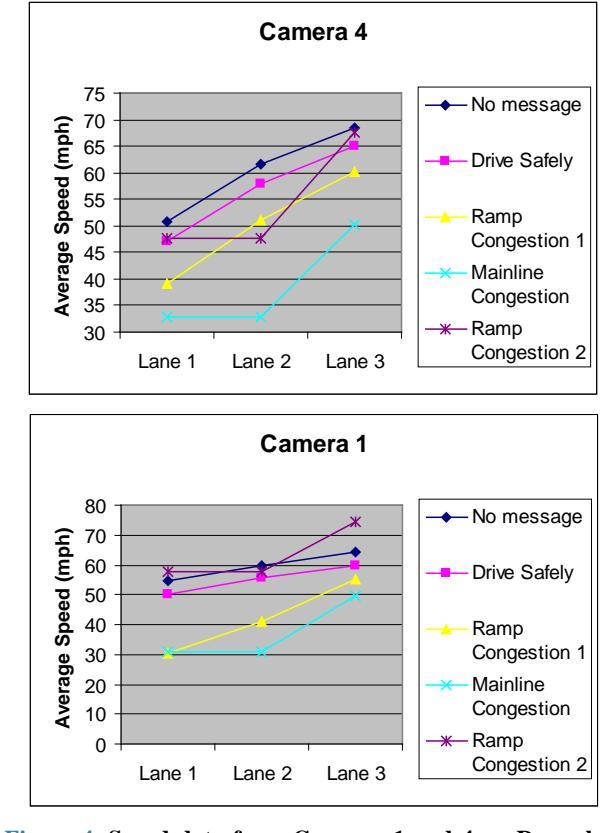
Figure 4. Speed data from Cameras 1 and 4 on December 15, 2007.

Figure 4 presents the patterns of speeds over the three lanes at the location where Cameras 1 and 4 were installed. From the upper chart in **Figure 4** it can be seen that the speeds when the message was "Drive Safely" was smaller than those when the CMS showed no message. When congestion started showing on the off ramp, the message turned to "Congestion Right Lane". The speeds were reduced further down. After the congestion was presented on the mainline freeway, the speeds were reduced additionally, which is the speeds shown at the bottom in the upper chart in **Figure 4**. When the congestion shrank back to the off ramp, the speeds went up to a level similar to the case when there was congestion at the beginning or the case when there was no congestion.

From the chart (for Camera 1) in the lower part of **Figure 4** it can be seen that the similar pattern of speed changes can be observed over these different time periods with different levels of congestion and messages shown on the CMS, One difference was that the speeds in these time periods at this location were lower than those at the upstream Camera 4. These results from Cameras 1 and 4 have been tested using the hypothesis test method. The test results in **Table 1** confirm the results observed from **Figure 4**.

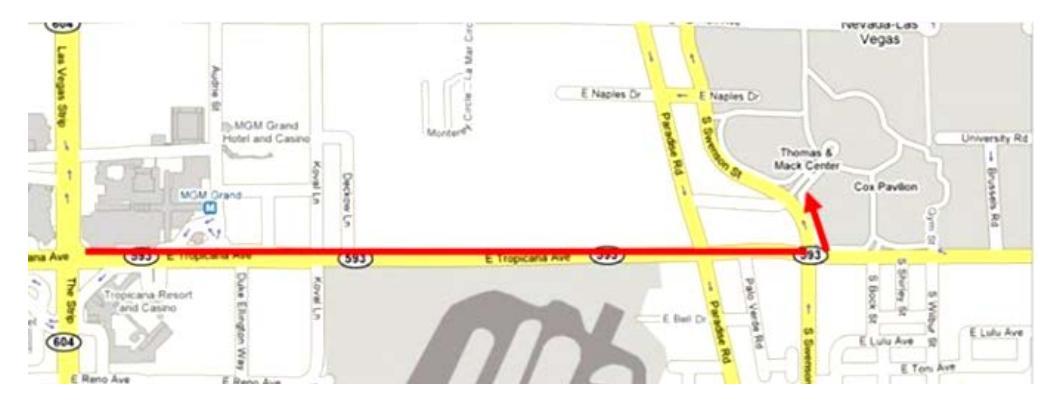
Figure 5. Direction of traffic to Thomas & Mack.

Visits were made to two special events held at Thomas & Mack for observing the traffic congestion on Tropicana Avenue (see **Figure 5**). Queue was seen fluctuating around the Pacific Terminal, very close to the Koval Ln. Intersection. This observation was briefed to the Thomas & Mack and was confirmed. It was also confirmed at the site that there were tall light poles that Clark County allowed to install cameras and antennas.

The site at the Thomas & Mack Center was chosen on Tropicana Avenue from Las Vegas Blvd to Paradise Road (see **Figure 5**). During special events such as Professional Bull Rider, queues were observed to form at the intersection of Paradise Road and Tropicana Avenue and backed up to the intersection at Koval Ln.

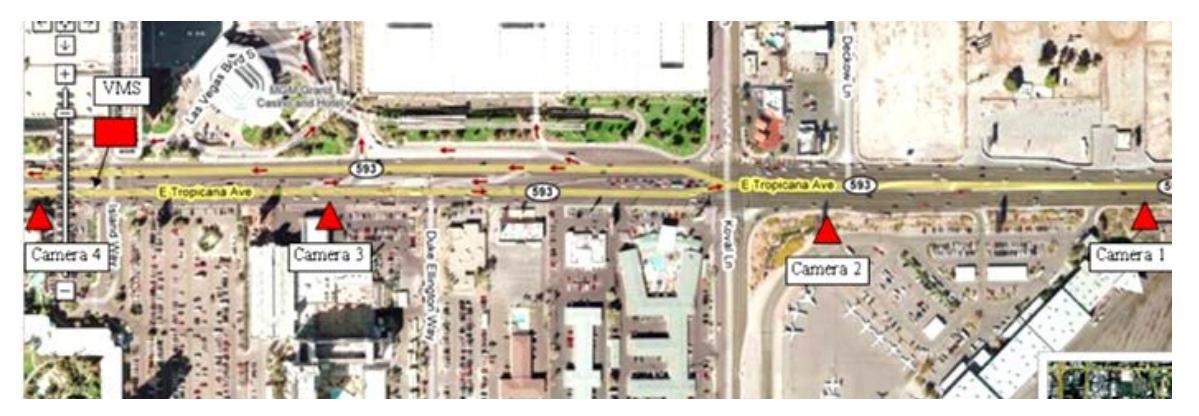
Figure 6. System layouts in the field on Tropicana Avenue.

To detect the queue backed up from Paradise Rd. and monitor the progression of the queue to Koval Ln, two cameras (Cameras 1 and 2 in Figure 6) were mounted on street light poles. The CMS was deployed on the median shoulder at the intersection of Island Way, facing the parking garage of MGM Casino and Hotel on Tropicana Avenue (see Figure 7). From Figure 5, it can be seen that the road segment on Tropicana Avenue from Las Vegas Blvd to Paradise Road was straight, between which there was no object blocking the eye sight for the communications between the RFs that were installed at Cameras 1 and 2 and the CMS.

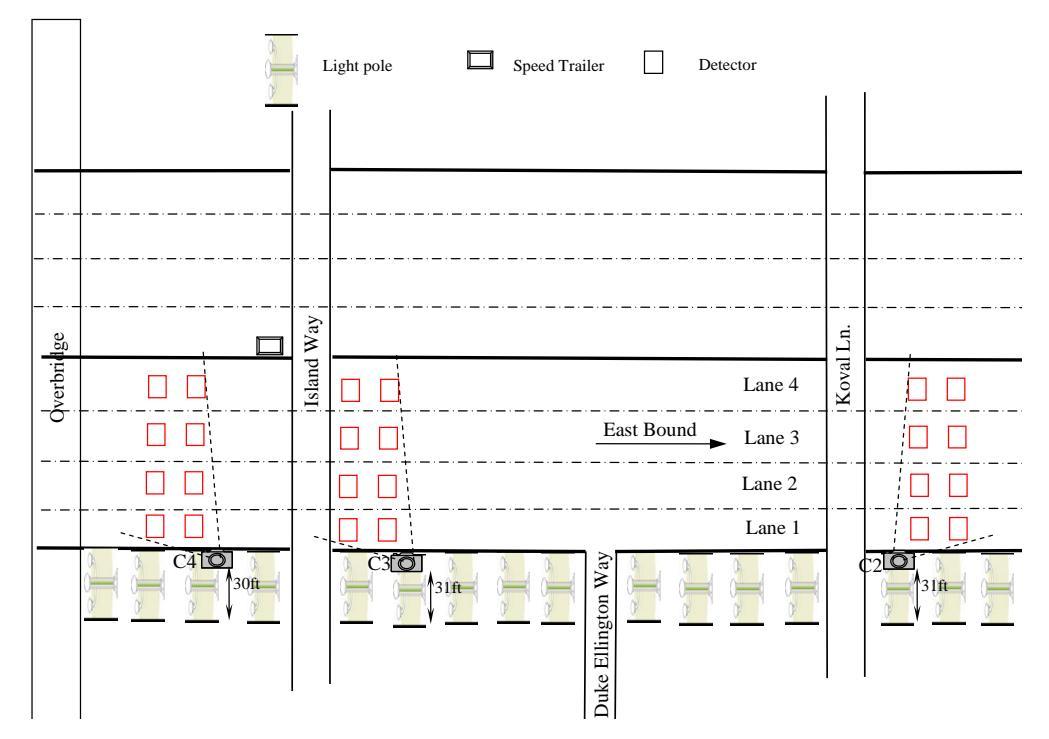
Figure 8. Cameras for collecting observational data for system evaluation.

To collect data for evaluating the performance of the queue detection system, Cameras 3 and 4 (see Figure 8) were mounted on two light poles, one before and one after Island Way. In the test on I-515, one camera was mounted on a plastic pole that was attached to the trailer that carried the CMS. In the test at this site, however, a camera was mounted on street light which provided the stability for the camera to collect stable images of videos.

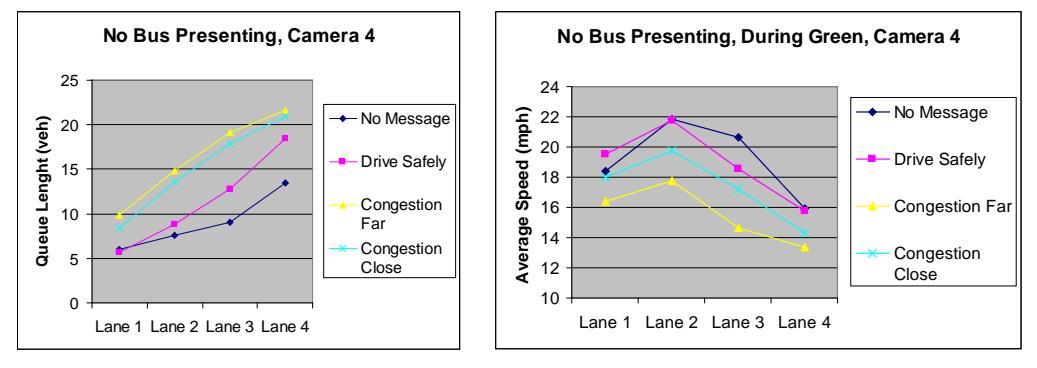
Figure 9. Queue length and speeds from Camera 4 on November 3, 2007.

Figure 9 presents the queue length collected from Camera 4. The upper chart for no bus at the bus stop indicates that there were longer queues in left lanes and right lanes. The queue lengths during the congestion time period were significantly longer than the other two time periods. The queue lengths during the two time periods corresponding to congestion visible (close) and invisible (far) were very close. A tendency that more traffic shifted to right lanes can be observed when the message showed "Congestion Left Lane", which implies that motorists spread out over the lanes even they *did not* see the congestion ahead.

From the lower part of **Figure 9**, which displays the speed data from Camera 4, it can be seen that the speeds on the right lanes were higher than the left lanes, which is consistent with our intuitive. In addition, the speeds during the congestion period were lower than those in non-congestion periods. This observation reflected the impact of congestion on speeds. The speeds during the congestion period when congestion was far from the CMS were lower than those when congestion was close to the CMS. Note that these differences in speeds in these two conditions are on the magnitude of 2 to 3 mph, which is small.

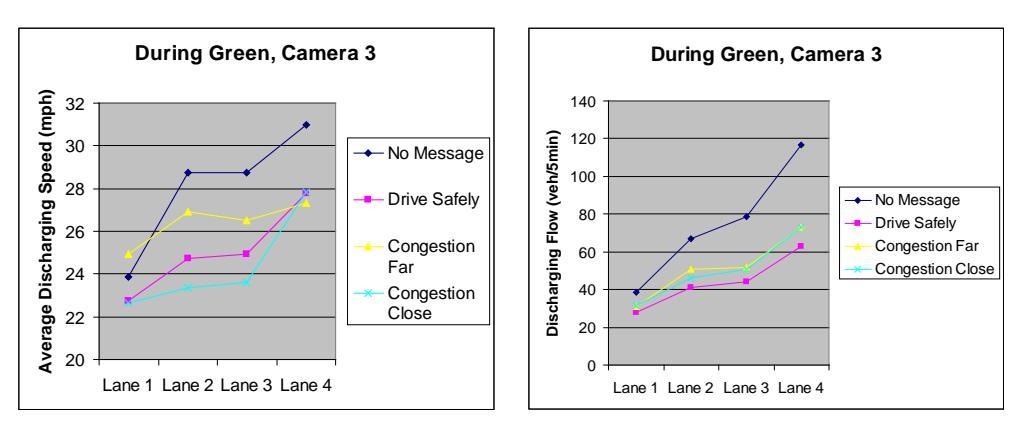
Figure 10. Speeds and flows at Camera 3 on November 3, 2007.

Figure 10 exhibits the speeds and traffic flow measured at Camera 3, downstream of Camera 4. It can be seen from the upper chart that the speeds during the time period when no message was displayed on the CMS were higher than those when there were message displayed. The speeds when congestion was visible to the motorists

close to the CMS were lowest. The speeds in the other two time periods were in between of these two cases, which implies that any message, either "Drive Safely" or "Congestion Left Lane", was effective in slowing down vehicles' speeds. It can also be observed from the chart that the speeds when the congestion was not visible at the CMS were higher than that during the "Drive Safely" was shown. This indicates that the message "Congestion Left Lane" was effective in spreading vehicles over the traveling lanes and thus increased vehicles' speeds. From the chart at the bottom of Figure 10 it can be seen that flows during the time periods when no message was shown and "Congestion Left Lane" was shown for visible congestion were either on the top or at the bottom levels. Those flows for the other two conditions were in between. This observation is an additional indication that support the findings based on the speeds at this location.
