Native Aquatic Plant Establishment Efforts in a High-Herbivore, Central Texas Reservoir

How to cite this paper: Schad, A.N., Bellinger, B.J., Dodd, L.L., Kelly, J., Hellinghausen, K., Dick, G.O. and Atkinson, S.F. (2021) Native Aquatic Plant Establishment Efforts in a High-Herbivore, Central Texas Reservoir. Journal of Water Resource and Protection, 13, 1024-1042. https://doi.org/10.4236/jwarp.2021.1312055

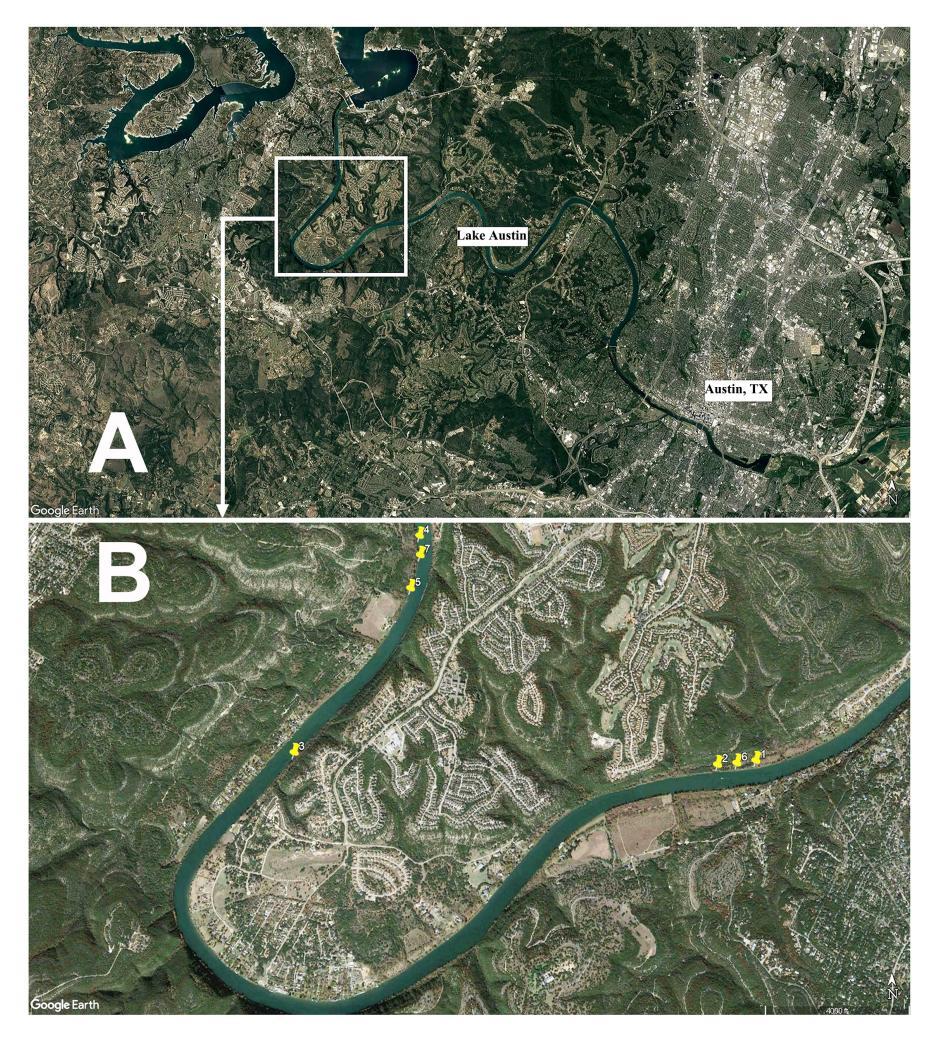
Figure 1. Native aquatic vegetation founder colony site locations on Lake Austin, TX, installed July 2015-2018; Lower Colorado River watershed in central Texas, USA (A) with map site callout (top), and (B) submerged aquatic vegetation establishment sites 1 - 7, American eelgrass sites 1 - 4 used for inferential testing (bottom), Google Earth Pro Version 7.3. damaged by floods. Originally called Lake McDonald, both earlier dams were known as the Austin Dam. The reservoir is 32.5 km long, with a maximum width of 396 m, and covers approximately 740 ha.

Lake Austin is an impoundment of the Lower Colorado River currently maintained by the Tom Miller Dam northwest of Austin, TX, U.S. (Figure 1). Primary functions of the dam are to provide hydroelectricity and water supplies to the City of Austin. Completed in 1939, the dam was constructed on top of the remains of two other structures (completed in 1893 and 1912), both of which were

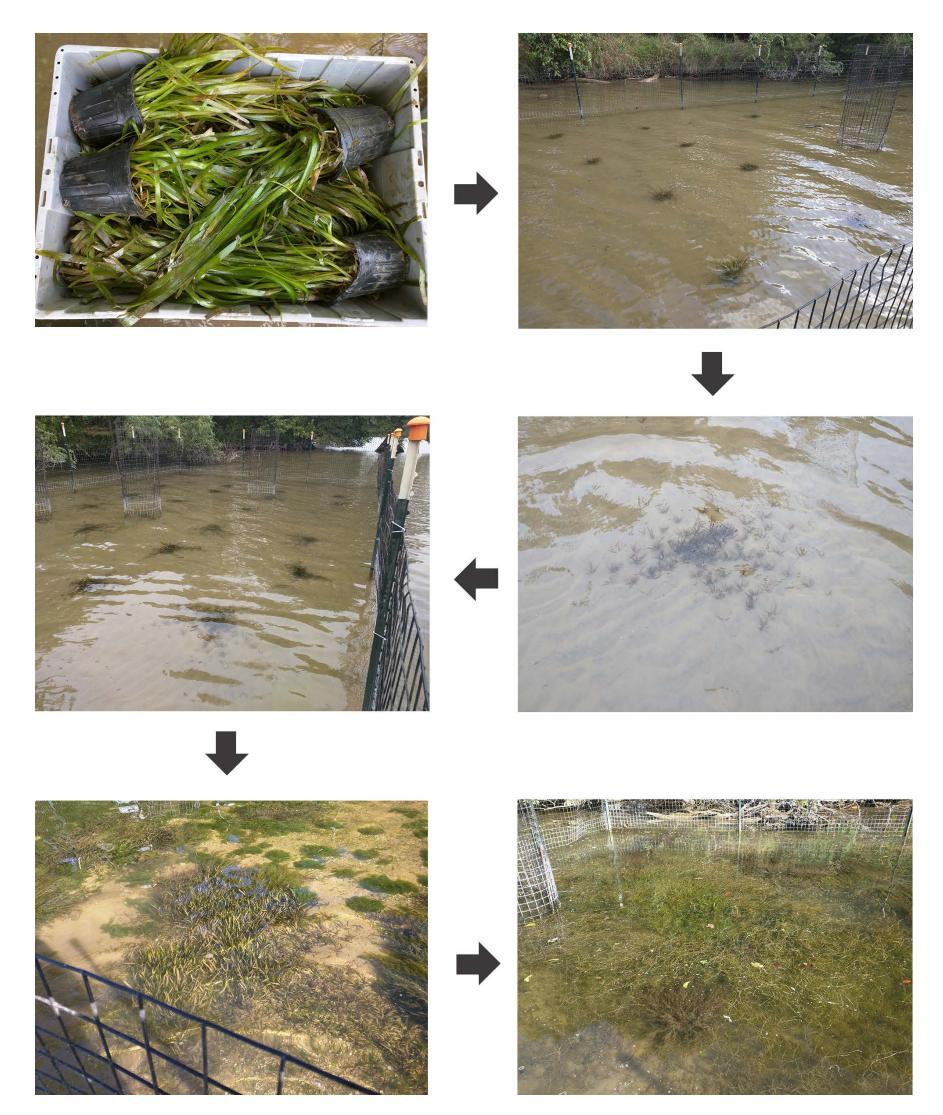
Figure 2. American eelgrass (*Vallisneria americana*) founder colony sites were installed in Lake Austin, TX, in July 2015: (top-left, July 2015)—containerized American eelgrass used for initial establishment; (top-right, July 2015)—newly planted herbivore exclusion pen with secondary ring cage protection; (middle-right, August 2015)—vegetative spread/daughter plants from American eelgrass plantings; (middle-left, August 2015)—pen view at same time as previous photo; (bottom-left, September 2015)—vegetative spread/daughter plants from American eelgrass plantings along with native and non-native volunteers; (bottom right, September 2015)—pen view at same time as previous photo.

In addition to American eelgrass, volunteer vegetation was observed inside of pens of both mesh sizes at Sites 1 and 2 including hydrilla (tubers), southern waternymph (*Najas guadalupensis*, seeds), muskgrass (*Chara vulgaris*, spores), and sago pondweed (*Stuckenia pectinata*, tubers and/or seeds), indicating that tuber and seed banks remained viable in some areas of the lake (Figure 2). No volunteers were observed within either sized mesh at Sites 3 or 4.

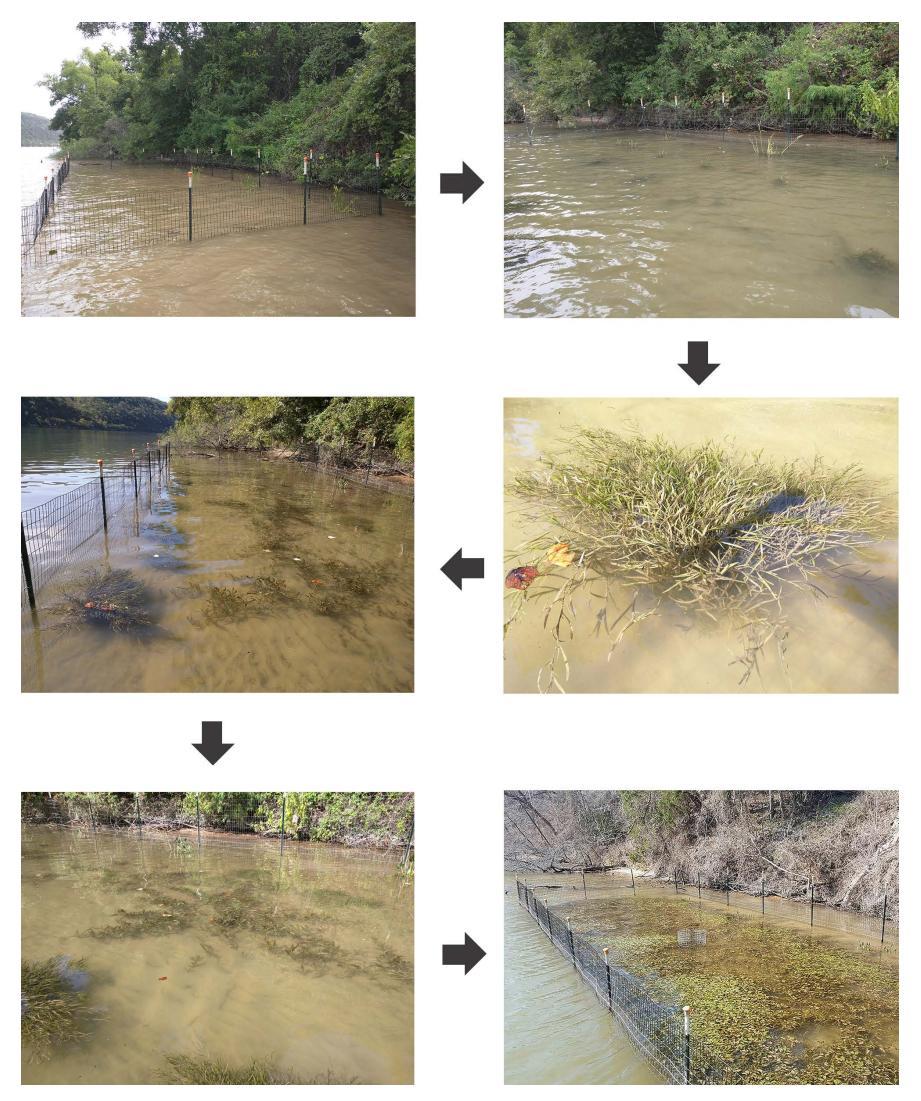
SM 1. The Site 5 founder colony site was installed in Lake Austin, TX, in July 2015: (top-left and right, July 2015)—newly constructed and planted pen; (middle-right, August 2015)—vegetative spread from grassleaf mudplantain (Heteranthera dubia) planting; (middle-left, September 2015)—total vegetative spread in pen grassleaf mudplantain and Il-linois pondweed (Potamogeton illinoensis) pictured; (bottom-left, September 2015)—total vegetative spread in pen grassleaf mudplantain and Illinois pondweed in pen grassleaf mudplantain and Illinois pondweed pictured; (bottom-right, February 2016)—total vegetative spread in pen Illinois pondweed dominated.

Site 5, also a large mesh pen, was planted with creeping burhead, American white waterlily, Illinois pondweed, grassleaf mudplantain, pickerelweed, and delta arrowhead. All plantings of those species were observed to have survived and were spreading during each of the three assessments, with greatest spread observed with grassleaf mudplantain and Illinois pondweed. The survivorship and spread of plants in the 5×10 cm mesh pen might be due to species—burhead pickerelweed, arrowhead—being too fibrous for small turtles to consume. The authors selected these species based upon their ability to persist in the presence of low grass carp densities [17].

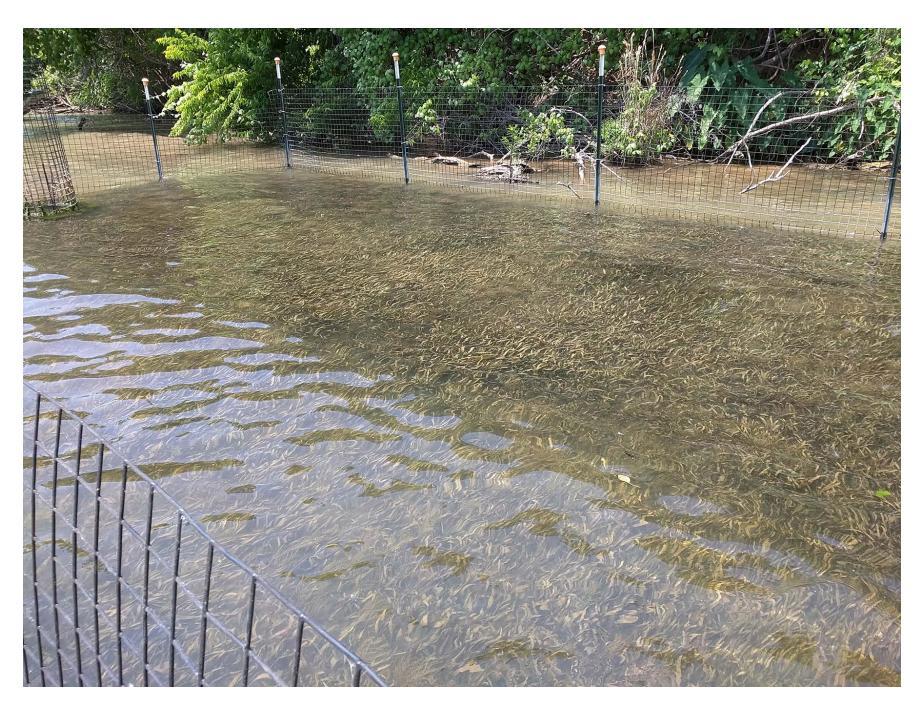
SM 2. American eelgrass (Vallisneria americana) full 5×5 cmmesh pen coverage (top) in May 2016, Lake Austin, TX.

Sites were assessed again in May 2016 for vegetation coverage; percent survival and percent grazed were not assessed due to the original transplants not being distinguishable from first year above ground spread and growth. Similar to the results in 2015, all 5×5 cm American eelgrass pens had coverages ranging from 90% - 100%. The 5 \times 10 cm pens in the southern Lake Austin reaches (Sites 1 and 2) were similar, but the pens at Sites 3 and 4 had American eelgrass coverages at 15% and 25% and total coverages at 65% and 85%, respectively. Coverages for both included volunteer hydrilla, bladderwort (Utricularia sp.), sago pondweed (Stuckenia pectinata), and Illinois pondweed, suggesting small turtles continue to gain access and graze selectively on American eelgrass (Table 5). Both the 5×10 cm American eelgrass pens nearest the dam (Sites 3 and 4), where cooler water is discharged into Lake Austin from Lake Travis, demonstrated less vegetative coverage. The 5×10 Site 5 pen was fully vegetated with Illinois pondweed (80%) being the dominate species after one year of establishment. Grassleaf mudplantain (10%), pickerelweed (15%), delta arrowhead (15%), and American white waterlily (1%) were also present (Supplemental Material).

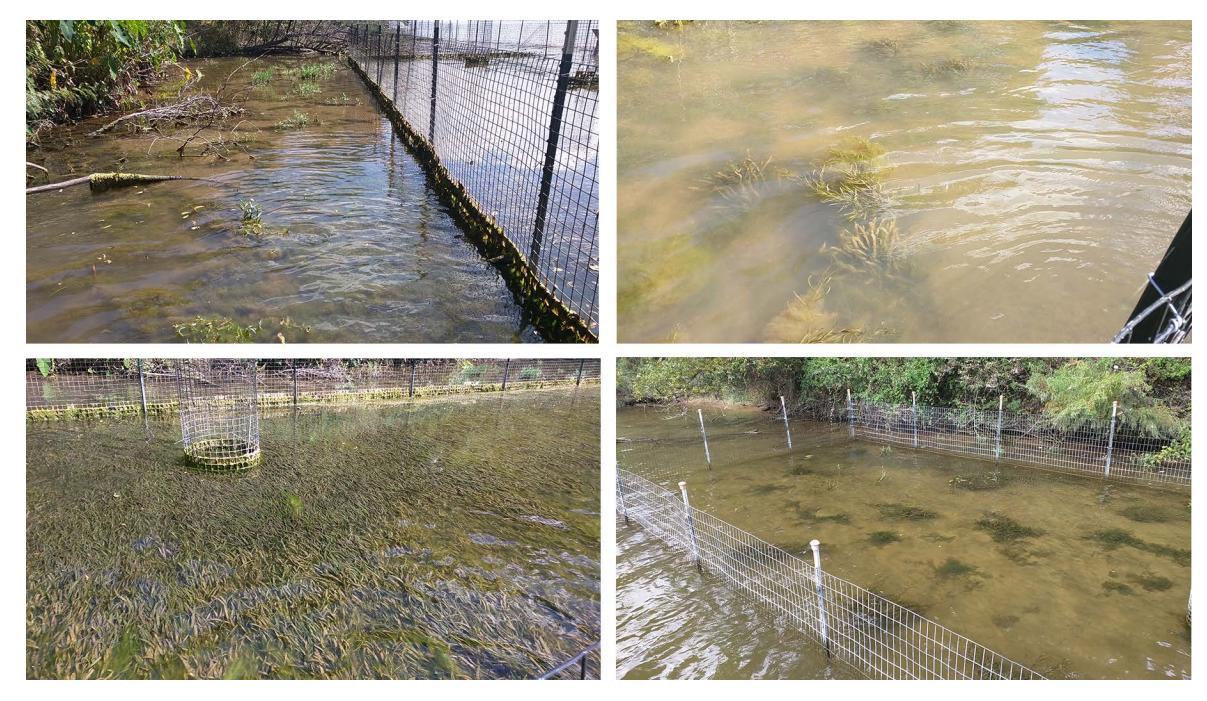
SM 3. Native aquatic vegetation established in pen expansion (top left and top right); dense vegetation establishment in 5×5 cm mesh pens (bottom left) and transplant survival and moderate spread in 5×10 cm mesh pens (bottom right, northern reaches), September 2016.

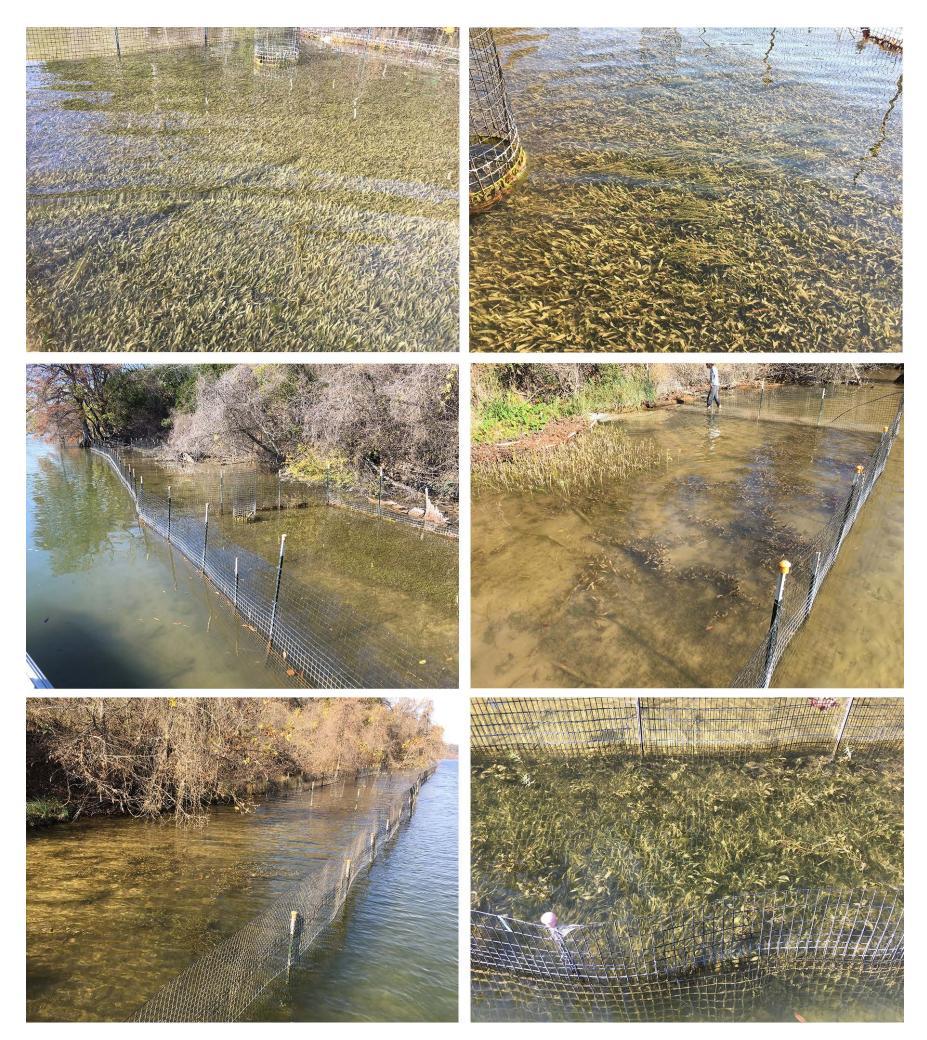
SM 4. Lake Austin restoration work assessment, December 2017; top left—original 2015 American eelgrass site, top right—small hydrilla recovery in protected areas indicated continued viable tuber and/or fragment bank, middle—functional protective sites near Commons Ford, bottom left—expanded megapen at Site 4, remained protective and functional, bottom right—2016 replanted pen with established aquatic vegetation.

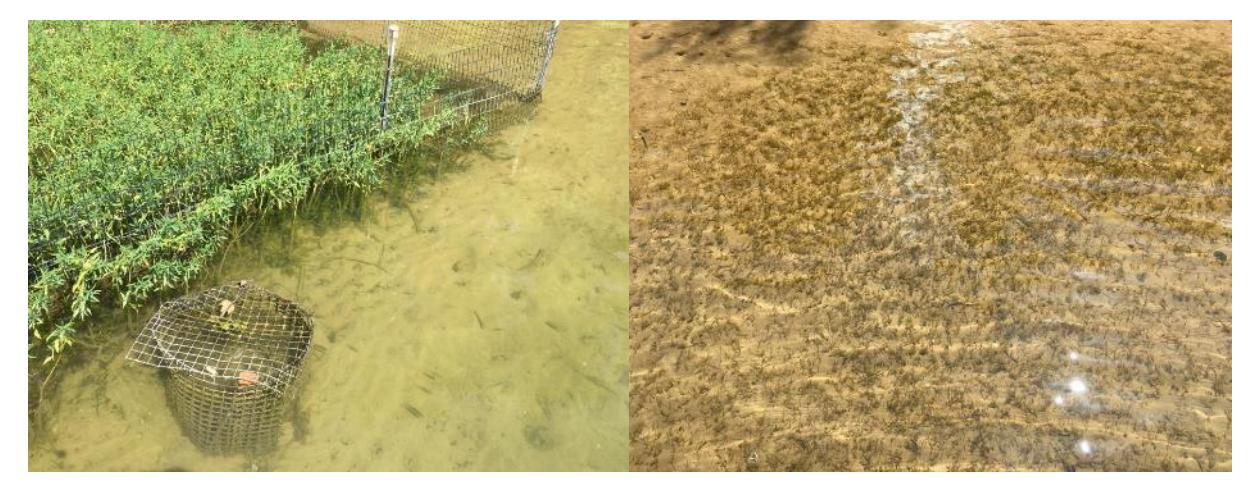
SM 5. Species beginning to spread beyond protective exclosures observed on Lake Austin, July 2017, left—American wa-terwillow, right—spikerushes.

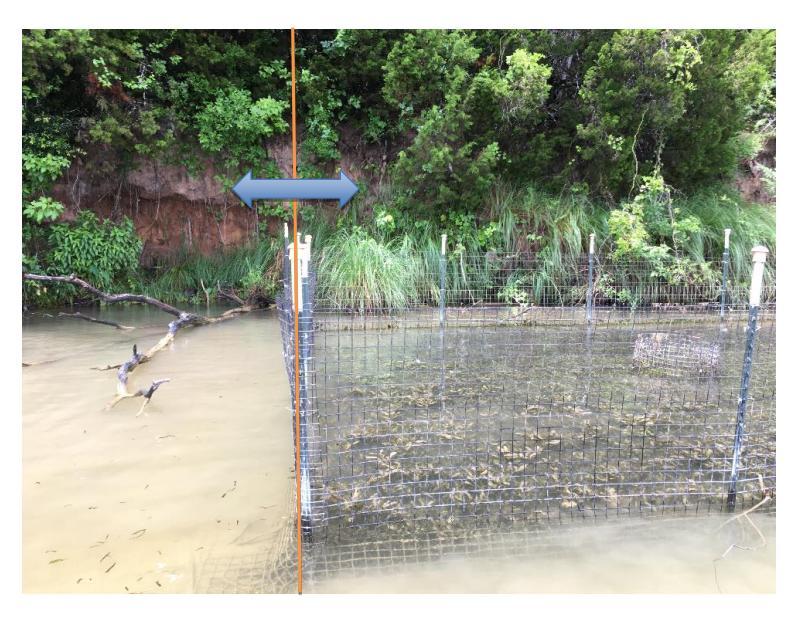
SM 7. Emergent/riparian vegetation appears to be more able to establish and spread behind founder colony protection, potentially due to reduction in heavy erosive-wave forces.

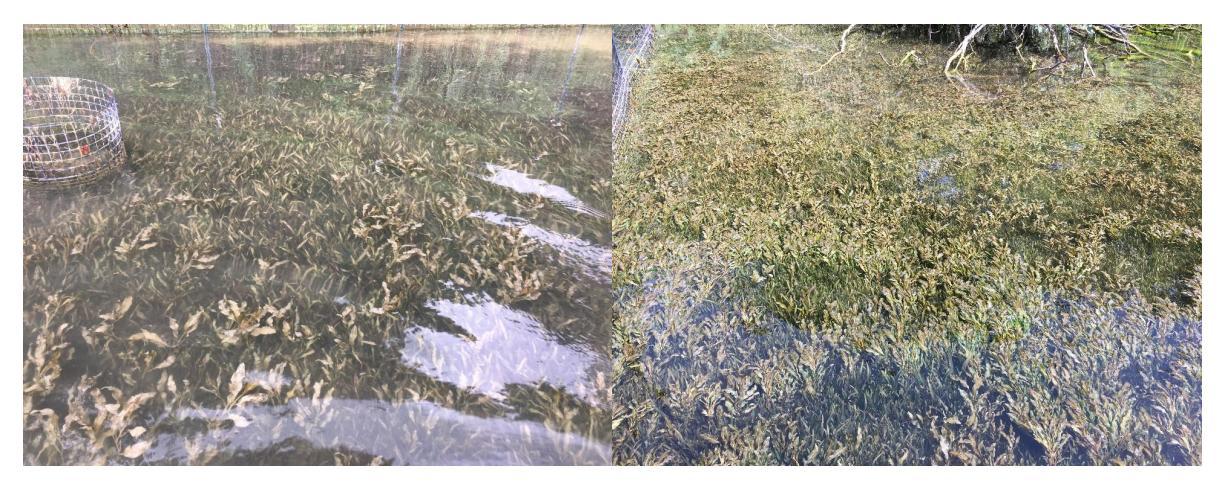
SM 8. Illinois pondweed establishment and spread condition as of June (left) and August (right) 2019.

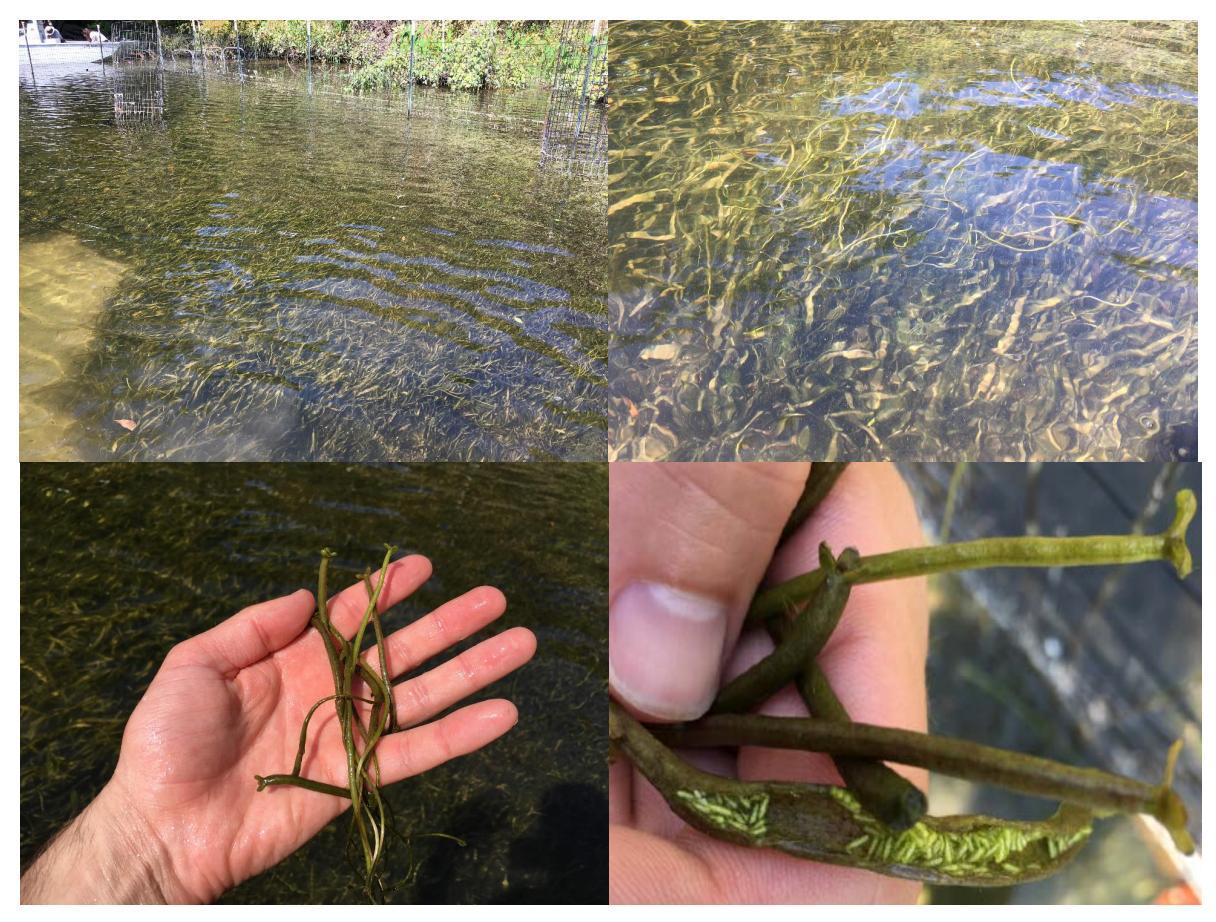
SM 9. American eelgrass establishment and spread condition, 2019. Pictured is occurring and observed sexual reproduction, a positive self-propagating sign.

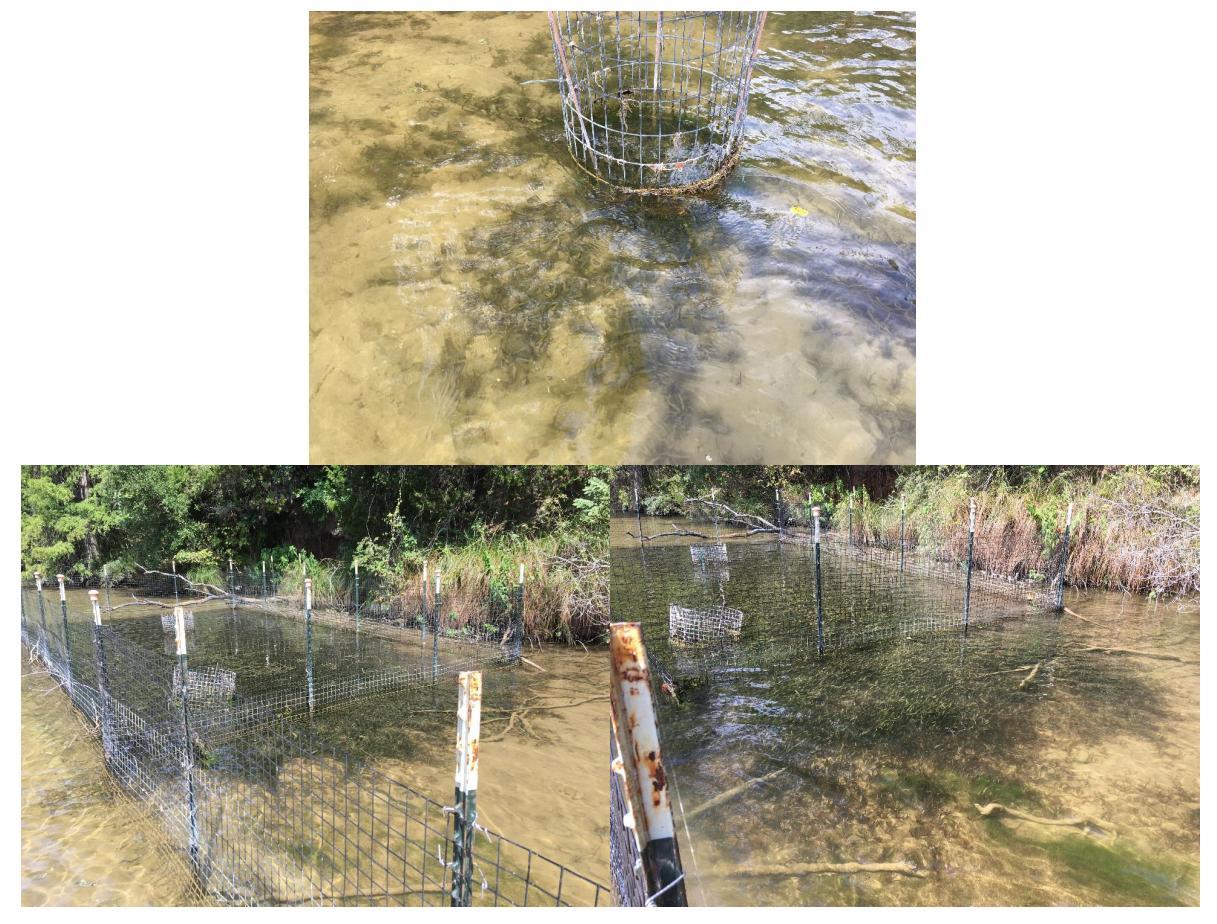
SM 10. American eelgrass spreading from protective exclosures—into other protected areas—post-herbivore-flood breaches. Bottom left to right, one month from August to September 2019.
