Geological and Geoengineering Properties of the 1997 Yangjia Shan Landslide, Enshi, China

Yangjia Shan instability has been evidenced by the occurrence of the July 16, 1997 landslide. The instability factor which leads to activating the landslide is the intense rainfall; lithology of Luoreiping Formation and the highly weathered slopes' rocks have played a great role in starting and aggravation. Weathering at the landslide site consists largely of attack on the cement and removal of support of the sandy mudstone and sandstone and decompose of shale. The weathering degree of the rocks decreases vertically with increasing depth from high, medium to slightly weathered corresponding to grade IV, III and II, respectively. The slip surface consists of moderate to highly weathered intercalated layers of sandy mudstone (mudstone) and shale, while, the layer below the slip surface is characterized by dark gray, moderately weathered and thick layered mudstone. The moderate to highly weathered lithology is probably attributed to the accumulation of the infiltrated rainfall water through fractures and porosity, raising the ground water level and wetting of the sandy mudstone and shale, lowere

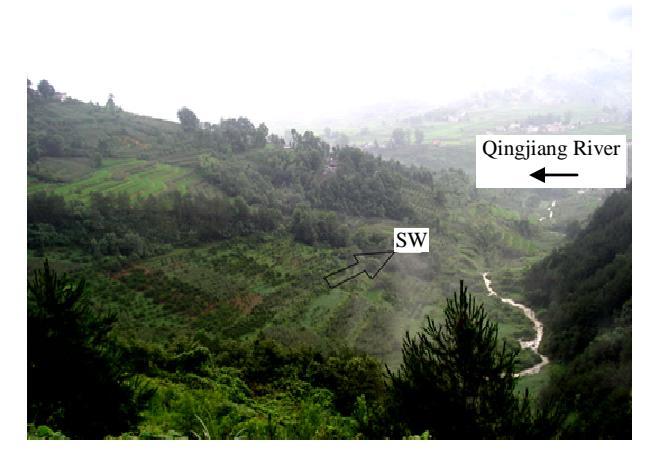
Figure 2. The small stream represents the western boundary of the Yangjia Shan landslide; it discharges into the Qingjiang River. SW (southwest) is the direction of Yangjia Shan landslide.

from the south, it incised into steeply wall rocky gorges and forms one of the upper reaches of larger subwater sheds that drain into the Yangtze River. Flows within the river are primarily in response to a combination of precipitation, karsts springs and groundwater seepage in the wet season, and springs and groundwater seepage in the dry seasons. Streams originated from the Yangjia Shan discharge their water into the Qingjiang River (**Figure 2**).

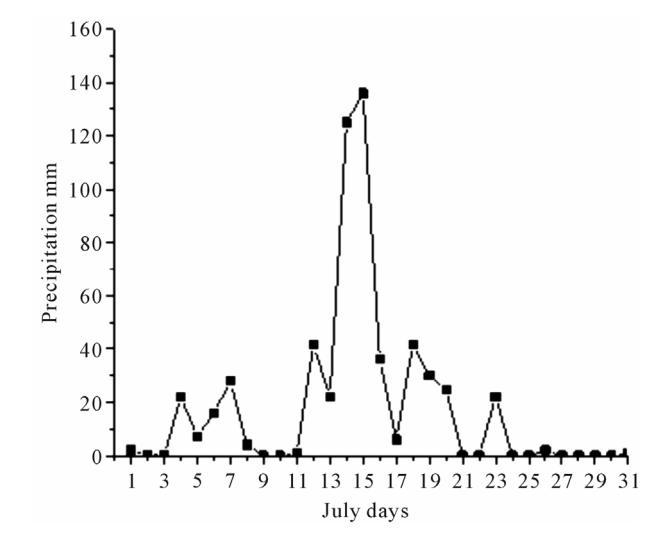
Figure 3. The maximum daily precipitation of Yangjia Shan on July, 1997.

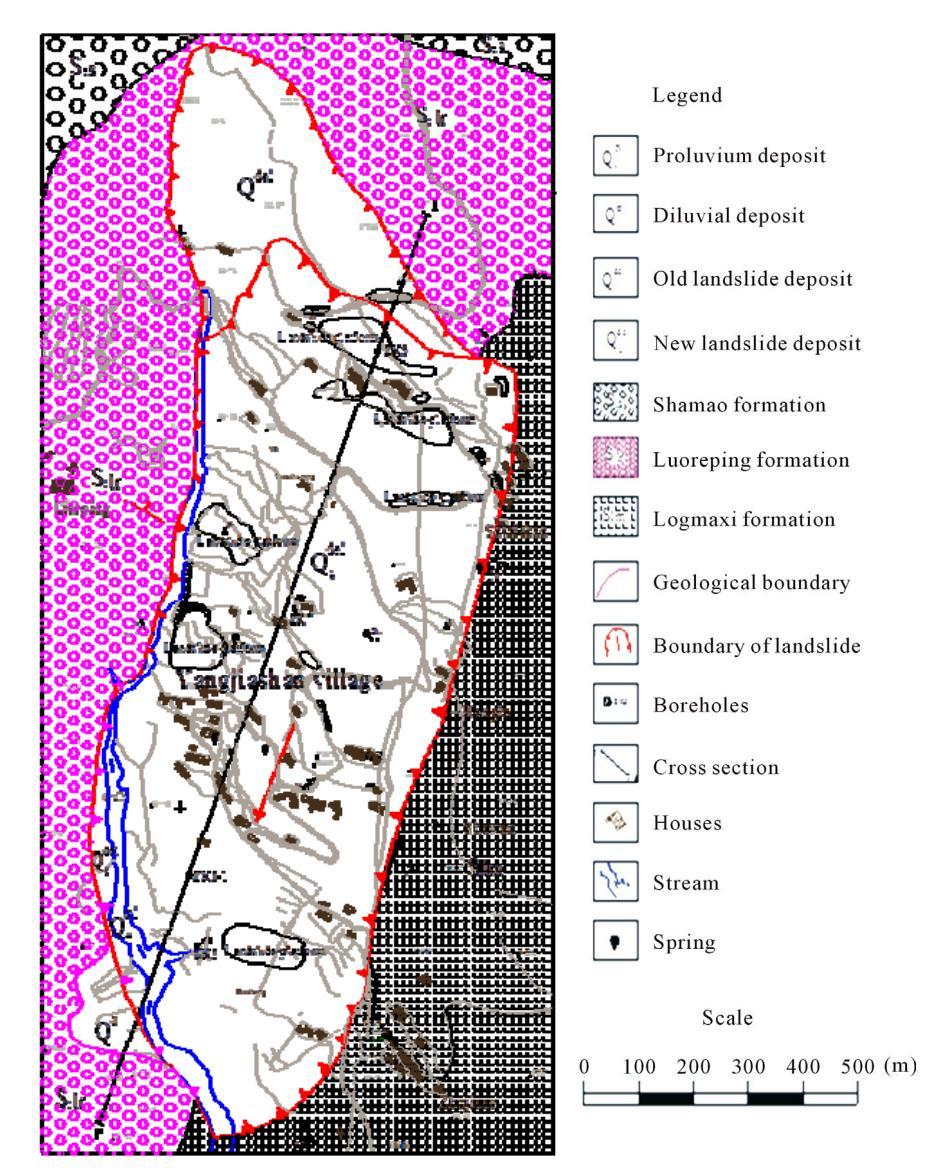
Figure 4. Engineering geological map of Yangjia Shan landslide.

Rocks of the Ordovician-Silurian Systems outcrop in the study area and its vicinity, their lithologies (**Figure 4**) mainly are carbonate, argillaceous and clastic rocks they are arranged chronologically in ascending order.

The Luoreping Formation is composed of yellow to green, thinly bedded sandy mudstone, thin to medium thickly bedded siltstone; fine to medium-grained sandstone contains iron oxides and carbonaceous material, sandy shale and dark gray shale with spider-shape structure. Their average dipping is 15°SW. The whole is alternating with each other. The rocks of this formation are very hard except the sandy mudstone (weak, fractured highly moisturized and the highly weathered is mixed with the Quaternary deposits) and shale, they are ductile and easily broken into irregular shapes, some varieties are of medium hardness. The lithology of this formation is responsible for the two events of the landslide (**Figure 4**).

The Longmaxi Formation (Figure 4) is composed of black and yellowish-green graptolitic shale. Its top which is the lower part of the Luoreiping Formation is drawn at the appearance of abundant shelly fossil-bearing silt mudstone with nodules. The Longmaxi Formation is further divided into a Lower Black Shale Member, and an Upper Yellowish-green Shale Member [15]. The Black Shale Member is a set of black shale, the upper part of which gradually weathers into gray black shale. There is also gravish-black thin-bedded siliceous rock with shale. On the other hand, the Yellowish-green Shale Member consists of yellowish-green shale, and sandy shale with a few sandstone bands, and few shelly fossils. The uppermost zone can, however, range up to the Luoreiping Formation. The average dip of the formation is 22°SW. The rocks of this formation apparently look strong, tough and slightly to moderately weathered than Luoreiping Formation.

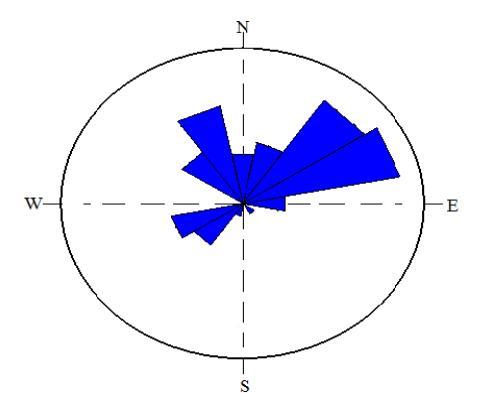
Figure 5. Rose diagram of strike trends of fractures showing their relative prevalence.

The rocks at the area of study are characterized by having different sets of fractures more or less parallel and regularly spaced; their spacing varies from narrow to wide. The horizontal fractures are coinciding with the bedding planes of sandy mudstone, shale, sandstone and siltstone. The successive distances between fractures are varied; they range from 20 cm to 130 cm and their width range from 1 mm to 7 cm. The length of some fractures exceeds 100 cm, run in two sets in rare cases cross each other. Most of the studied fractures can be described as tight, partly open or have very clear visible cavities. The cavities are either empty or filled by clays and/or rock fragments. Their surfaces are wavy, smooth, rough or weathered. Their set frequency increases with proximity to the tectonic plane. In case of tight fractures, the rupture is quite apparent to the naked eye, though the walls of the fractures are brought together to such an extent that it becomes impossible to see the cavity along the rupture [18]. Blind and refilled fractures by iron oxides, calcite and clays are not uncommon. The measurements of the strikes of the fractures were plotted using rose diagram, with the aim of establishing the predominant orientation of the fractures (Figure 5). The genesis of the fractures is probably tectonic in origin.

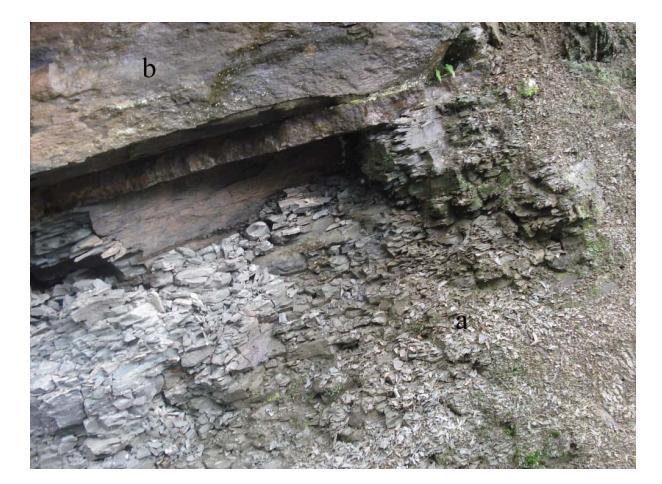
Figure 7. (a) Highly weathered (below) and (b) moderately weath ered shale, Yangjia Shan landslide.

Weathering at the landslide site consists largely of attack on the cement and removal of support of the sandy mudstone and sandstone and decompose of shale (**Figure 7**), siltstone and limestone. The clay matrix and sandstones weather by breaking down and elevations of clay. The petrographic study indicated that there is mineral alteration occurred to the plagioclase and K-feldspar. The alterations attribute to the action of the penetrating water

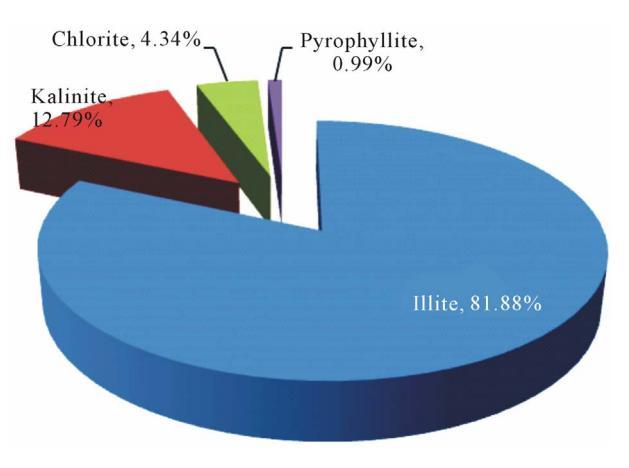
Figure 8. Clay minerals % of Yangjia Shan landslide.

Landslide material properties were determined on samples collected from the different locations of the landslide area by laboratory tests. Disturbed samples were collected for grain-size analyses, Atterberg limits, water content and specific gravity tests according to ASTM standards [27]. In addition, the X-ray diffraction analysis was carried out in order to identify and semi-quantitatively deduce the percentages of the different clay minerals present in the soil of the landslide at China University of Geosciences Central Laboratory using a Philips diffractometer. The XRD analysis revealed that, the soil samples composed of four clay minerals (Figure 8), their dominant availability is: Illite (occurs in most of the examined samples throughout the study intervals), Kaolinite, Chlorite (is authigenic formed by the alteration of biotite as detected in some thin sections) and Pyrophyllite, respectively.

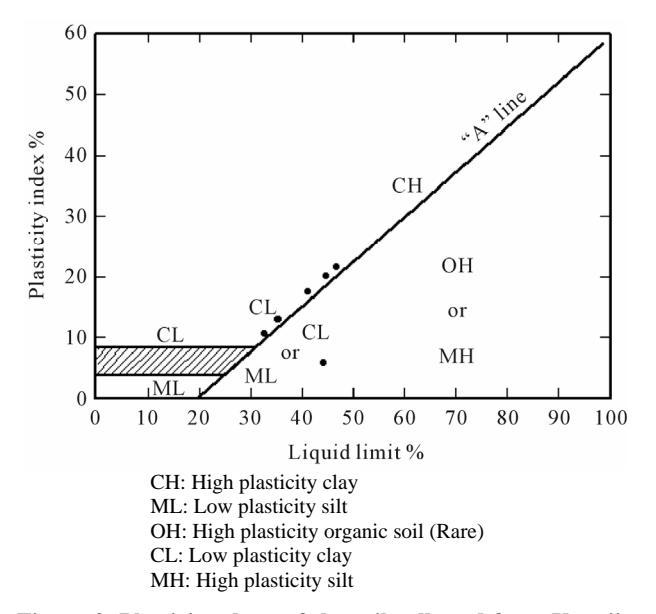
Figure 9. Plasticity chart of the soil collected from Yangjia Shan landslide.

The plastic properties of the fine soil material are expressed in terms of liquid limit (LL), plastic limit (PL) and plasticity index (PI), as first proposed by Atterberg. These limits control the consistency of the soils as wetting conditions change. The liquid limit (LL) ranges from 5.32% to 49.86% for the soil samples, the plastic limit (PL) from 33.82% to 23.32% and the plasticity index from 4.11% to 18.87%. Therefore, the liquid and plastic limits of the soil samples can be classified as low to medium plasticity and in terms of plasticity; it can be classified according to [29] as: slightly to moderate plastic inorganic clay (CL) (Figure 9). The results of the XRD analysis and Atterberg limits showed that, the slightly to moderately plastic inorganic clay indicates the existence of inexpansive clays in the soil of the Yanjia Shan landslide.

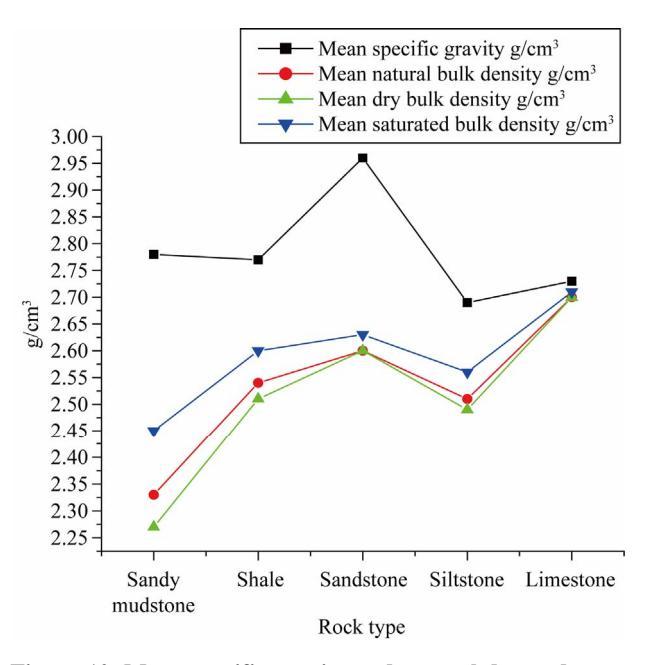
Figure 10. Mean specific gravity and natural dry and saturated bulk densities of Yangjia Shan rocks.

stone, were determined. The mean values of the specific gravity and bulk densities fall within the normal range given to the rocks (**Figure 10**).

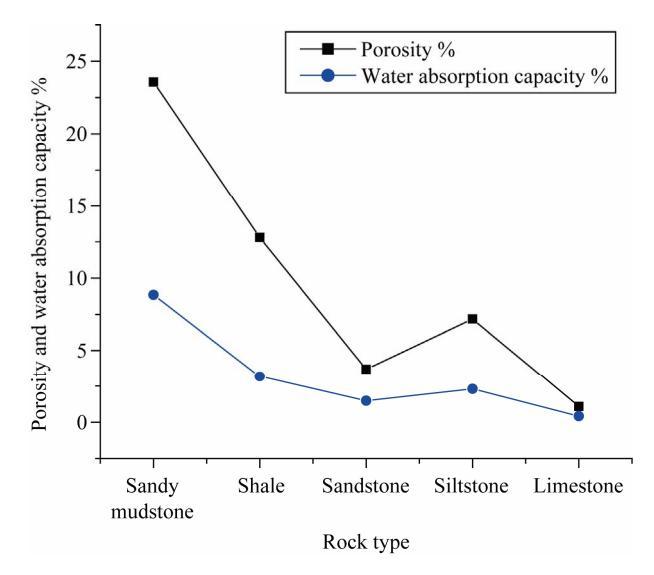
Figure 11. The mean porosity, specific gravity and water absorption capacity of Yangjia Shan rocks.

Porosity is one of the important physical properties that govern physical attributes of rocks such as moisture content and strength. Weathering processes cause progressive changes in rock porosity due to change in pore size distribution, pore geometry, pore connectivity, pore infilling and new pore formation. In sedimentary rocks, porosity depends on grain size, shape of the grains, degree of sorting, and degree of cementation. Highly fractured solid rocks, however, could have high porosity. The nature of the fluid or fluids that flow through the pores between the grains often determines changes to the pores and porosity as does the composition of the grains and their chemical stability. The sandy mudstone and shale have recorded the highest porosity compared with sandstone, limestone and siltstone (Figure 11). The low porosity of the sandstone can be attributed to the nature and characteristics of the sand and cement that accumulates after deposition. The limestone and siltstones are silicified, compact and tough due to their location near to Enshi fault zone.

The water absorption capacity of the sandy mudstone, shale, sandstone, siltstone and limestone is carried out to determine whether there is a relation between the natural porosity and the water absorption for the mentioned rocks. As seen in **Figure 11**, the sandy mudstone and shale showed high susceptibility to absorb water than siltstone, sandstone and limestone. There is a significant correlation between the porosity and water absorption for the Yangjia Shan rocks, the sandy mudstone and shale rocks have relatively higher porosity therefore, they have

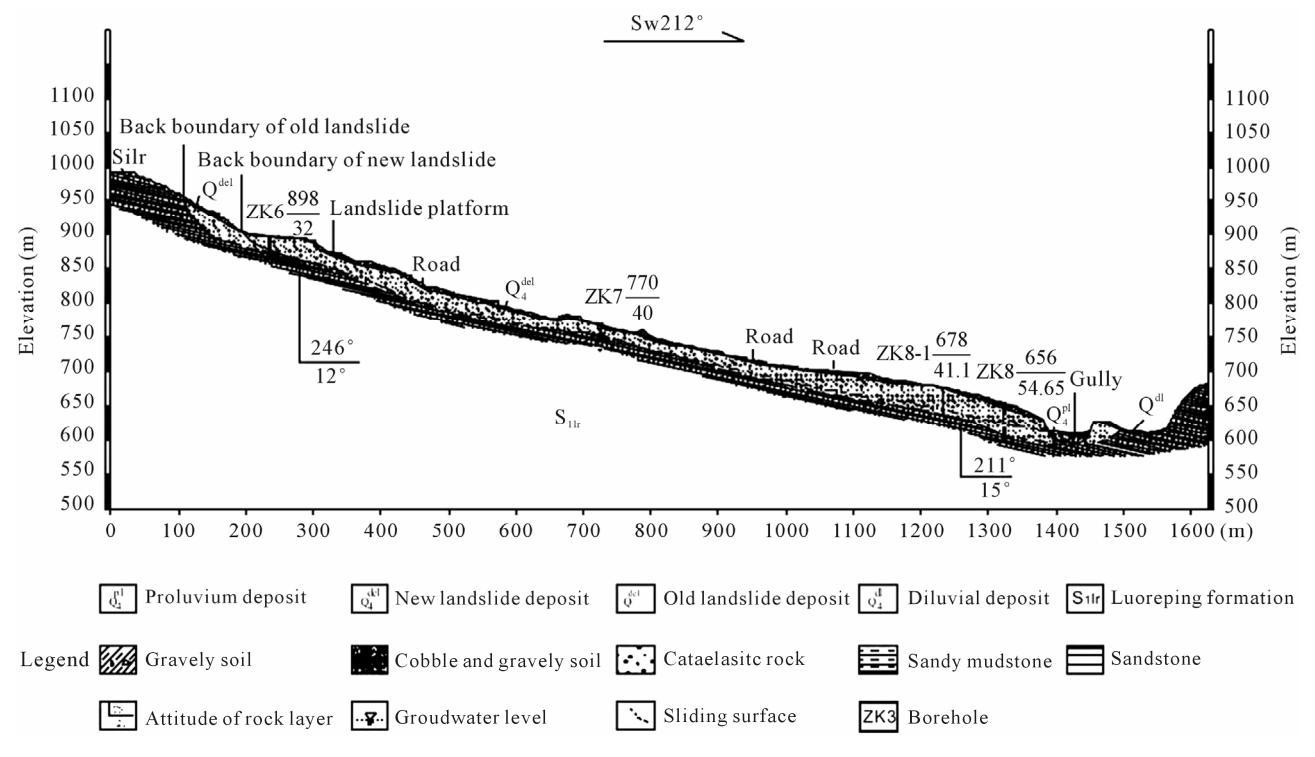
Figure 12. NE-SW geological cross-section along Yangjia Shan landslide.

To explore the body of the landslide from the top till below the slip surface, five exploratory boreholes (ZK6, ZK7, ZK8-1, ZK8 and ZK9, the latter borehole is situated east of ZK8) were drilled along the landslide from NE to SW (Figure 12). The log description of the boreholes gave the details of the slip surface, the geological structures and the hydrogeological characteristics of the landslide. The core logs from the whole boreholes contained slickensided and striated surfaces, deformed structure, fine-grained particles, which is generally range from 10% - 30%, rock fragments and ferruginization at 23.7 m, 17 m, 39 m, 49 m and 12.8 m depth, respectively. The deformed layers were considered as the slip surfaces. The slickensided surfaces were generally undulating but occasionally planar. The thicknesses of the slip zones normally vary from 0.4 m to 1 m. Notably, although materials of the slip zones could be visually identified as finegrained soils, they contain significant amount of gravelsized rock fragments. The slip surface consists of moderate to highly weathered intercalated layers of sandy mudstone (mudstone) and shale. The layer below the slip surface is characterized by dark gray, moderately weathered and thick layered mudstone. The 1997 landslide has initiated its activation from the same slip surface of the early 1980 landslide.

Water has been observed in the drilled boreholes (ZK6, ZK7, ZK8-1, ZK8 and ZK9) at several depths 24.9 m, 18.0 m, 32.0 m, 47.12 m and 11.6 m, respectively (Figure 3). Several ponds were formed in the low lying parts of the deposits. They are of two types; artificially formed by the local farmers and naturally formed by the intense rainfall. Very quick stream runs from the northeast to the southwest, it represents the western boundary of the landslide within Luoreping Formation; it drains the mountain's water during rainfall into the Oingjiang River. The stream forms a permanent channel with plenty of water; it erodes and washes away the sediments and highly weathered rocks down slope. It is narrower at the top and wider at the confluence with the Qingjiang River; the width and depth of the stream is approximately 4 m and 2 m, respectively. [30] mentioned that, the in situ rainfall infiltration at a hillside it will flow laterally; a portion of water will infiltrate further down to join the regional groundwater in the form of matrix flow. Therefore, the infiltrated rainfall water through fractures and the porosity of the lithology, accumulate at the subsurface and then lead to increase the groundwater water level, wetting and absorption of water and degree of weathering of the sandy mudstone and shale rocks of Luoreping Formation. Moreover, the infiltrated rainfall probably, lead to increase the rocks weathering, porewater pressure and lowered the shear strength, thus leading to increase of the driving force of the slope and landslide susceptibility.
