Bridge Girder Crack Assessment Using Faster RCNN Inception V2 and Infrared Thermography

Manual inspections of infrastructures such as highway bridge, pavement, dam, and multistoried garage ceiling are time consuming, sometimes can be life threatening, and costly. An automated computerized system can reduce time, faulty inspection, and cost of inspection. In this study, we developed a computer model using deep learning Convolution Neural Network (CNN), which can be used to automatically detect the crack and non-crack type structure. The goal of this research is to allow application of state-of-the-art deep neural network and Unmanned Aerial Vehicle (UAV) technologies for highway bridge girder inspection. As a pilot study of implementing deep learning in Bridge Girder, we study the recognition, length, and location of crack in the structure of the UTC campus old garage concrete ceiling slab. A total of 2086 images of crack and non-crack were taken from UTC Old Library parking garage ceiling using handheld mobile phone and drone. After training the model shows 98% accuracy with crack and non-crack types of structures.

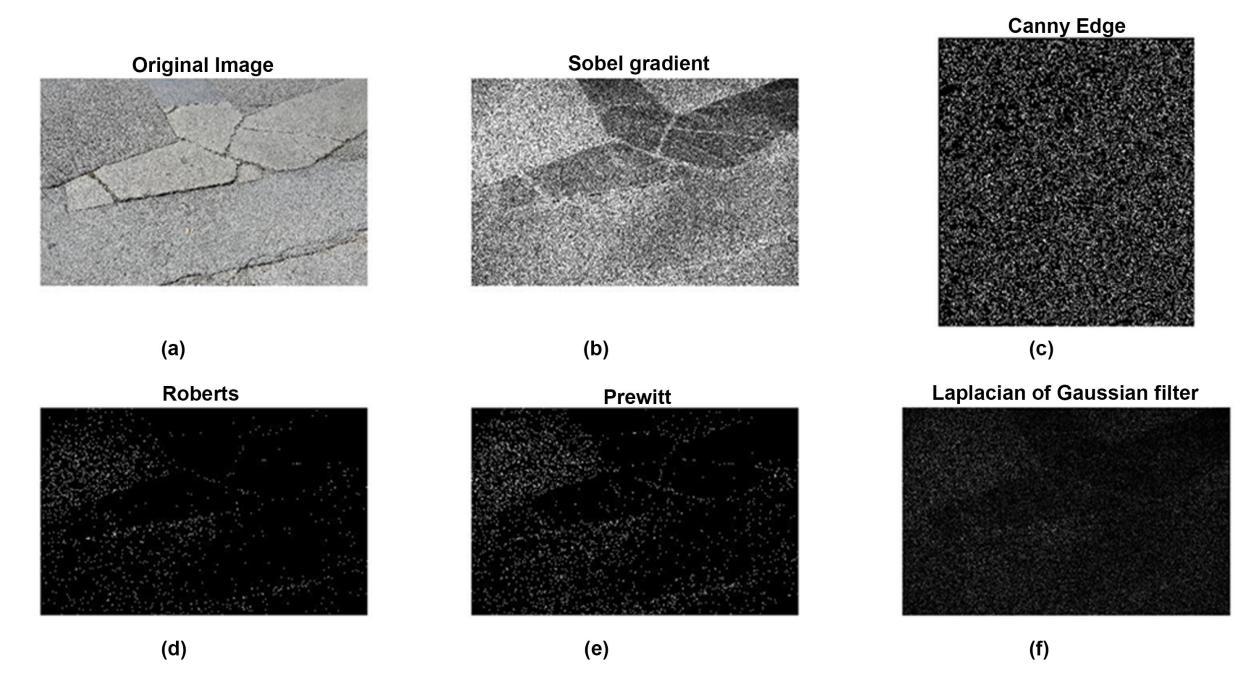
Figure 1. Crack detection using (b) Sobel, (c) Canny edge, (d) Roberts, (e) Prewitt, and (f) Laplacian of Gaussian filter detection.

We used Sobel, Canny edge, Roberts, Prewitt, and Laplacian of Gaussian filter detection algorithms to detect crack from a hand mobile phone capture image. But all the algorithm failed to produce satisfactory result to identify the crack as shown in **Figure 1**. With the same image, we used different corner detection algorithm such as BRISK Feature Corner Detection, Harris Feature Corner Detection, FAST Features Corner Detection, Min Eigen Features Corner Detection, MSER Features Corner Detection, SURF Features Corner Detection, Extract Corner Features, HOG Features Extraction around corner point. Although some of the corner detection algorithm shows better detection compared to **Figure 1** algorithms, some of the algorithm's detections are over-exceeded as shown in **Figure 2**.

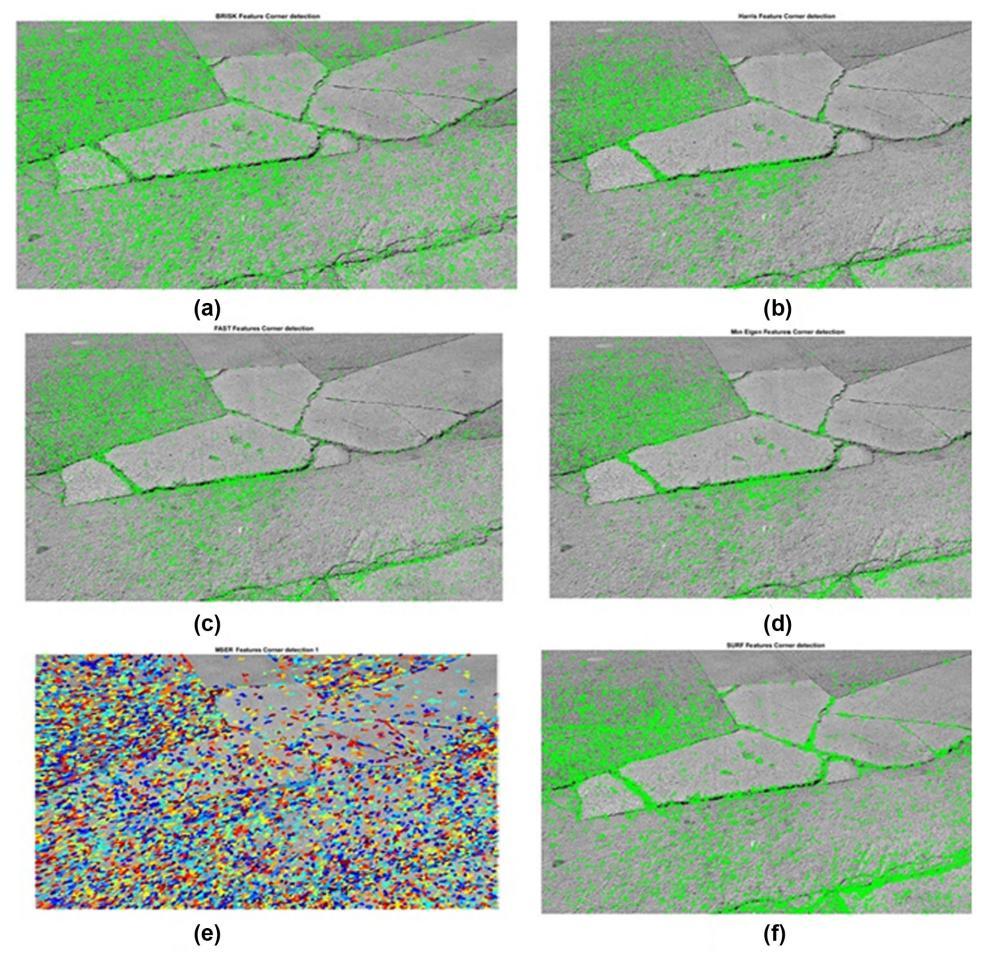
Figure 2. (a) BRISK Feature Corner Detection, (b) Harris Feature Corner Detection, (c) FAST Features Corner Detection, (d) Min Eigen Features Corner Detection, (e) MSER Features Corner Detection, (f) SURF Features Corner Detection, (g) Extract Corner Features, (h) HOG Features Extraction around corner point.

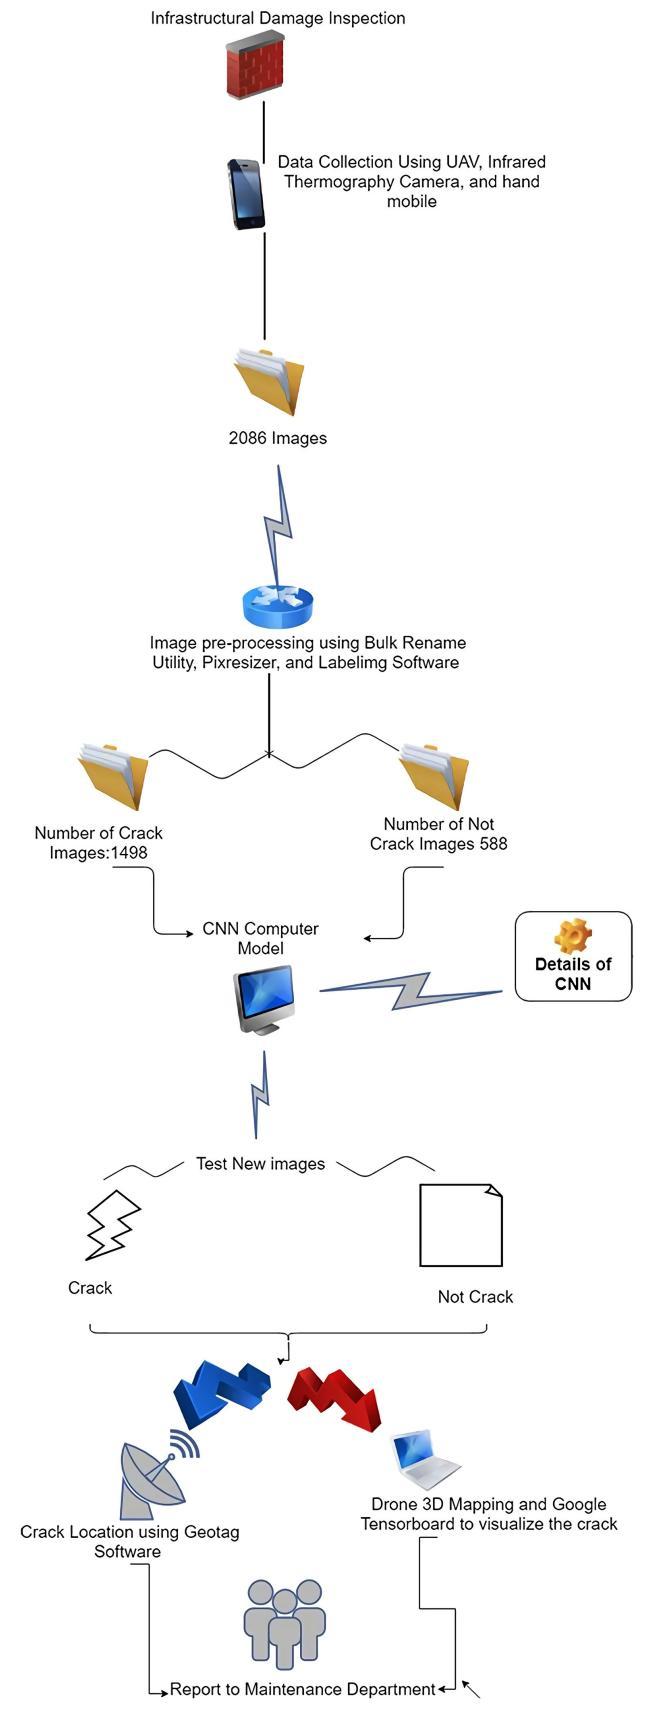
Figure 3. A conceptual framework of data acquisition and model training.

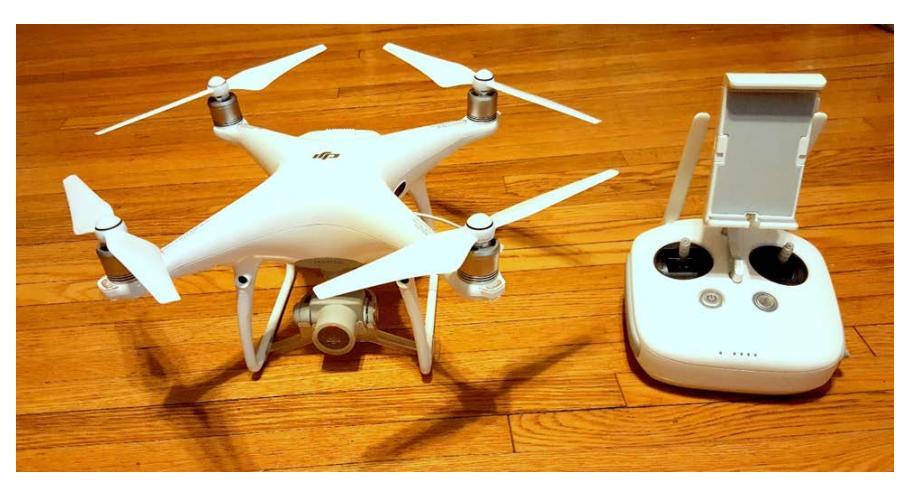
Figure 4. DJI Panthom 4 pro Drone.

In this work, we used UAV (*i.e.* drone) to get access to bridge or anywhere we need to collect images from. With the drone a FLIR 6.8 mm f/1.3 thermal imaging camera were incorporated to capture the thermal images, damages inside

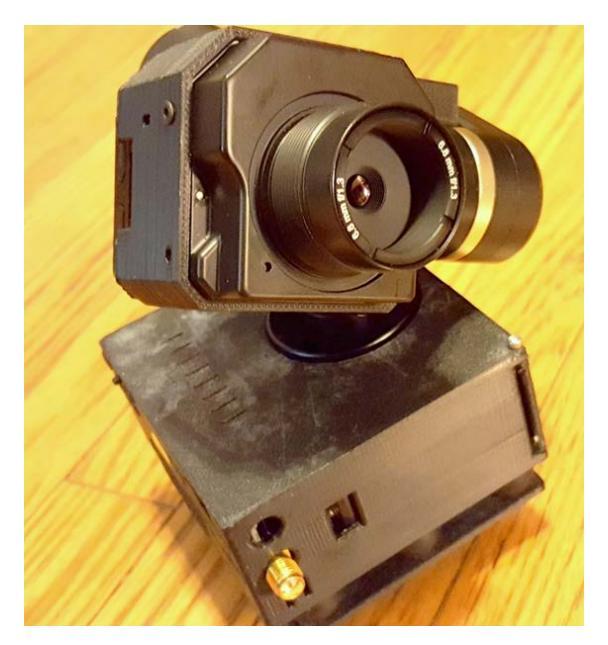
Figure 5. 6.8 mm f/1.3 thermal camera.

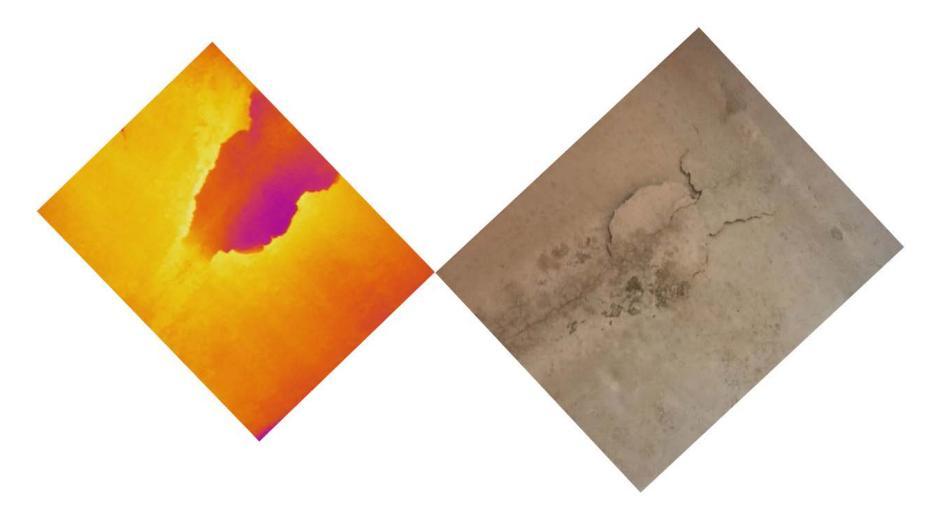
Figure 6. Comparison of the Infrared image and the naked eye image.

structural components can be identified, classified and evaluated. A short tutorial was made for the demonstration of data acquisition in this YouTube video link (https://www.youtube.com/watch?v=q4ZDH7MDh9E). A total of 2088 images of crack and not-crack were collected [37]. All the images were split into two groups of images: one for training and the other for testing or validation purpose. In the next step, a neural network model was developed and compared it with a commercially available deep convolutional Neural Network by using the labeled training images. Finally, the trained network applied to classify unknown images. **Figure 3** shows the conceptual framework of data acquisition and model training. **Figure 4** and **Figure 5** show the DJI Panthom 4 pro Drone and the infrared thermal camera respectively. The difference between the infrared image and the naked eye image were shown in **Figure 6**.

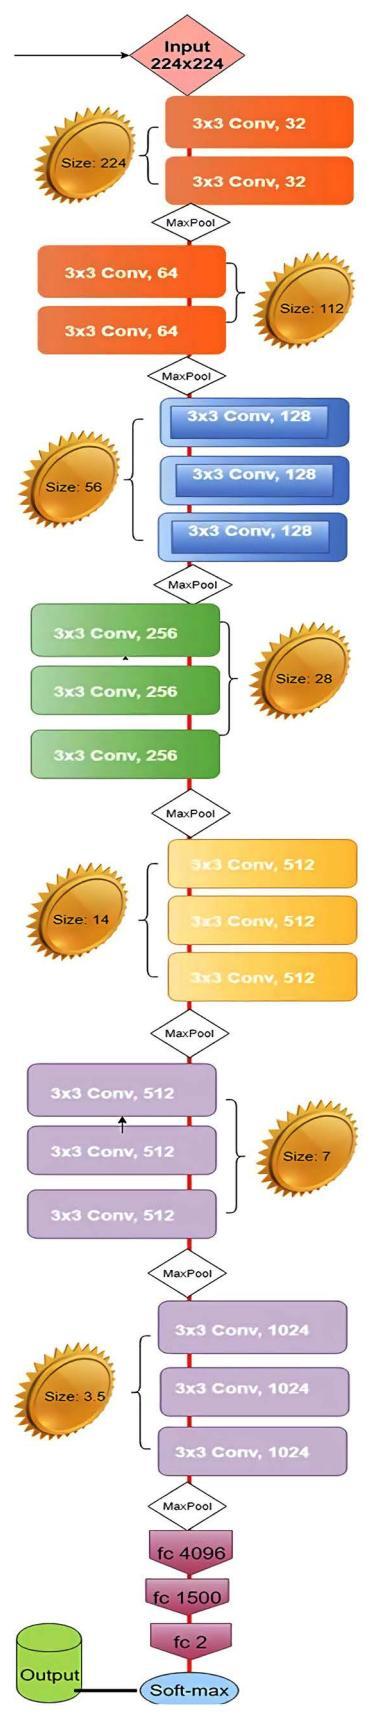
Figure 8. VGG-22 model.

A 22-layer (20 hidden layer, one input layer and one output layer) convolution model was developed names as Visual Geometry Group (VGG 22). During the training process, different ratios of train vs. test images were implemented. One example is 1668 images used for training the model and 418 images used for validating purpose. The input size of images was maintained as $224 \times 224 \times 3$ (height × width × channel). In **Figure 8**, the VGG 22 model architecture is described.

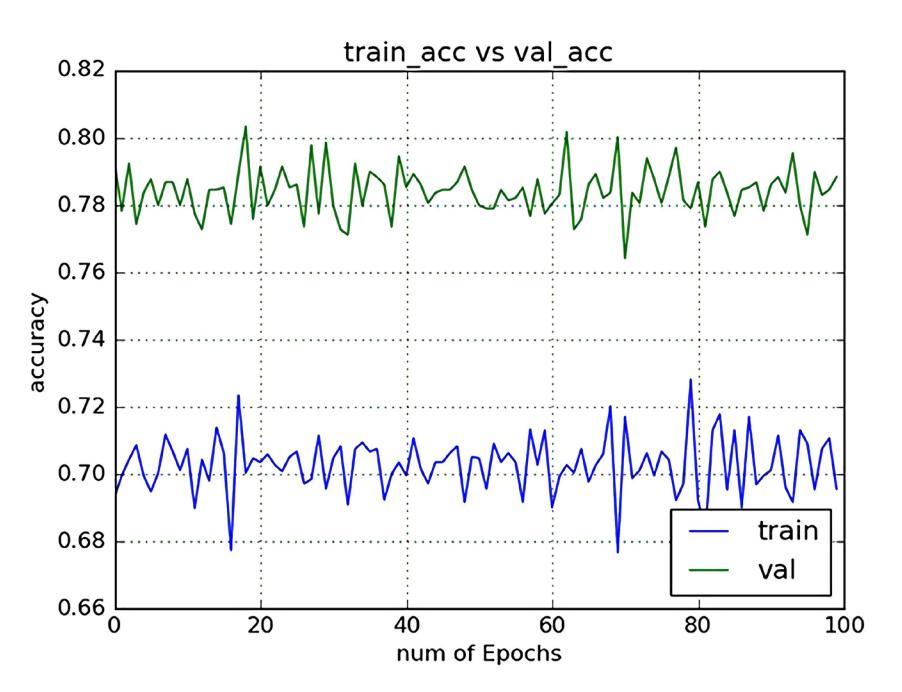
Figure 10. VGG-22 training vs. validation accuracy with respect to number of epochs.

The VGG-22 model shows 80.35% validation accuracy and 70.03% training accuracy at 19th global steps. The faster RCNN with Inception V2 shows 99% confident at 60 k global steps. A test image was provided in the faster RCNN and the model successfully detected the crack and non-crack structure with an average confident 99% as demonstrated in **Figure 19**. The 99% confidence means the trained model is 99% confident to classify the crack and non-crack image which is the best confident model percentage.

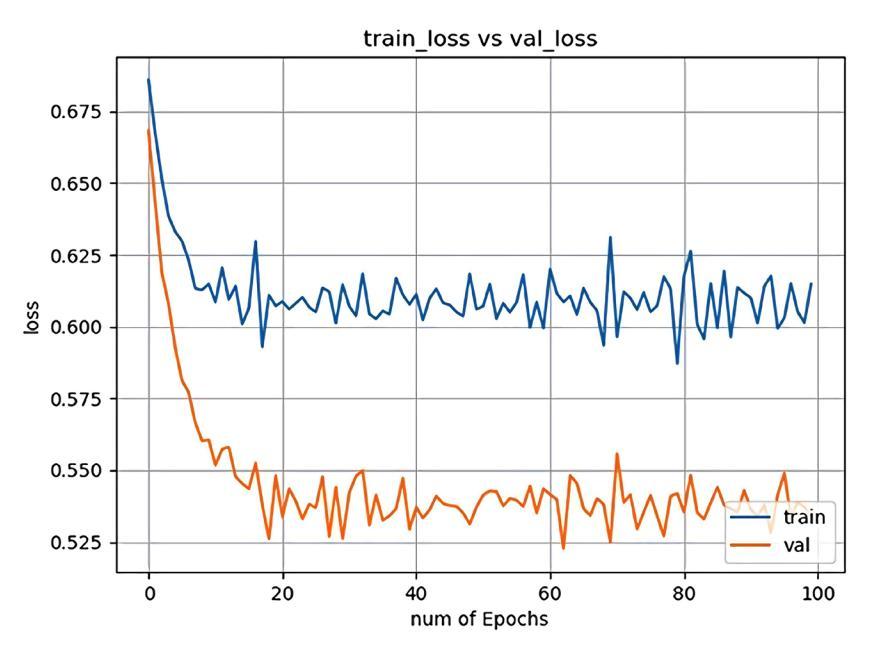
Figure 11. VGG-22 training and validation loss with respect to number of epochs.

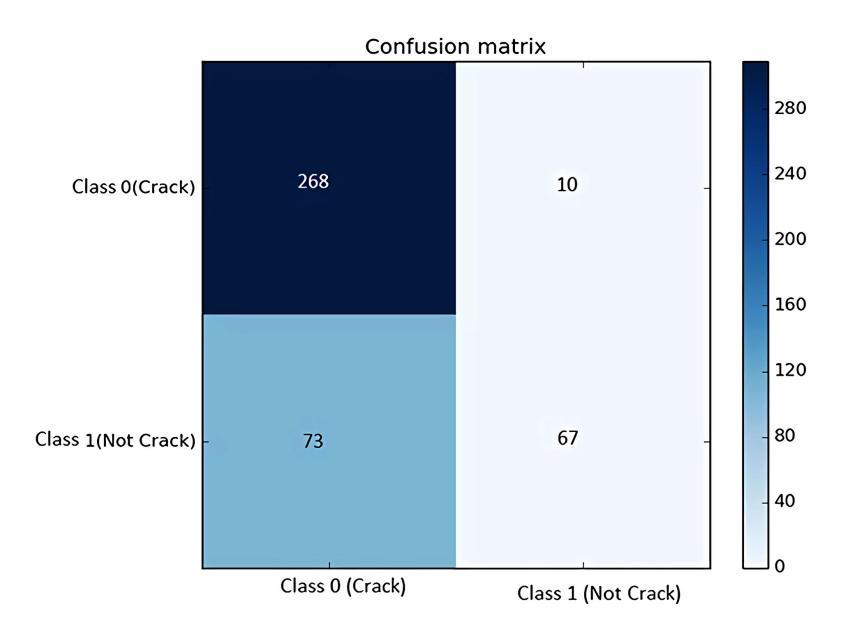
Figure 12. VGG-22 confusion matrix.

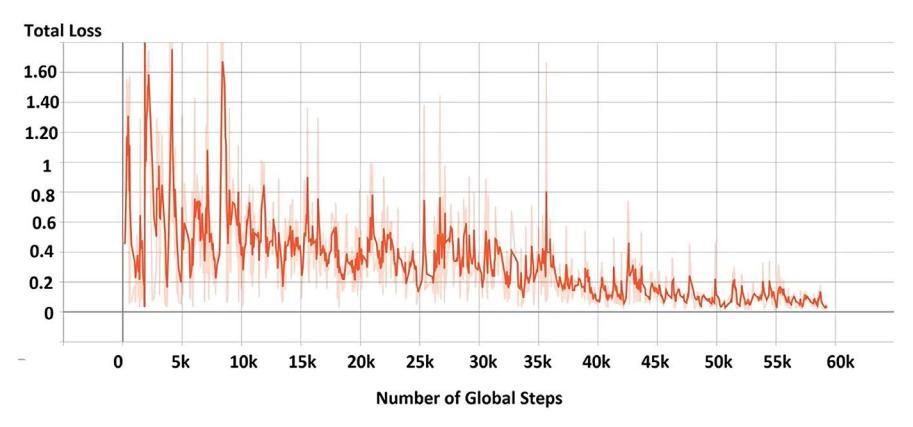
Figure 13. Faster RCNN total loss vs. global steps.

The feature extractor defines as the pattern recognition image processing algorithm. The input image size was taken as 838×600 . The model was trained up to 60 k global steps. After the training, the model reached almost zero loss as shown in **Figure 13**. In **Figure 14**, the localization loss and in **Figure 15** localization loss were shown compared to number of global steps.

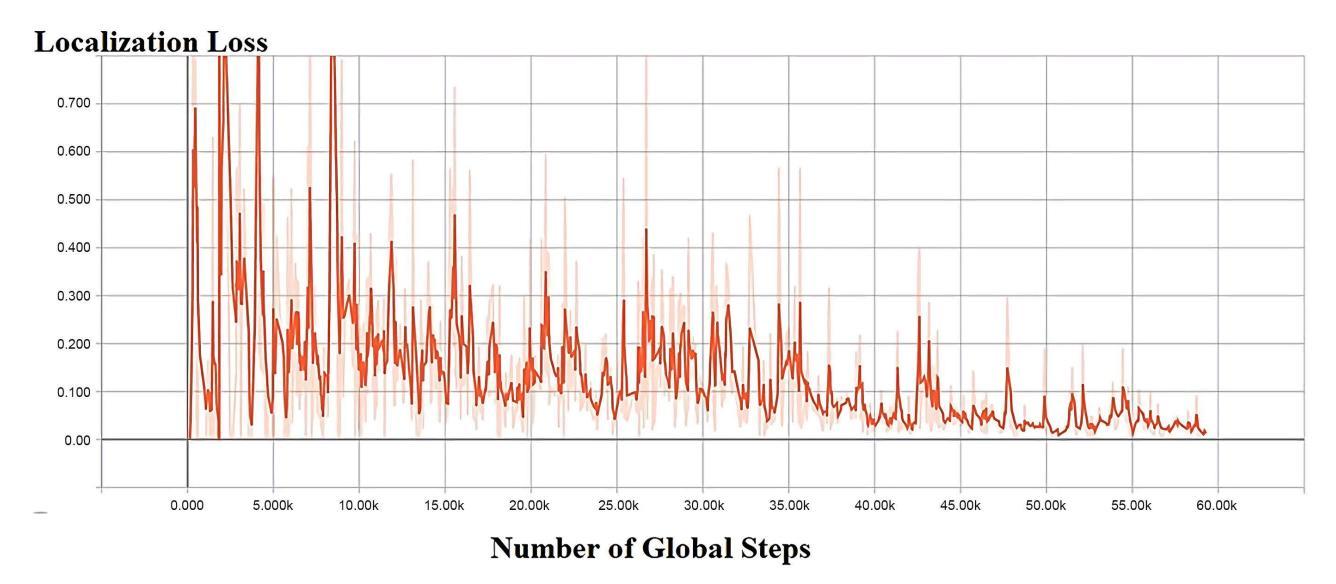
Figure 15. Faster RCNN localization loss vs. global steps.

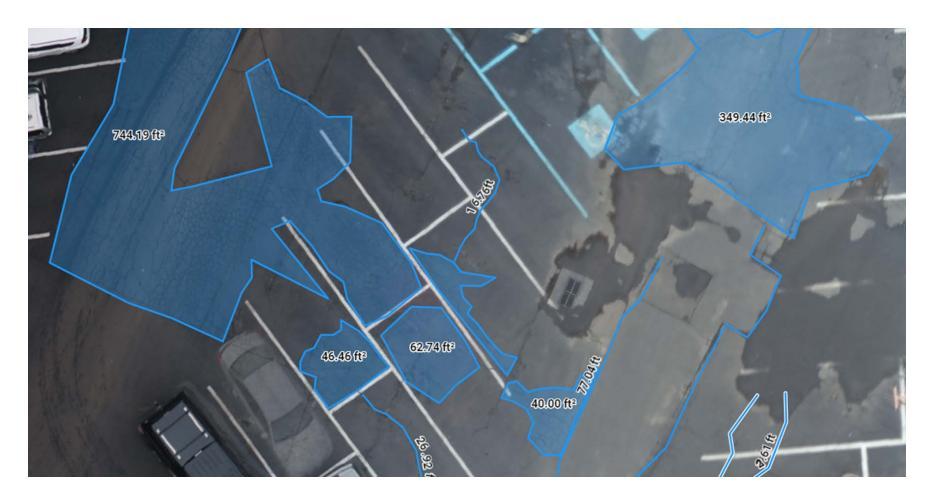
Figure 18. Length and area of crack.

3D Drone mapping was used to determine the area and the length of cracks. Pix4D software was used to process the aerial photogrammetry images into 3D modelling. Using Pix4D software dimension tool the cracks measurement was completed as shown in **Figure 18**.

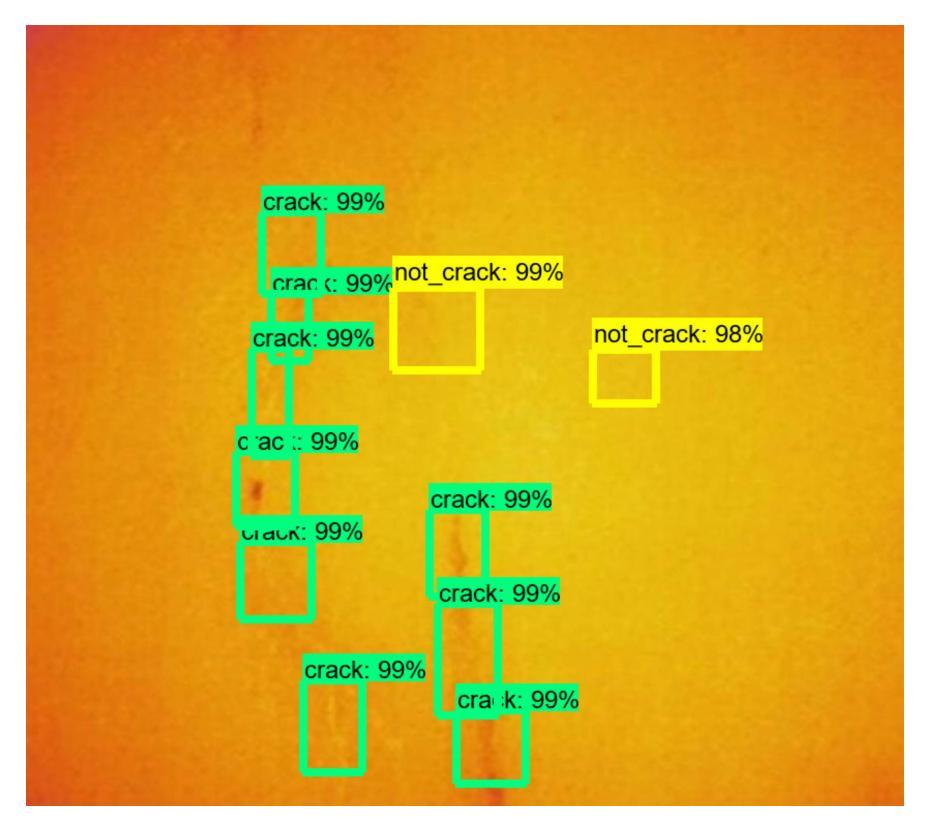
Figure 19. Crack detection using infrared thermography.
