# An Unusual Peripherally Inserted Central Catheter (PICC) Fractured *in Vivo* with Embolization Happened in a Child: A Case Report

Fang Fang, Hongyan Zhang, Wu Yang

Department of Hematology, The Affiliated Hospital of Qingdao University, Qingdao, China  
Email: [fasjp@163.com](mailto:fasjp@163.com)

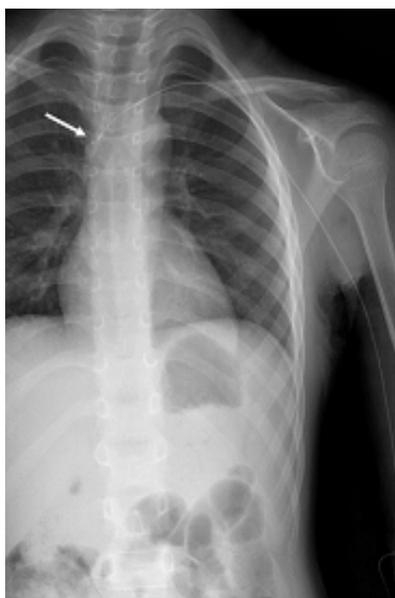
**Figure 1.** The tip of the PICC was located at the beginning of the superior vena cava (SVC) after inserting.

The tip of PICC should be put in the lower third of the superior vena cava (SVC) proximal to the right atrium. A “short” catheter was called for the catheter whose tip is located in the upper or middle third of the SVC or in the innominate veins [5], as in this case. Formation of a fibrin sleeve around the short catheter occurs more frequently with persistent withdrawal occlusion and ball valve obstruction [6]. The 1 cm blood embolism found inside the point of the fractured fragment showed the thrombotic occlusion happened before long. In fact, occlusion evidence was given by the parents for difficulty flushing and withdrawing from the catheter during outpatient period. Thrombosis happened in this case may be easily explained by changed intrathoracic pressure from febrile seizures history occasionally. For the patient discharged home with the catheter *in situ* cared by his family, the dysfunctional catheter was likely power-injected for attempts to flush the obstruction by non-special persons. These silicone catheters such as the 3-way valve Bard Groshong PICC were shown to tolerate power injection pressure between 95 - 125 psi, inadequate power injection of PICCs might result in catheter rupture [7]. In additional, the likelihood of any catheter-related complication may occur with time for catheter fatigue [4]. The catheter in this case stayed for 328 days, remarkably more than the average dwelling time of 246 days which is longer than any previously reported studies for children [2]. The exact explanation of this case is not well understood and many hypotheses have been strongly proposed of the partial obstructive catheter ruptured by force procedure.

The malposition of PICC catheter may be explained by inaccurate anthropometric measurements. These measurements estimate the desired length of the catheter in association with the site of venipuncture, the venous choice and the height of the patient. Anthropometric method is quite precise in estimating the length of the catheter in the adult patients, but not in children. PICC catheters should be put more suitably in right arm for accurate tip location. If the fluoroscopy arranged, PICC nurses may perform the catheter insertions in the im-

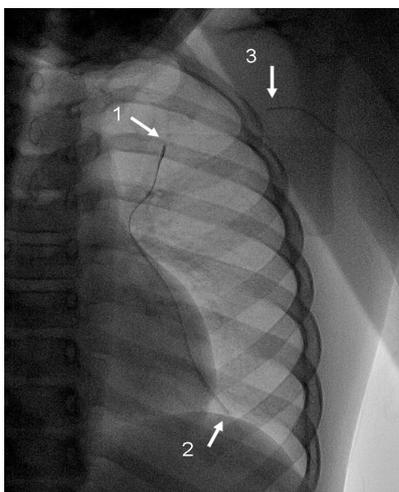
**Figure 2.** The chest angiograms immediately taken after X-ray films. Fractured piece of PICC line in the left main pulmonary artery is noted. Both ends (arrows 1 and 2) of the fractured fragment are in the upper and basal segment branches in the left lobe, while the remained line fractured distal fragment (arrow 3) is located in the axillary venous.

A 7-year-old boy diagnosed with acute lymphocytic leukemia had a peripherally inserted central catheter (PICC) line procedured for chemotherapy. The patient was recorded normal nutrition status with 26 kg weight and 118 cm height. A single-lumen 18-guage (4 Fr) catheter (Bard Groshong, USA) was inserted via the basilic vein of the left arm at the point of 0.5 cm below elbow crease on December 22, 2010. Postoperative routing chest radiograph showed the tip position of the line was at the beginning of the superior vena cava (SVC) with 37 cm long inserted (**Figure 1**). Blood withdraw and infusion though the catheter all did well. Before discharging from the first therapy scheme with the PICC line in situ, the patient's parents were received the education of the catheter maintenance skills. Because of the far distance from their residence to the specialized clinic, the line routine flushing and re-steriled dressing care had to be given by family members or local non-specialized nurses, further simplifying outpatient treatment such as antibiotic infusions. During successful eight plans of chemotherapy administated, the patient suffered from febrile seizures during neutropenia period, while his parents complained the difficulty of the tube flushing. When the patient attended the pediatric chemotherapy unit to receive the next cycle of treatment on November 15th, 2011, the charge nurse found the catheter be difficultly aspirated and flushed, infusion drop rate via the line decreased obviously than before. The patient had not noticed any leakage or other changes at the insertion site, and had no respiratory distress or arrhythmia disorders. Occlusion is the most likelihood complication practically happened in the catheter. Condsidering of the nearly one-year dwell time and the possibility of catheter migration or thrombosis, chest X-ray films were taken before urokinase medication, which showed that the catheter was fractured inside at axillary section. The fluoroscopy, angiograms immediately were taken to get the exact position of the embolized line fragment (**Figure 2**). It revealed the fractured piece of PICC line lying in the left main pulmonary artery (arrows 1 and 2) with both ends in the upper and basal segment branches in the left lobe, while the point of fractured line distal fragment (arrow 3) remained in the axillary venous. Fortunately, the fractured fragment embolism was successfully snared by percutaneously inserted femoral catheter, the remained line was removed intactly. No further complications appear after catheter removal. On checking the embolized fragment of the fractured catheter, we found there has been a 1 cm long blood thrombosis at the point of fractured fragment inside (arrow 1).
