Reduced Disposal Area Performance Utilizing Secondary-Treated Effluent in Profile-Limiting Soils

How to cite this paper: Meints, D.A., Brye, K.R., West, L.T. and Wood, L.S. (2019) Reduced Disposal Area Performance Utilizing Secondary-Treated Effluent in Profile-Limiting Soils. *Journal of Environmental Protection*, 10, 745-771.
<https://doi.org/10.4236/jep.2019.106045>

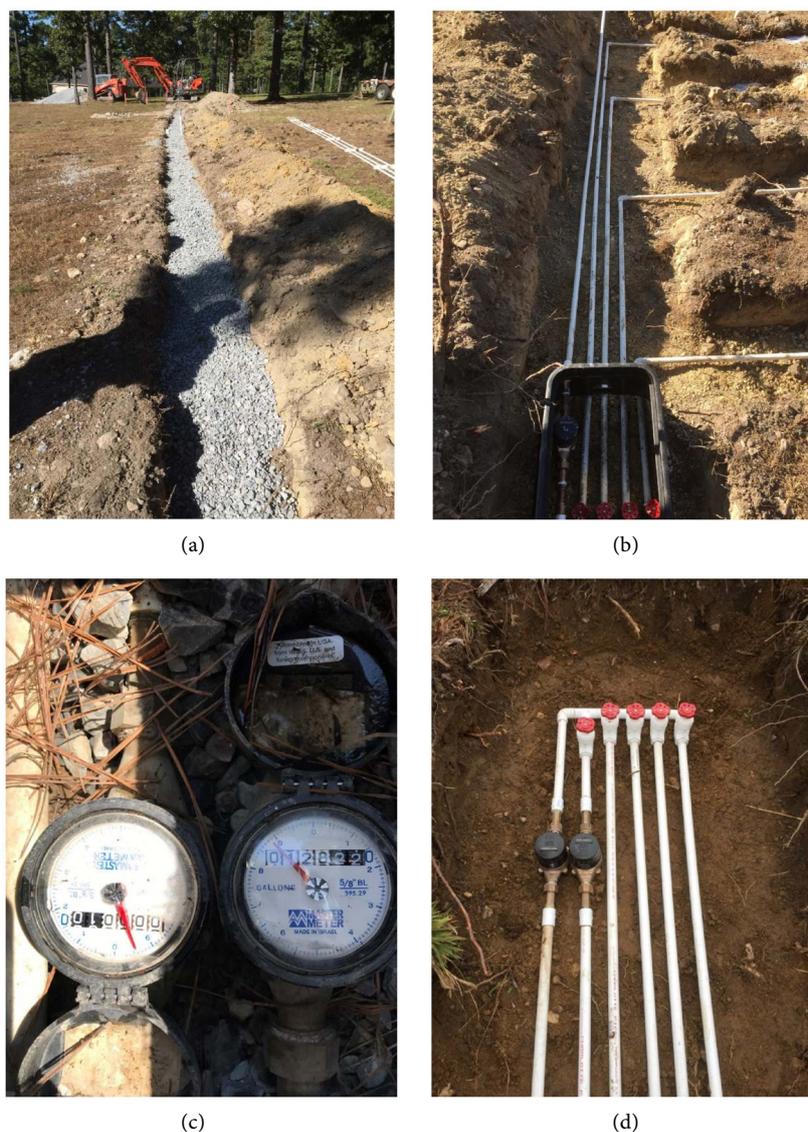
Figure 2. Disposal-area trench line 1 of 4 at research Site A that has been excavated and filled with gravel (a); Image of the low-pressure distribution network installed at Site A to control and deliver secondary-treated effluent to the four disposal lines (b); Image of flow meters installed at each research site to record the flow of secondary-treated effluent into the disposal area (c); Image of gate valves installed at Site E. Gate valves were used to regulate squirt height across the disposal area for even distribution (d).

Four disposal trenches were excavated at each site with a rubber-tracked 4500 kg track hoe. Disposal trenches were 21-m long, 35-cm deep, 45-cm wide, spaced 1.2 m center to center (**Figure 2(a)**), and disposal trenches were installed following the contour (*i.e.* the same elevation on the trench bottom along the length of a trench). Disposal trenches were backfilled with a 20-cm thick bed of commercially available, washed, crushed gravel, 2.5 cm in diameter or less. A low-pressure distribution network was constructed from 1.9-cm-diameter polyvinyl chloride (PVC), Schedule-40 pipe and installed in the center of each disposal trench atop the crushed-gravel bed (**Figure 2(b)**). Holes, 0.32 cm in diameter, were drilled every 120 cm and protective orifice shields (STF-106TDS, SIM/TECH, Boyne City, MI) were snapped over each hole. Geotextile fabric (2624RB 24 × 300, Advanced Drainage Systems, Hilliard, OH) was cut to a 45-cm width and laid over the low-pressure distribution network and gravel bed. The gravel and pipes were then covered with 15 cm of native soil, with slight mounding over the disposal trench to allow for settling over time.

A 1.6-cm × 1.9-cm flow meter (MMPD Oscillating piston meter, Master Meter, Mansfield, TX) was installed at the supply line entering the upper-most disposal trench to measure flows (**Figure 2(c)**). Polyvinyl chloride socket-gate valves, 2.67-cm diameter, were installed at the in-flow end of each lateral line for squirt height adjustment (**Figure 2(d)**), where squirt height is a common visual assessment conducted to verify equal distribution in the low-pressure network of pipes. The gate valves allowed for adjustments to be made to make flows equal

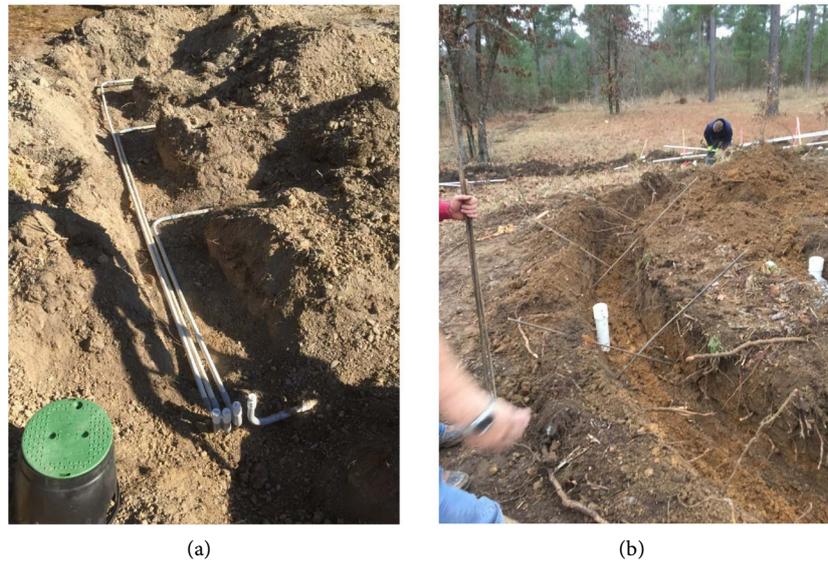
Figure 3. Image of the flush sweeps installed at Site A (a). Flush sweeps allow for squirt-height measurement and the ability to flush the low-pressure distribution network. Image of an in-trench monitoring port being installed at Site B (b). Site B was one of the mound disposal areas. The inspection port is used to measure ponding depths within the disposal trench. Each trench has its own monitoring port.

allowed for the soil solution to equilibrate inside the monitoring port so the depth from the soil surface to free solution (*i.e.* solution ponding) inside the trench could be measured (**Figure 3(b)**).

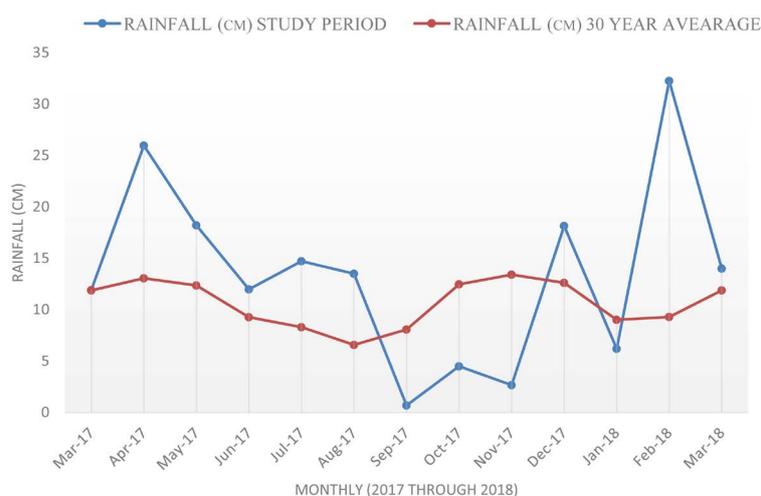
Figure 4. Monthly rainfall data, both actual and 30-year (1981-2010) average amounts associated within the study area.

Rainfall during the study period had a direct impact on the performance of the reduced drainfield in limiting soils (Figure 4). Rainfall measurements from March through July 2017 and December 2017 through March 2018 indicated 38% more rainfall than the 30-year normal. However, rainfall from August through November 2017 indicated 53% less rainfall than the 30-year normal. Data collected during the above-average rainfall periods provided information on how a reduced drainfield in limiting soils would react during hydrologically stressed conditions, as well as how the reduced drainfield would react during below-average rainfall conditions.

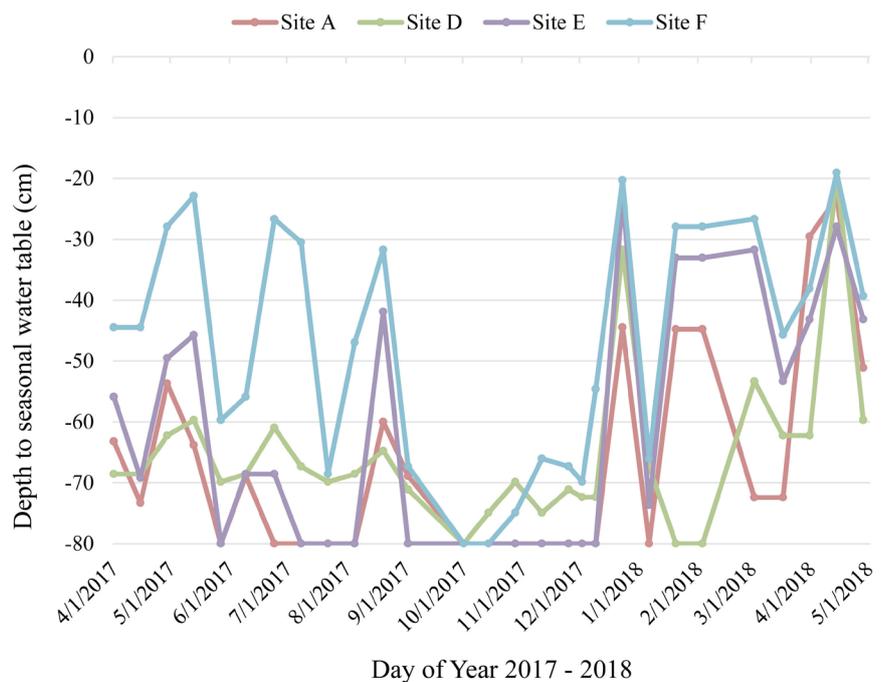
Figure 5. Seasonal water table fluctuations from April 2017 to May 2018 from the up-slope observation port at research Sites A, D, E, and F. No water table was measured for Sites B and C. The soil surface is the 0-cm line on the y-axis. The bottom of the observation well is at the -80-cm line depth.

Among the four non-mounded sites, the seasonal water table depths, as measured in the observation ports up-slope of the upper-most disposal trench, ranged from 25 to >80 cm from the surface (**Figure 5**). For the wet period of March through July 2017, the seasonal water table was recorded between 25 and 80 cm from the surface at Site A, D, E, and F compared to ponding depths in the disposal trenches, as measured by the monitoring ports within the disposal trenches themselves, recorded between 0 and 39 cm from the surface (**Figure 6** and **Figure 7**). For the dry period of August through November 2017, the seasonal water table was recorded at 65 to >80 cm from the surface at Sites A, D, E, and F compared to the ponding depths in the disposal trenches of 8 to >39 cm from the surface (**Figure 8** and **Figure 9**).

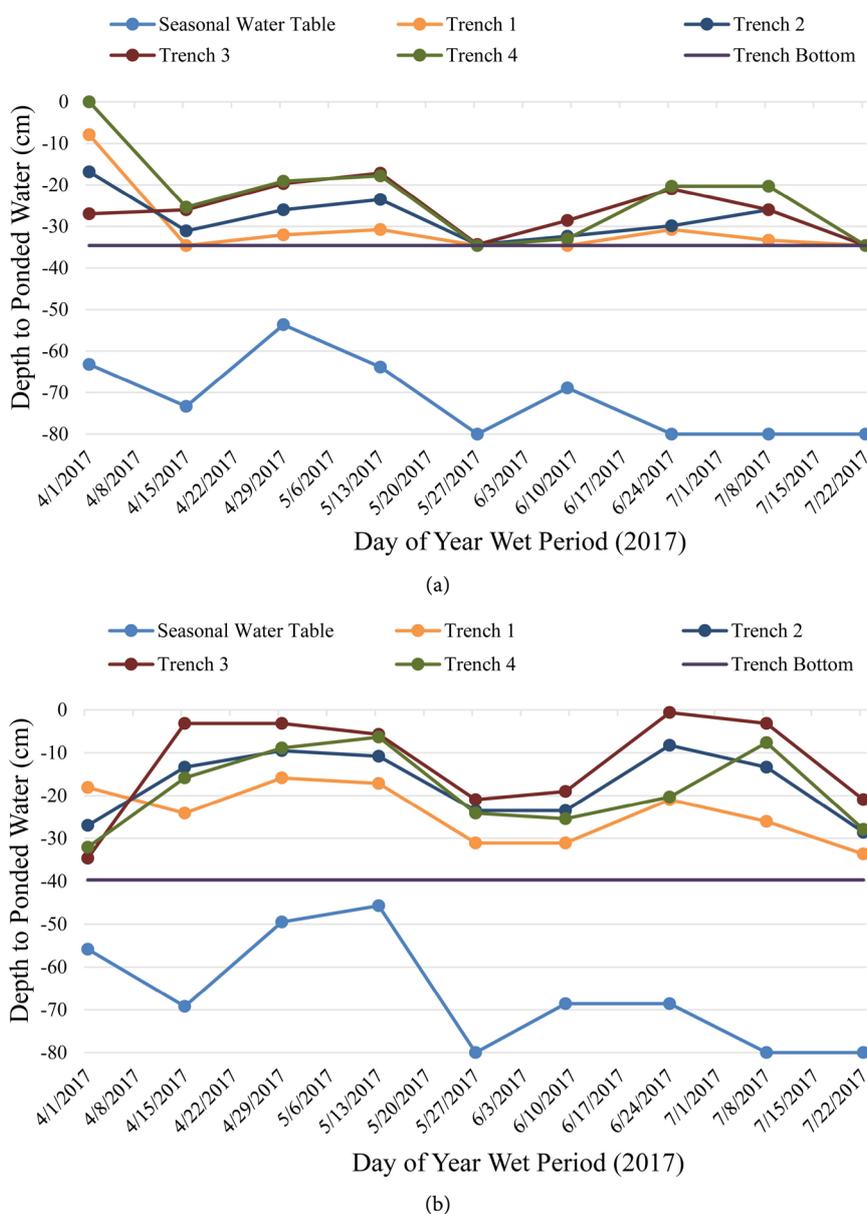
Figure 6. Depth to ponded secondary-treated effluent during the wet period of April to July 2017 from the up-slope observation port and the four disposal trenches at research Site A (a) and Site E (b). The soil surface is the 0-cm mark on the y-axis. The trench bottom is at the 35-cm depth mark.

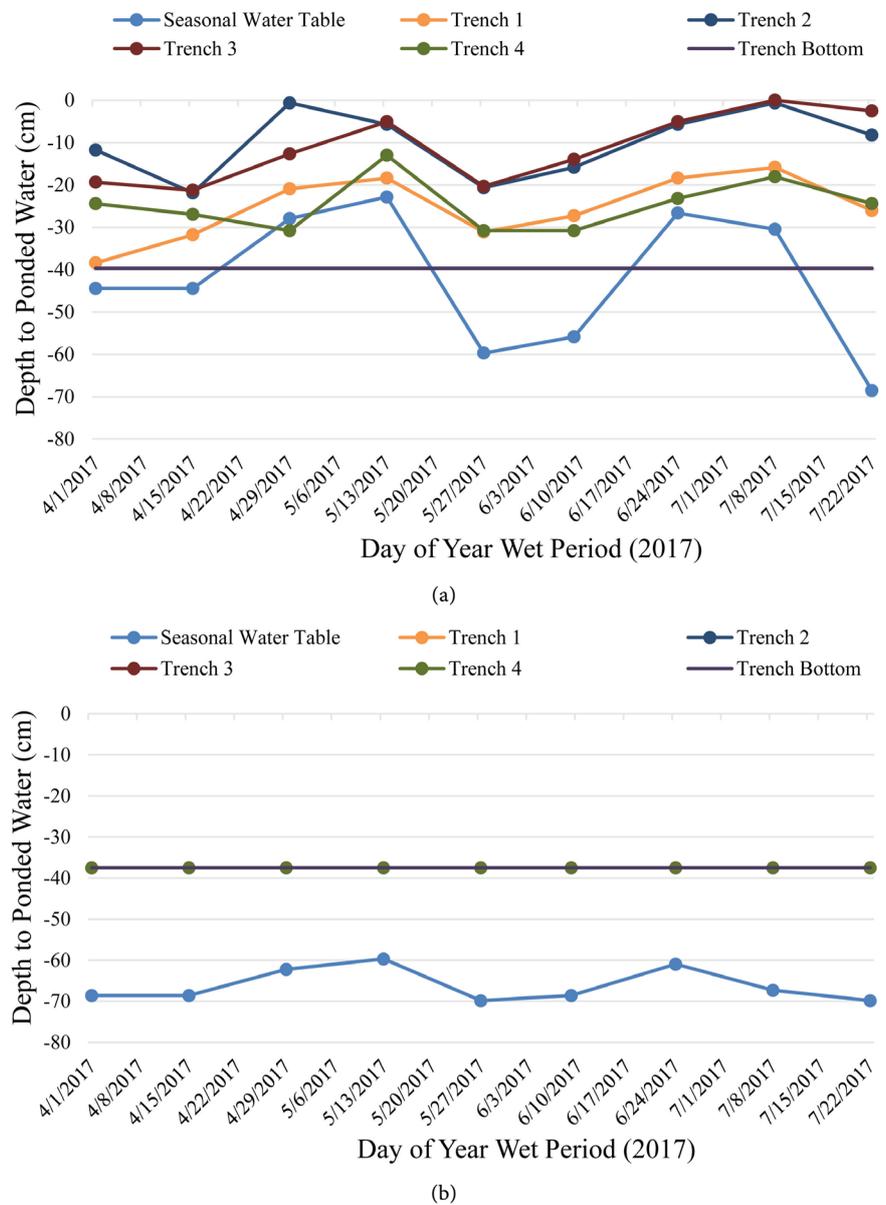
Figure 7. Depth to ponded secondary-treated effluent during the wet period from April to July 2017 from the up-slope observation port and the four disposal trenches at research Site F (a) and Site D (b). The soil surface is the 0-cm mark on the y-axis. The trench bottom is at the 40-cm depth mark for Site F and the 37-cm depth mark for Site D. No ponding was measured during the study period at Site D; however, the seasonal water table was present throughout this period.

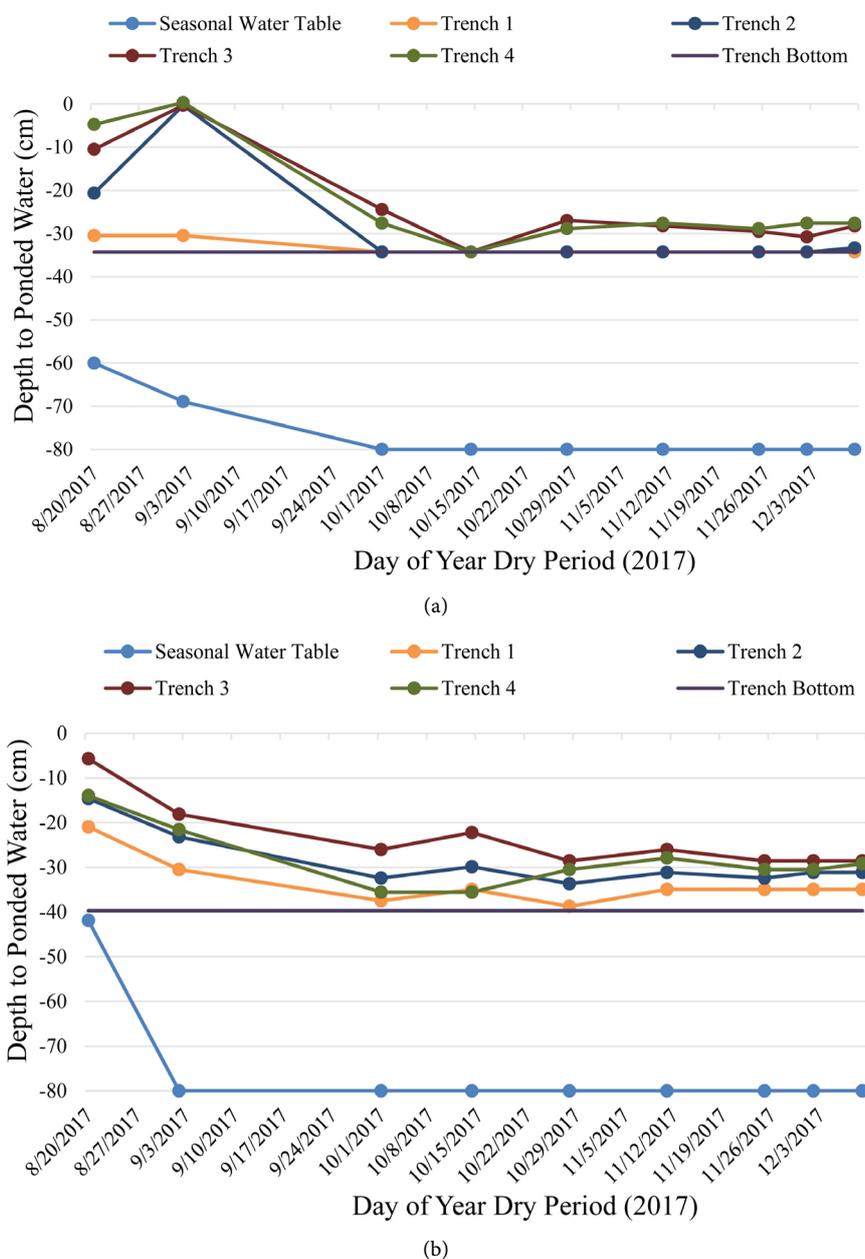
Figure 8. Depth to ponded secondary-treated effluent during the dry period from August to December 2017 from the up-slope observation port and the four disposal trenches at research Site A (a) and Site E (b). The soil surface is the 0-cm mark on the y-axis. The trench bottom is at the 34-cm depth mark for Site A and the 40-cm depth mark for Site E.

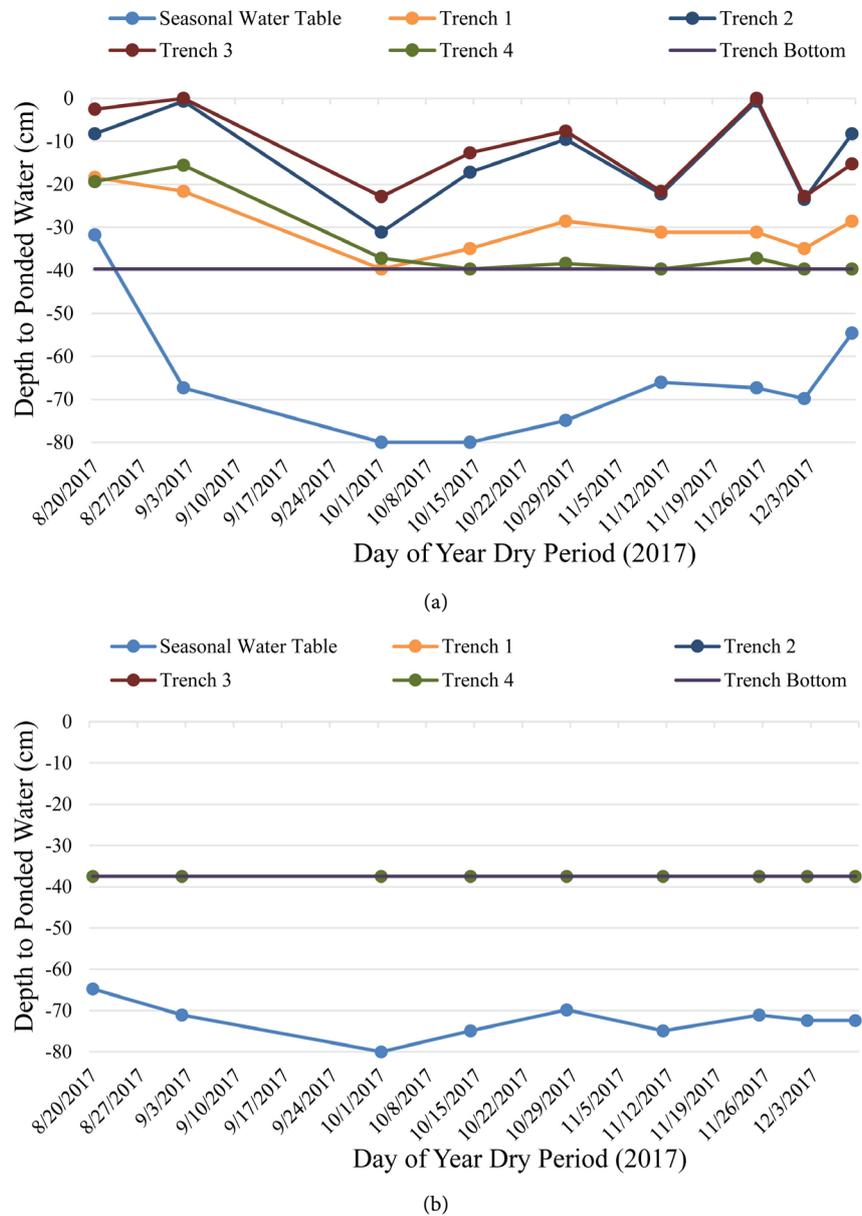
Figure 9. Depth to ponded secondary-treated effluent during the dry period from August to December 2017 from the up-slope observation port and the four disposal trenches at research Site F (a) and Site D (b). The soil surface is the 0-cm mark on the y-axis. The trench bottom is at the 40-cm depth mark for Site F and the 37-cm depth mark for Site D. No ponding was recorded in any trench during this period at Site D; however, the seasonal water table was present throughout the study period.

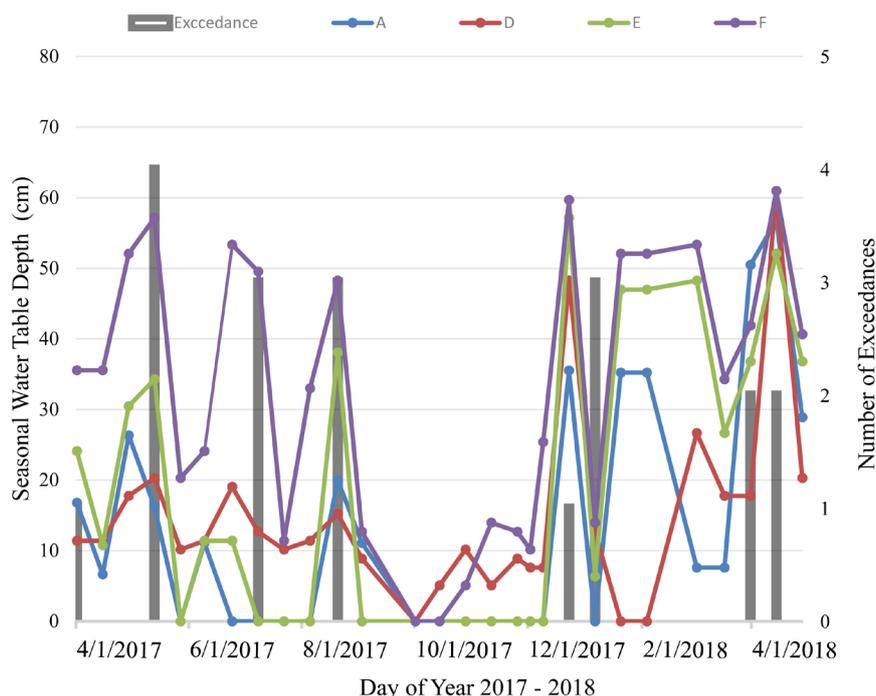
Figure 10. Seasonal water table fluctuations compared to exceedances. The surface is represented on the left y axis by the 80-cm mark. The bottom of the observation port is represented on the left y axis by the 0-cm mark. The number of exceedances is represented on the right y axis. The exceedances represent any monitored period > 14 days where any of the trenches in sites A, D, E or F had a ponding depth > 27 cm. Site B and C are not represented because no seasonal water table was measured, nor exceedance recorded during the study for these two sites.

Measurements of the seasonal water table depths correlated with rain events and impacted ponding depths in the disposal trenches (**Figure 10**). Rain events

and corresponding seasonal water table fluctuations accounted for 19 exceedances of a total of 116 observations (16%) between April 2017 and April 2018. An interceptor drain installed up-slope from the disposal area could be used to divert the seasonally shallow water table and may have alleviated a portion of the hydrologic stress to the disposal area at each site.

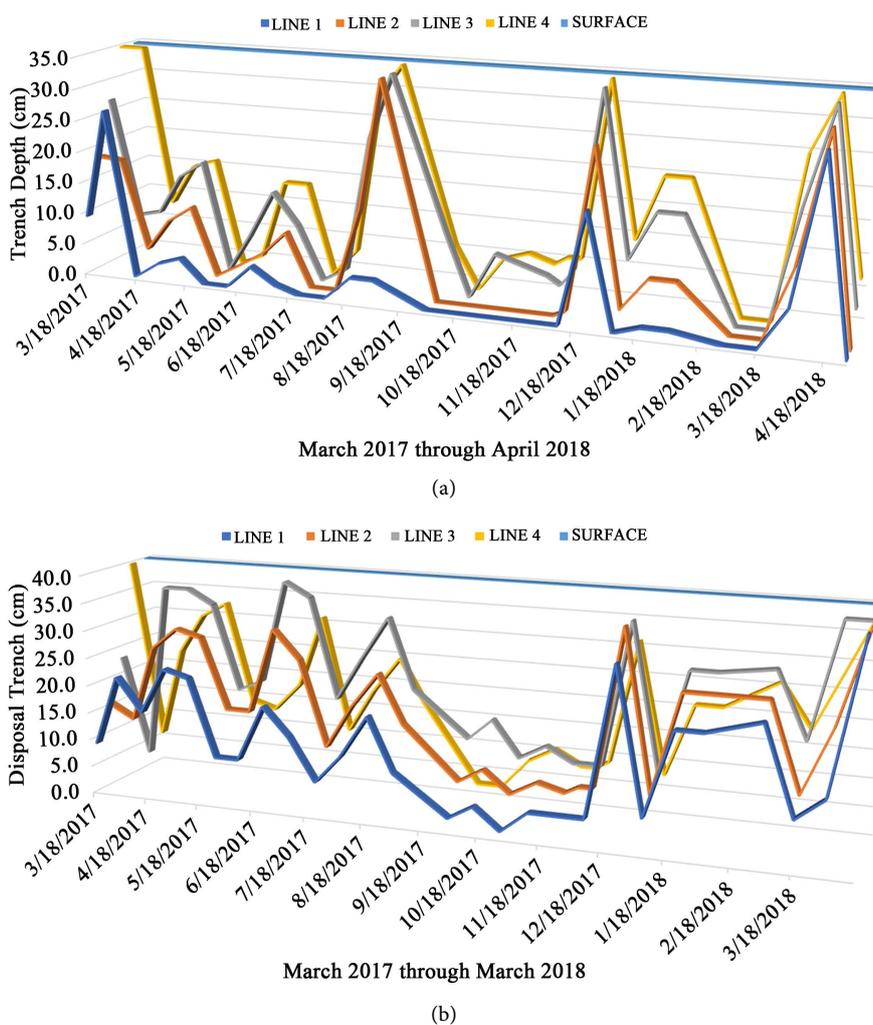
Figure 11. Lateral movement of secondary-treated effluent at Site A (a) and Site E (b). Observation dates are represented on the x axis. The y axis represents the depth of the disposal trench where 35 cm is the surface for Site A and 40 cm is the surface for Site E and 0 cm represents the bottom of the trench. Although the secondary-treated effluent is evenly distributed to the disposal trenches, ponding depths incrementally increased as the water moved laterally downslope. Line 4 at Site E was turned off in March 2017; however, a ponding depth was recorded throughout the study, further highlighting the lateral movement of secondary-treated effluent in the disposal area.

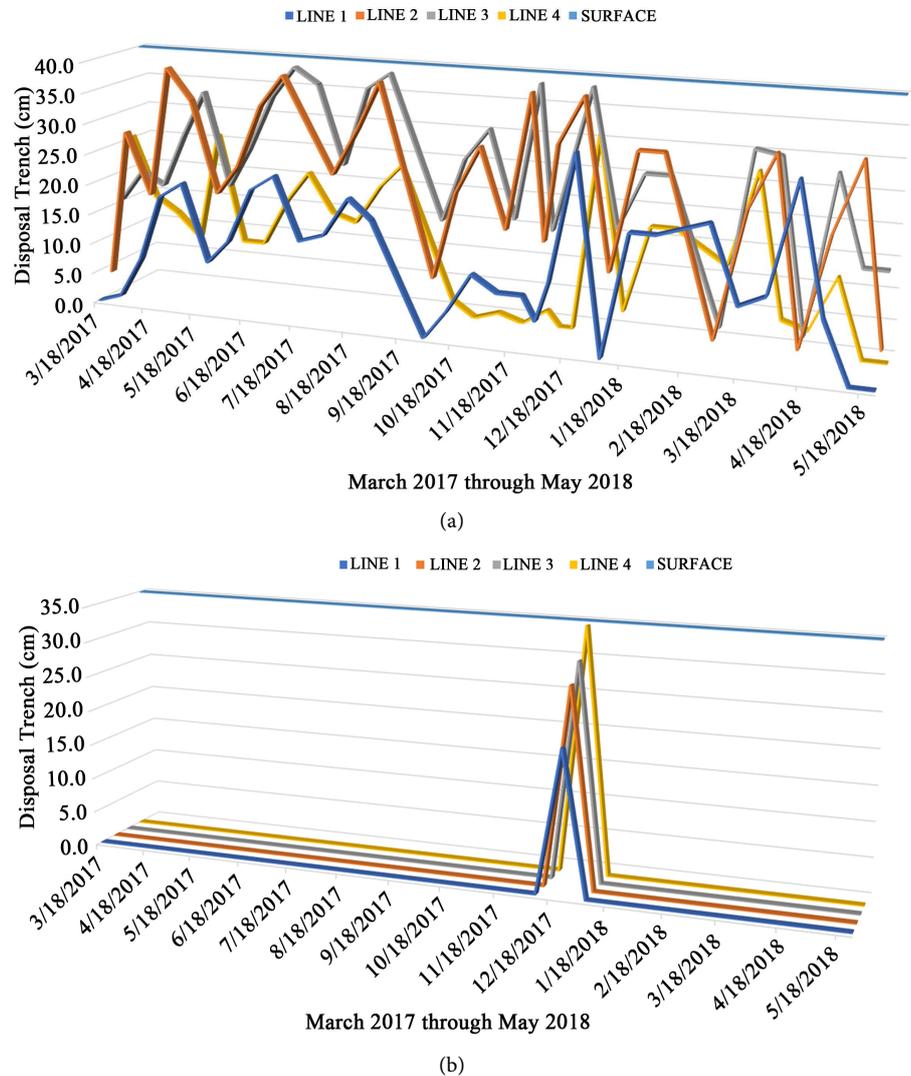
Figure 12. Lateral movement of secondary-treated effluent at Site F (a) and Site D (b). Observation dates are represented on the x axis. The y axis represents the depth of the disposal trench where 40 cm is the surface at Site F and 35 cm is the surface at Site D and 0 cm represent the bottom of the trench. Although the secondary-treated effluent is evenly distributed to the disposal trenches, ponding depths incrementally increased as the water moved laterally downslope. Ponding depths at Site D were only recorded in December 2018 after a heavy rain the night before, while 3 days later, ponding was non-measurable. Lines 2, 3 and 4 at Site D were turned off in March 2017.

study, with exception of after a single rain event in December 2017 (**Figure 12(b)**). Observing the ponding depths in the lower disposal lines, when secondary-treated effluent was not delivered to the lowest disposal line, clearly demonstrated the sub-surface, lateral movement of the secondary-treated effluent downslope. Based on the data, the concept of sub-surface, lateral flow should be considered in the design criteria when using a reduced disposal area and secondary-treated effluent in profile-limiting soils, as sub-surface, lateral movement of effluent would still provide renovation despite the effluent's minimal vertical flow in the soil profile.
