Study of Lowlands Drainage Problems, Case Study Kamal El-Den Hessen Reclaimed Area, North Sinai, Egypt

Mohamed Gabr

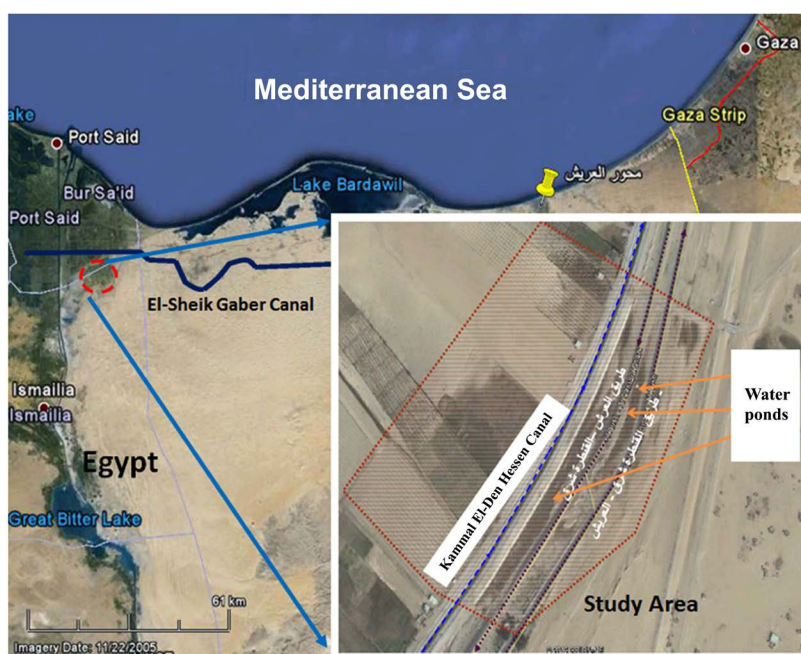
Kamal El-Den Hessen Canal region, North Sinai Egypt was selected to be a study area. It lies in the North Sinai Peninsula, where the North Sinai Development project (NSDP) to reclaim and cultivate 168 thousand hectares (**Figure 1**). El-Sheikh Gaber Canal is the main feeder for the NSDP, the annual water resources for the project are 4.5 Millard m³. The water resources in the study area are Nile freshwater mixed with agriculture drainage wastewater in a ratio 1:1 with salinity up to 1000 ppm [20]. Kamal El-Den Hessen Canal area served is 1650 hectares and it takes its water from the South East El-Qantara Canal (**Figure 2**). The Water Resources, Irrigation, and Infrastructures Sector, North Sinai, Ministry of Water Resources and Irrigation Egypt has operated the canal since 2000. The canal was lined with plain concrete since 2000 to prevent seepage losses where it is passed through sandy soil, the canal length is 10.500 km, water depth 1.5 m, bed width 1.5 m water slope 15 cm /km, and inside slopes 2:1. Surface drainage network consists of Main Gelbana Drain and Tall Elhair Drain

Figure 1. Location of study area.

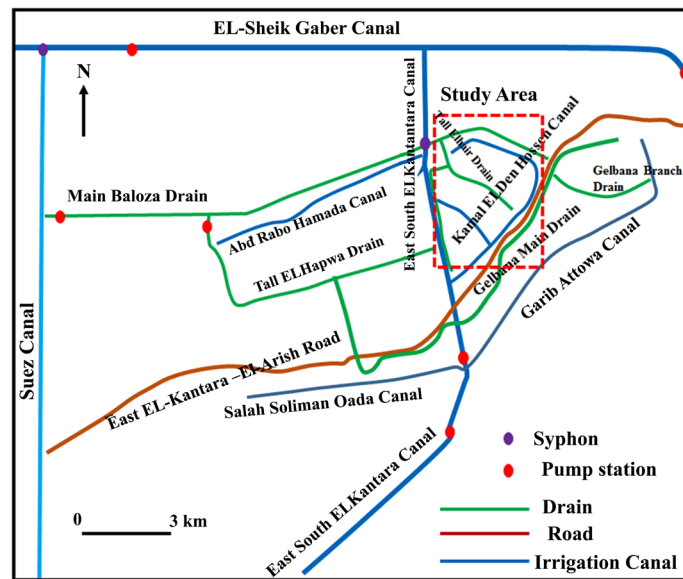
Figure 2. Irrigation and drainage canal networks in the study area.

(Figure 2). Many farmers complain about the formation of water ponds in their lands, bad soil drainage, and low yields rate. The studied area experiences a semi-arid climate type. The topography is sand terrain with large differences in elevations and steep slopes. The applied irrigation systems are sprinkler irrigation and drip irrigation. The surface drainage network was implemented together with irrigation facilities. Subsurface drainage networks did not implement till now. Wheat, sugar beet and corn are the major crops grown in the study area, besides vegetables, and fruits.

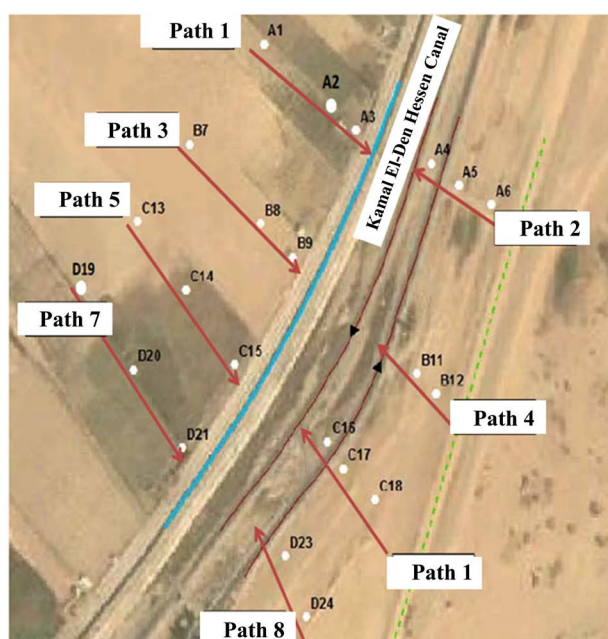
**Figure 3.** Suggested infiltration paths, 22 boreholes and observation wells distributions.

Eight infiltration paths were selected based on land topography, existing water ponds and irrigation canal (Kamal El-Den Hessen Canal). Twenty-two boreholes were carried out to describe land topography, soil permeability, groundwater levels and directions. Figure 3 shows the suggested infiltration paths, location of boreholes and the ground water observation wells distribution. Coordinates of the selected boreholes and groundwater observation wells for the infiltration paths coordinates were shown in Table 1. Topographic survey for the study area was carried out using double difference GPS Device by the Drainage Research Institute (DRI) team, National Water Research Center (NRC), Ministry of Water Resources and Irrigation (MWRI), Egypt. The existing drainage system was investigated where a group of 11 cross-section along the Main Gelbana Drain were measured at distances 0.00 km, 1.00 km, 1.300 km, 2.500 km, 4.200 km, 8.00 km, 9.00 km, 10.50 km, 13.00 km, 15.00 km, and 16.00 km from its outlet using total station survey instrument. The measured cross-sections were compared with designed cross-sections. The results showed that the main Gelbana Drain cross-section is suffering from deposition and needs dredging. Figure 4 shows the contour map, the ground surface levels were ranging from 1.5 m to 4.28 m

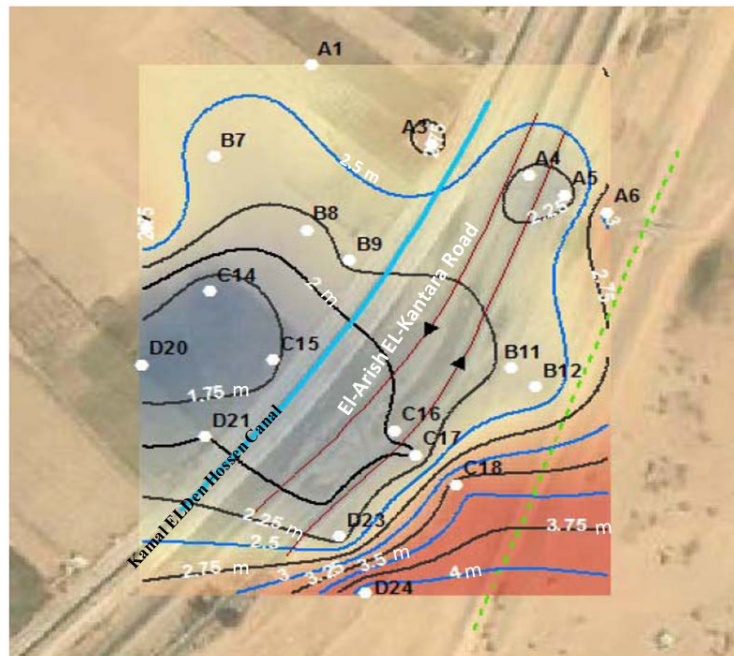
Figure 4. Contour map for the study area.

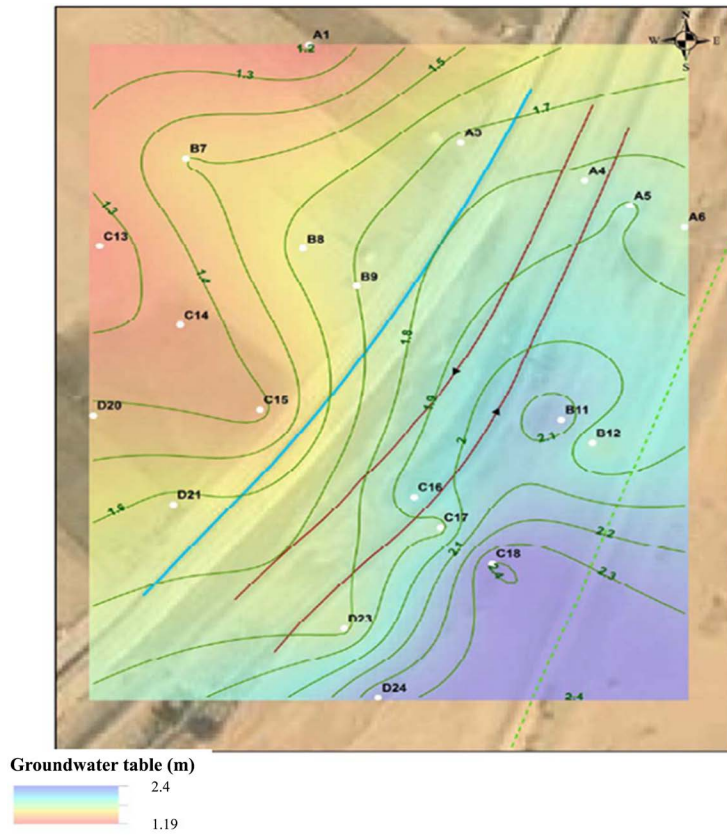
Figure 5. Average groundwater levels.

locations D20 and C16 water ponds have existed, (Table 4 and Figure 5) showed average surface groundwater levels. Studying of groundwater levels results of infiltration paths were shown in Figure 6 as following: 1) for infiltration path 1, at location A1 the mean groundwater depth was 1.36 m, then decrease at A2 to 0.83 m, then increased to 1.08 m at A3. 2) For infiltration path 2, at location A4 the mean groundwater depth was 0.35 m, then decrease at A5 to 0.16 m, and then increased to 1.31 m at A6. 3) For infiltration path 3, at location B7 the mean groundwater depth was 0.8 m, then decrease at B8 to 0.53 m and then increased to 0.6 m at B9. 4) For infiltration path 4, at location B11 the mean groundwater depth was 0.11 m, then decrease at B12 to 0.41 m. 5) for infiltration path 5, at location C13 the mean groundwater depth was 1.56 m, then decrease at C14 to 0.17 m, then increased to 0.4 m at C15. 6) For infiltration path 6, at location C16 the mean groundwater depth was 0.07 m, then increased at C17 to 0.12 m, and then increased to 1.01 m at C18. 7) For infiltration path 7, at location D19 no

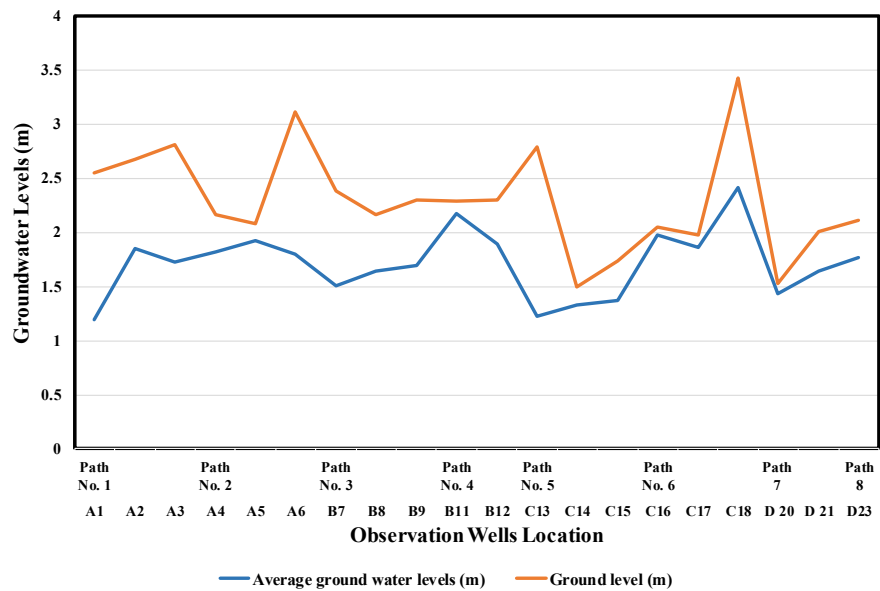
Figure 6. Average groundwater levels through infiltration paths 1, 2, 3, 4, 5, 6, 7, and 8.

groundwater (dry well), at location D20 the mean groundwater depth was 1.43 m, then decrease at D21 to 0.37 m. 8) For infiltration path 8, at location D23 the mean groundwater depth was 0.34 m, and at location D24 no groundwater (dry
