A Sluice Gate in Hezekiah's (Iron Age II) Aqueduct in Jerusalem: Archaeology, Architecture and the Petrochemical Setting of Its Micro and Macro Structures

Aryeh E. Shimron¹, Vitaly Gutkin², Vladimir Uvarov²

How to cite this paper: Shimron, A. E., Gutkin, V., & Uvarov, V. (2022). A Sluice Gate in Hezekiah's (Iron Age II) Aqueduct in Jerusalem: Archaeology, Architecture and the Petrochemical Setting of Its Micro and Macro Structures. *Archaeological Discovery*, 10, 69-113.

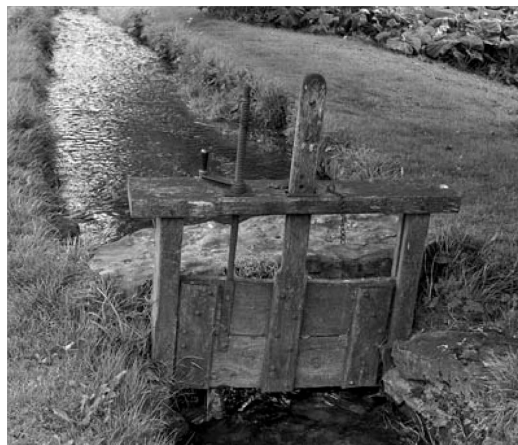
Figure 6. An ancient (Middle Ages) sluice gate crossing a village stream in Morland, Cumbria UK. Note the hand crank on the upper left of the frame. Source: <https://lindamphotos.wordpress.com>.

Below we use the term sluice, or sluice gate, for a “movable gate constructed and used for controlling the level and flow of water”. Traditionally it was made of wood (**Figure 6**), or more rarely as a metal barrier sliding in grooves that are set in the sides of a waterway. To the best of our knowledge no sluice gates have been recorded that predate the Roman ~1 - 2nd century CE Period (Schram, <http://www.romanaqueducts.info>). The oldest Iron Age structures referred to as sluice gates were found in the Judean Desert (Stager, 1976). Constructed to raise the level of water behind a stationary stone dam (photos provided in ref.), these structures are weirs rather than sluice gates. Consequently, if Hezekiah’s Tunnel sluice ever functioned as a movable blocking wall, it may well be the oldest sluice gate on record.

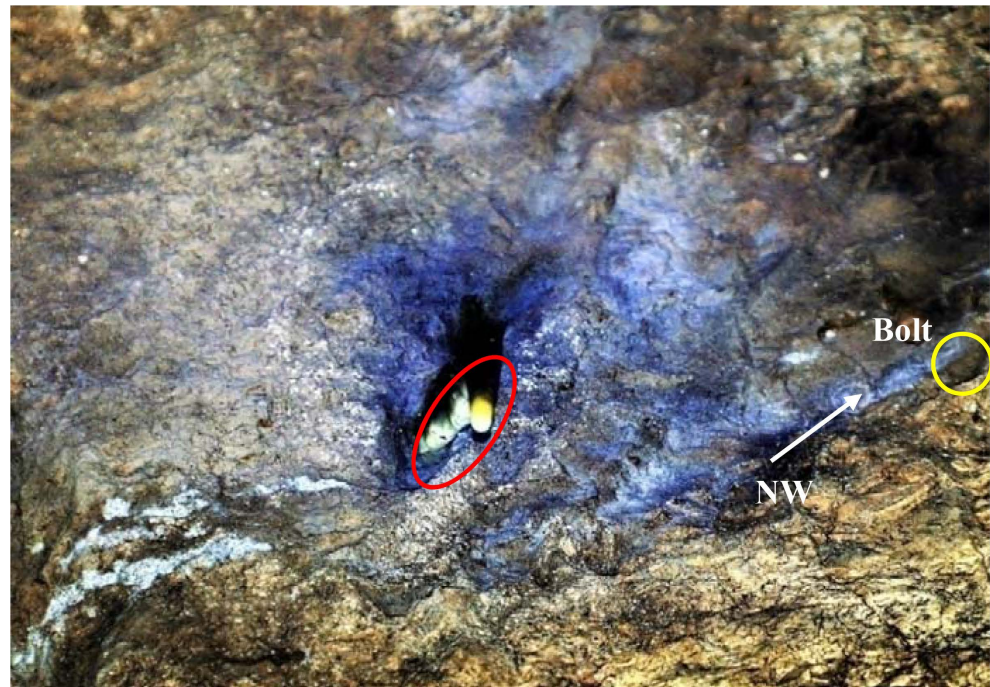
Figure 13. Zone 1 ceiling speleothem (rotated into the orientation as seen in **Figure 11**). We attribute the distinctive deep blue coloring (filter enhanced) to the presence of organic carbon compounds contributed from soot and calcified fibers embedded in plaster. Note the presence of what is now a kind of calcified bolt (encircled yellow) emplaced in the ceiling near the speleothem.

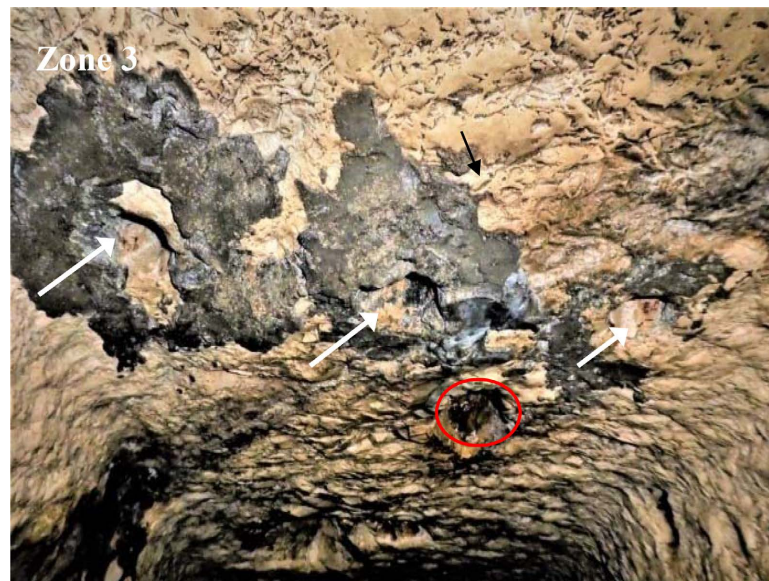
Figure 16. Tunnel ceiling, alteration Zone 3. Three hand-carved depressions (arrows) roughly encircled with a layer of black pozzolanic mortar. Another depression with a rust interior is present beneath (encircled red). (see **Table 2**, **Table 3**, Analyses for Zone 3).

Zone 3. What we refer to as the “Mamluke zone” (**Figure 16**) consists of three hand-carved round depressions ~5 cm deep and ~5 cm diameter carved into the hard dolomitic limestone ceiling. A fourth depression, beneath the above, is heavily coated with brown rust in its interior. The depressions are ringed by fine layers of black hydraulic mortar thereby marking them as important features in the local architectural setting. The mortar is unique and differs from the common (8th century BCE) hydraulic plaster still evidenced along most of the aqueduct. The mortar is characterized by high concentrations of the elements Ca, Fe, Mg and S (**Table 2, Table 3, An. HT5A - HT5e**) which we attribute to the presence of ferruginous pyritic iron ore slag, FeCa and ZnCu species, traces of high temperature calc-silicates such as gehlenite and anorthite and rare charred wood chips added to what is now a recarbonated lime base (**Table 2, An. HT 5 - HT5e**). A similar black plaster characterizes a number of wall repairs and karstic voids along the tunnel and a similar mortar also covers walls constructed to block access of water into a number of unused conduits in the area of the spring. We have dated a fragment of charred wood retrieved from the black mortar and obtained an ¹⁴C age of 605 ± 65 yr.BP (**Frumkin et al., 2003, Frumkin & Shimron, 2006**). Based on the above age we have here documented what con-

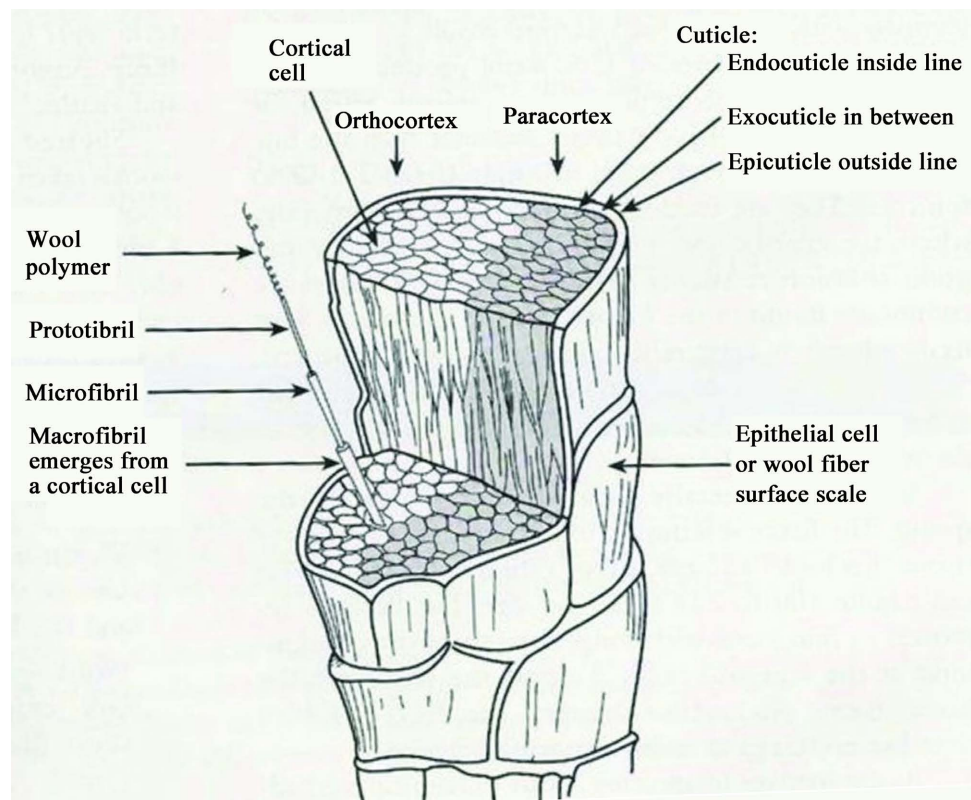
Figure 17. Cross-sectional and longitudinal view of a wool fiber showing its most important micro-structural features. The outer part of the fiber stem forms the cuticle. This segment consists of thin, flat-curving sheets that overlap one another like fish scales. The scales can be several layers thick. Inward the cuticle is followed by the epidermis and the cortex which contains keratin and melanin in rod-like fibrous cells twisted together like a rope. Finally, the core of the hair is the medulla which forms the soft area at the center. Source:

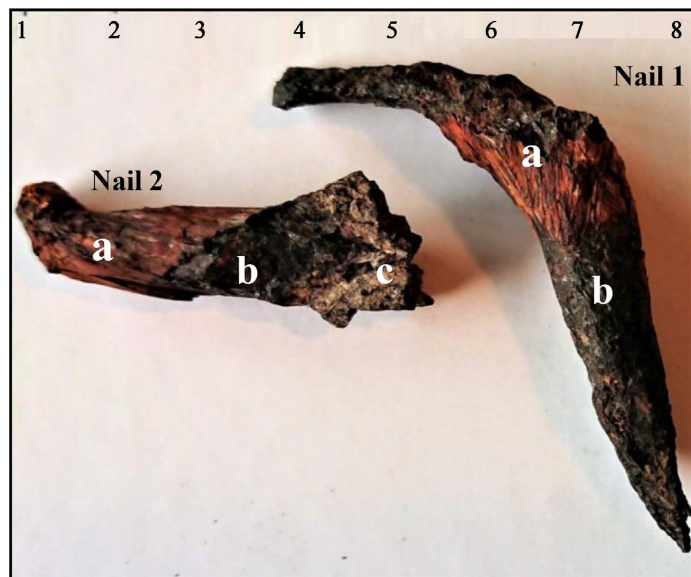
Figure 21. Two iron nails extricated from their source. Key: a-petrified wood, b- oxidized iron covering a metallic iron core, c-carbonate flowstone veneer with calcite, aragonite, gypsum and ankerite (Table 6, An. AS 6). The head area of Nail 1 (left edge) and bottom of Nail 2 (left edge) are both bent and the extremities are broken off. Indents in the nails made by hammering are not clearly visible in the photos.

It is quite amazing that both nails have retained, perhaps for a period of close to 3000 years, a partial envelope of well preserved although now fully petrified, wood (**Figure 21**, **Figure 23(A)**). Under the SEM, although most wood microstructures are reasonably well preserved, the wood species is difficult to identify

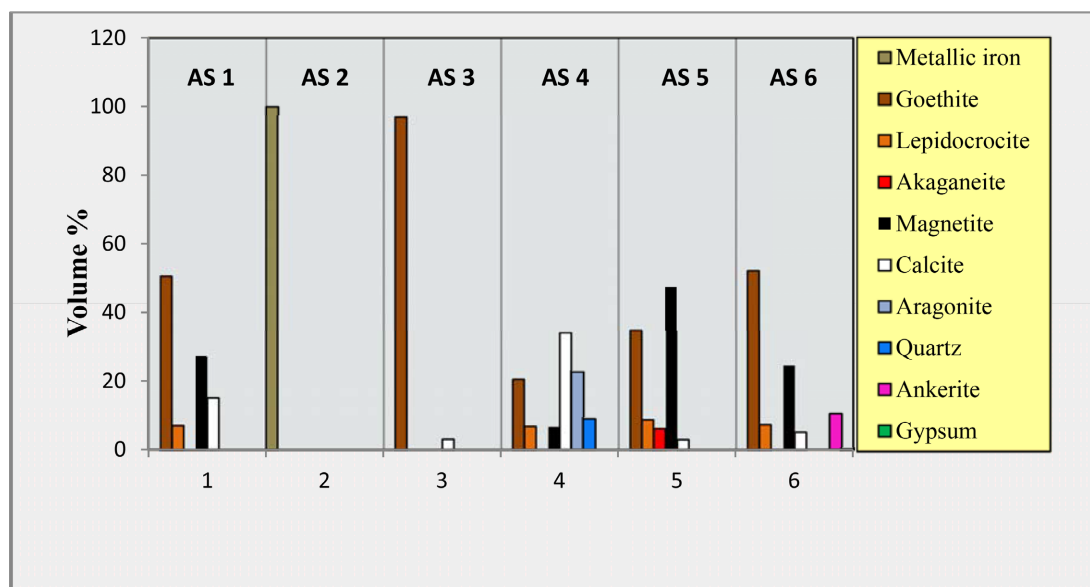
Figure 22. Columnar plot showing the types and volume % of iron oxidation products and trace mineral species which cover the head area (Nail 2) of the metallic iron core of the bolts.

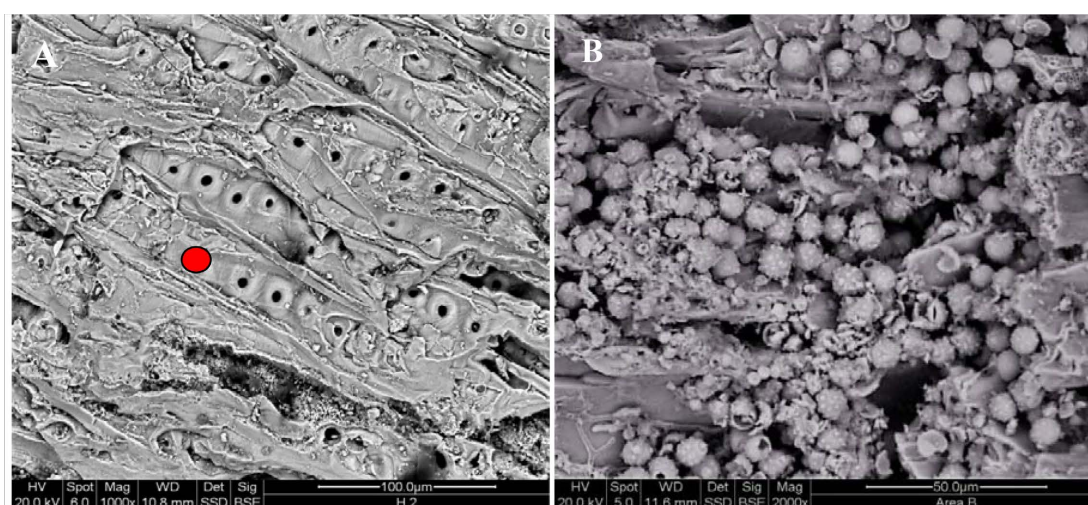
Figure 23. (A) Segment of wood accreted on Nail 2. Tracheids (wood cells with resin channel) show numerous pits in what is probably a tangential section of the cells. The small amounts of Si, Ca and Cl in the wood analyses is caused by contamination from incursions of tunnel moisture, the ~4% carbon concentration is probably all that remains from the original organic carbon. The high Fe content is due to slow replacement of wood carbon by goethite thereby recording one of a number of climate phases which affected the chemistry of the tunnel (see **Table 5**, An. 1-7). (B) Wood segment on Nail 1. The organic spheres that colonized the wood are probably spores of the fungus *Lycoperdon* (Puffball). Individual spheres are 6 - 7 μm in size and exhibit projecting nano-globules ~ 0.5 μm in size.

The wood was colonized by spores which we have identified as *Lycoperdon* (puffball, **Figure 23(B)**). We emphasize that although the wood morphology was deformed during nail emplacement through wood panels followed by deterioration, the spores are perfectly well preserved. We reason that spore colonization of the wood slivers took place well after the nails were already hammered into HT walls. The wood and spores have been chemically altered to the iron hydroxide goethite (**Table 5**, An. A-01, B-01, C-01, D-02).
