# Thinking on Effective Methods of Successful Prediction of Geological Hazards in Shaanxi, China

Chaowei Yao<sup>1,2,3,4\*</sup>, Yonghong Li<sup>2,3,4</sup>, Yiping He<sup>2,3,4</sup>, Hui Li<sup>2,3,4</sup>, Chaomei Xu<sup>2,3,4</sup>, Ping Fang<sup>2,3,4</sup>

**How to cite this paper:** Yao, C.W., Li, Y.H., He, Y.P., Li, H., Xu, C.M. and Fang, P. (2023) Thinking on Effective Methods of Successful Prediction of Geological Hazards in Shaanxi, China. *International Journal of Geosciences*, 14, 271-289.

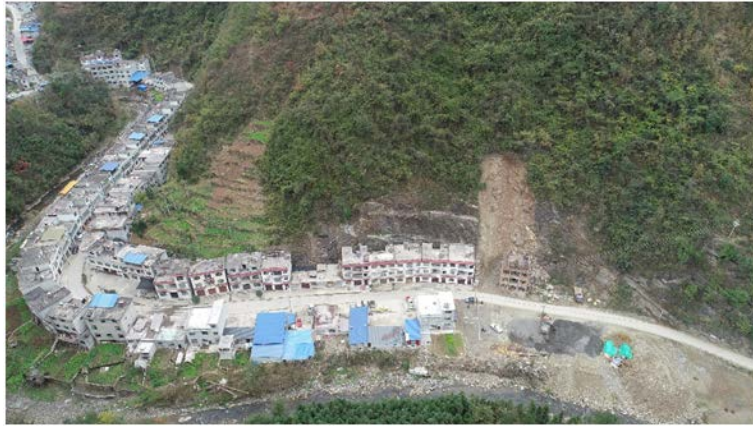
**Figure 1.** Images of three groups of landslides in Tongmu community before the occurrence.

The hidden danger points of geological hazards on the list are the results of geological hazards special survey, detailed investigation, daily inspection and mass report in our province over the years [11], which are the most easily found points. In Shaanxi Province, 100% of the potential geological hazard points found are included in the group monitoring and prevention network system, and warning signs are set up at significant locations of each potential hazard point. Warning signs explain to the masses the progress of disaster prevention work and protection, rescue, evacuation plans, equipped with professionals and grants, and explain to each threatened household how to avoid disasters [12]. The group survey and prevention personnel shall conduct daily observation on the hidden danger points on the list, and conduct intensive observation during special periods of time such as rainfall, and immediately give an early warning once the disaster precursor is found. For example, the landslide of the third group of Tongmu Community, Tongmu Town, Xunyang County, Ankang City was successfully predicted. At about 20:40 on August 7, 2020, there was a heavy rain in Tongmu Town. When the government officials and community officials of Tongmu Town inspected, they found that the tiles of the wall of the house of Yan Zhanqiang, a threatened household in the west of the three groups of two-and-a-half registered geological hazards hidden danger points in Tongmu Community, fell off. When they carefully checked, they found that the wall of several households was deformed, and found that the steps on the street floor moved forward (Figure 1). They immediately shouted and sounded a gong to

warn, 119 people from 35 households were organized to move to a safe area. At the same time, warning lines and no traffic signs were set up at both ends of the two or three highways under the slope. At 21:20 on the same day, a large area of landslide occurred on the west side of the site. The surface rock mass of the original rock landslide on the east side collapsed, resulting in the collapse of three houses at the lower part of the slope, and the damage for four houses (**Figure 2**), with a direct economic loss of about 5 million yuan. The final result was to avoid 39 casualties due to timely evacuation.

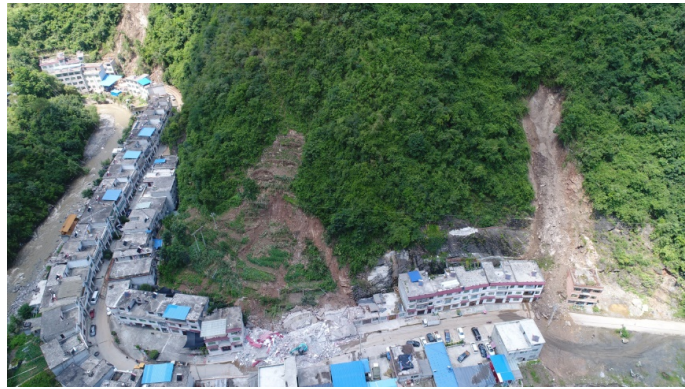
**Figure 2.** Images of three groups of landslides in Tongmu community.

In view of the counties prone to geological disasters, a comprehensive investigation before flood season, inspection in flood season and reexamination after flood season are carried out every year. It is also necessary to check before heavy rainfall, inspect in the rain and check after the rain according to the weather forecast information. In addition, the dangerous sections with poor geological environment conditions should also be inspected, checked and verified. The above work is called “three inspections” work [13]. The “three inspections” work is a supplementary work to the mass survey and mass defense network system. Once the precursor of disasters is found during the patrol inspection, emergency measures for evacuation can be taken to avoid casualties. The successful prediction of geological disasters in Shaanxi Province in 2020 was mostly found in the “three inspections”. For example, the landslide of Jijiashan Formation, Baojiagou Village, Guanyinsi Town, Lueyang County. At about 10:00 on August 15, 2020, the geological disaster investigation of Lianghekou land location in Lueyang County, Hanzhong City found that the slope of Jijiagou Village had deformation, displacement, and signs of sliding. Immediately notify the households at the foot of the slope to evacuate five people in one household, and help evacuate some properties. Meanwhile, report the situation to the duty room of the County Natural Resources Bureau and the People’s Government of Guanyinsi Town.

After receiving the report, the People's Government of Guanyinsi Town set up warning lines and warning signs around the dangerous area. At 01:00 on August 16, a landslide occurred on the slope, with a volume of about 3500 m<sup>3</sup>. The soil poured into the houses under the slope, causing damage to doors, windows and properties. Due to the timely evacuation, 5 casualties were avoided in this landslide.

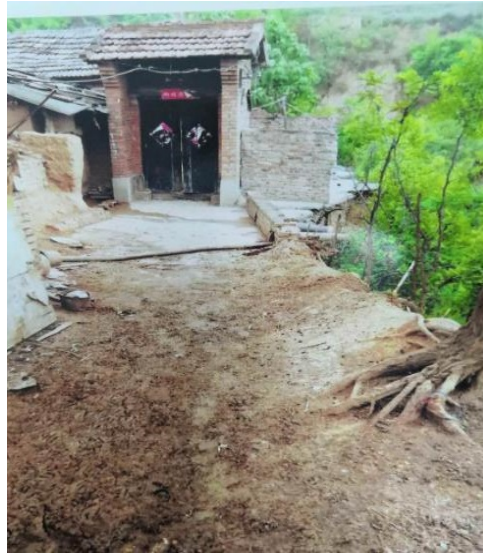
**Figure 3.** Image before the landslide behind the white building in the building materials factory.

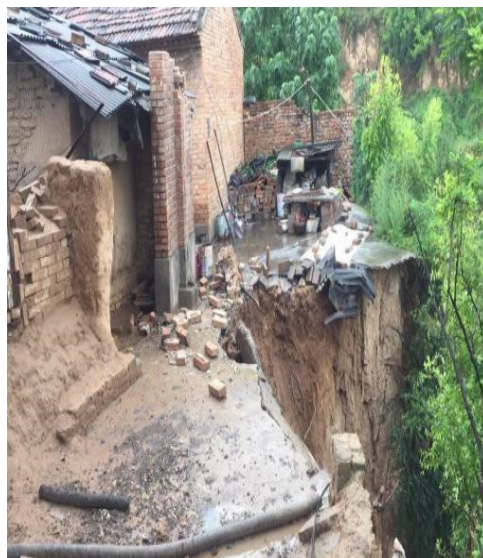
**Figure 4.** Image of the landslide behind the white building in the building materials factory.

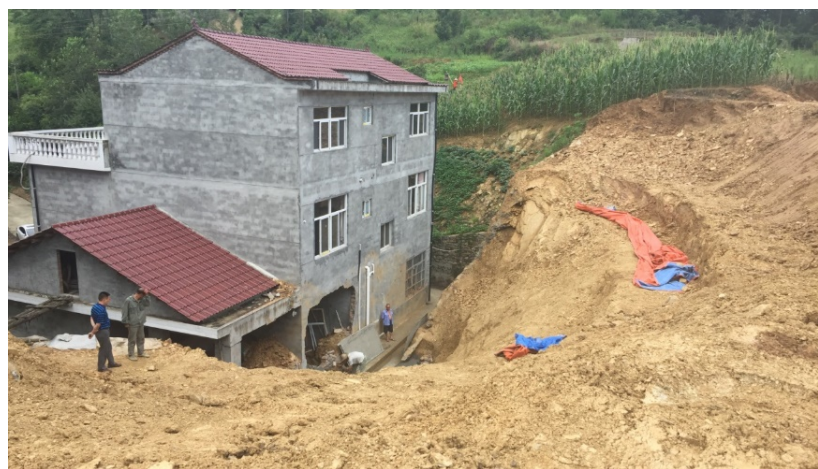
**Figure 5.** Image of Group I Landslide in Huaishu village before treatment.

and control personnel and equipment were stationed in cities and counties in the form of contracts. The above practices not only solved the problem of less personnel and weak technology in grass-roots departments, but also enriched the technical services of geological disaster prevention and control to all corners of the province. In addition, providing daily technical services for the masses was of great help to the successful prediction of geological disasters [14]. For example, the landslide in Group I of Huaishu Village, Dazhuyuan Town, Hanbin District was successfully predicted. In July 2020, there was continuous heavy rainfall in Hanbin District. At 9:00 a.m. on July 22 of the same year, the staff of Dazhuyuan Land and Resources Office found that the slope behind the house of Li Zhong'an, a group of villagers in Huaishu Village, Dazhuyuan Town, showed signs of sliding and may collapse at any time. The danger was immediately reported to the main leaders of Dazhuyuan Town Government. The main leaders of the town government asked the staff of the Land and Resources Bureau to closely monitor and prevent the work, and set up warning signs and set up warning lines at the same time. At 14:00 pm on July 22 of the same year, the observation danger of staff of the National Land Institute was further aggravated. Therefore, an emergency evacuation notice was immediately issued to the threatened households, and the village cadres evacuated all five people from the threatened Li Zhong'an household to a safe area for resettlement. At about 16:00 pm on the 22nd, the slope behind Li Zhong'an's house collapsed, damaging the slope retaining wall and house originally built by himself behind Li Zhong'an's house, causing damage to the walls of three houses and small indoor appliances (Figure 5). Due to the timely evacuation, five casualties in one household were avoided. The professional team of "peacetime and wartime combination" in Hanbin District not only participated in daily inspections, but also proposed a combination of slope cutting, retaining wall and interception and drainage for Li Zhong'an's house according to the actual geological conditions after the disaster, which provided technical support for eliminating the geological disaster (Figure 6).

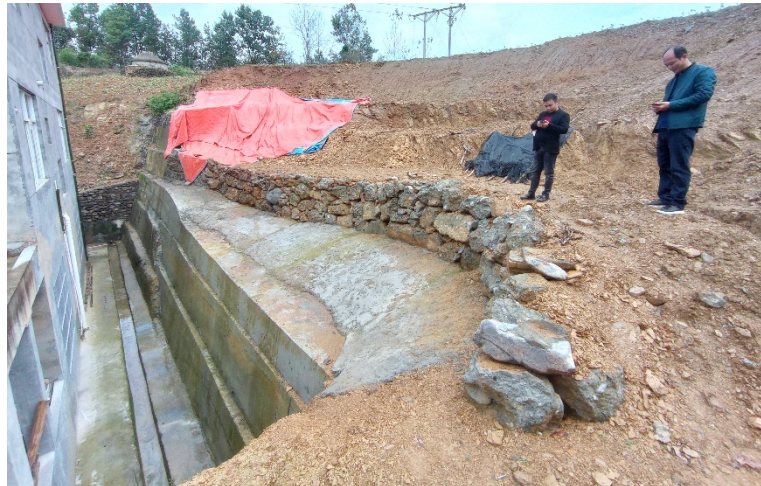
**Figure 6.** Image of a group of landslides in Huaishu village after treatment.

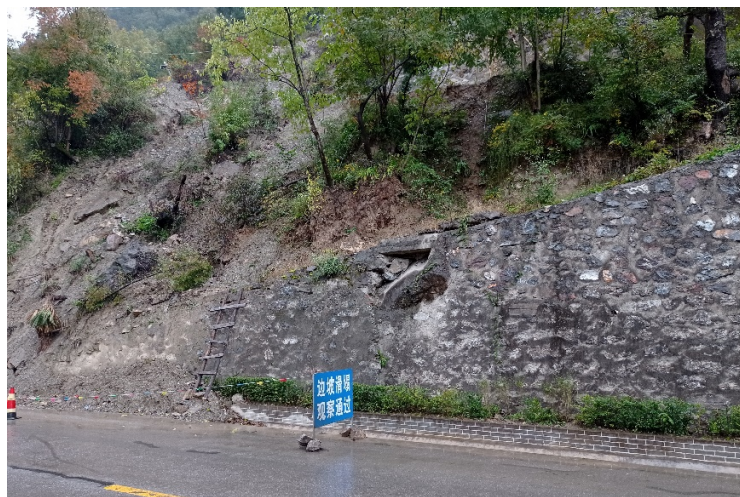
Figure 7. Landslide road blocking in Guandi mountain village.

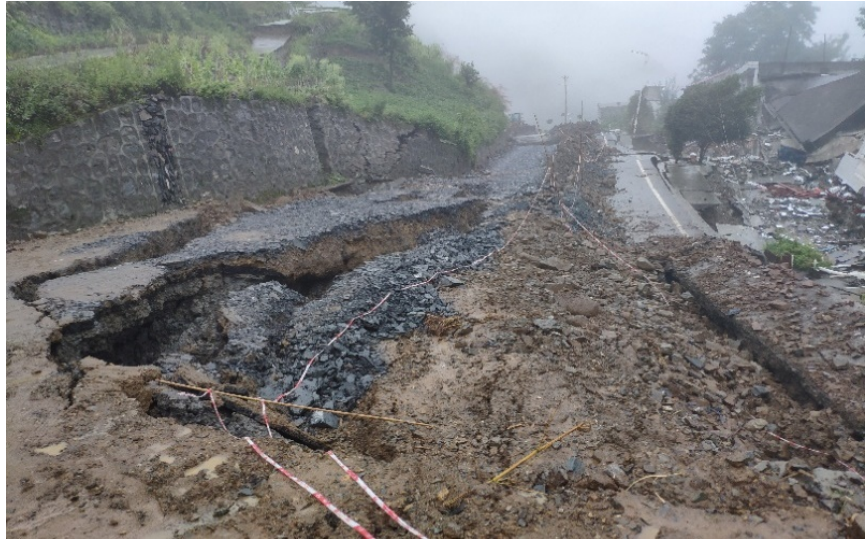
**Figure 8.** Traffic interruption due to landslide in Group 4, Zhujiexi village.

the traffic. At 6:10 on July 20, the landslide slipped, and the road surface of S225 Province sank about 1.6 m. Two houses of Xu Longbing and Xu Longguo collapsed, and the other eight houses were subject to different degrees of settlement and damage. After the pavement and houses were deformed and damaged, the traffic and power of S225 Provincial Highway were interrupted. As a result of organizing mass evacuation in advance, 23 casualties in 10 households were successfully avoided, and production and living materials worth about 1.5 million yuan were transferred in advance.
